International
Journal of
Sustainable
Construction
Engineering and
Technology

Effective Building Surveying Using Laser Scanning for Heritage Building Documentation

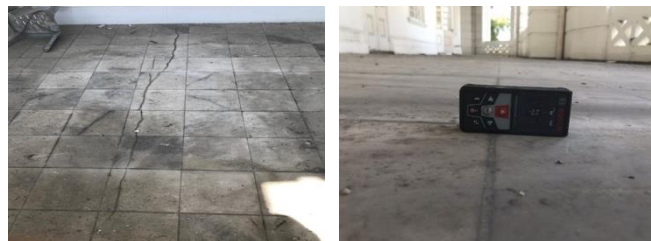
Due to its abandonment, the post office had more flaws than the town hall. The façade, roof, ceiling, floor, doors, and windows were the primary areas of the building where defects were found during the walk-in survey. The most prevalent flaws in this structure were cracks, moisture, leaks in the roof and ceiling, leaky waterproofing on the roof slab, broken decorative elements on parapet walls, mould growth, and paint-related defects (peeling, spalling, and blistering). Moreover, the first level's timber floor was buckling and the concrete floor had a structural crack (Figure 2). The crack was observed during the walk-in survey and noted alongside the falling ceiling.

Fig 2 - Structural crack, slanting of floor slab, and fallen ceiling detected during the walk-in survey

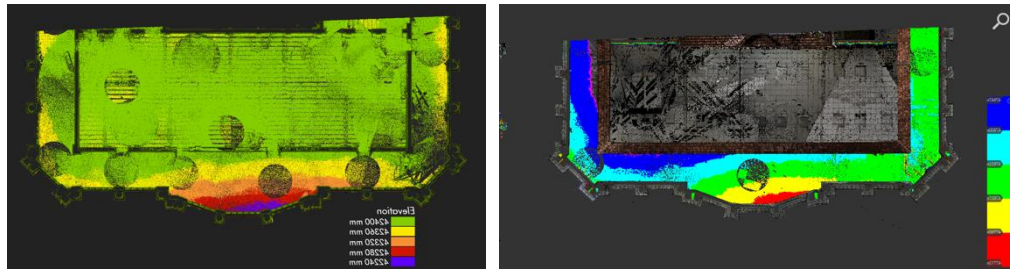
Analysis of the laser scanning image further indicated the structural problems of the floor based on the level of sloping indicated through level analysis. A 3D rendering of the building was produced via laser scanning and it depicted every little aspect of the façade, including cracks and growth. According to the TLS study, the post office's veranda slab

sloped significantly towards the building's southeast corner. Conversely, TLS created an elevation heat map from the roof floor and slanting veranda to find any issues and the source of deterioration (Figure 3). It also precisely recreated a building's section in order to show the slant and inclination. Further forensic analysis by structural engineers is recommended to ensure the structure's integrity.

Fig 3 - Heat analysis from scanned images showed differences in height (represented by colours), confirming the slanting of the floor

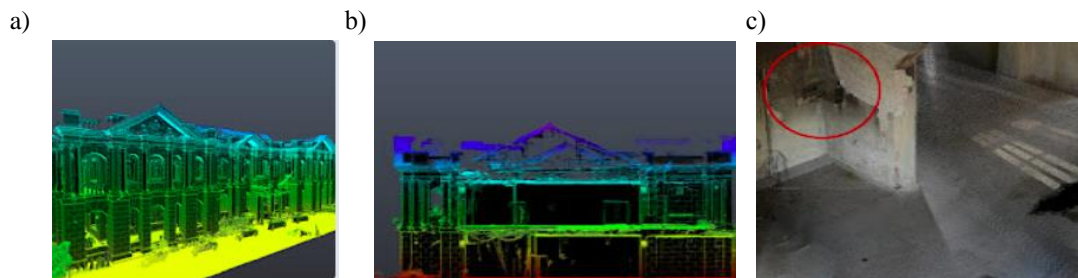
The Galeri Kraftangan Seremban building was left unoccupied during the surveying process. The main areas where faults were discovered during the walk-in survey were the façade, roof, ceiling, lighting and electrical systems, floor, doors, and windows. The most common defects in this building were cracks, wetness, roof and ceiling leaks, mould development, paint-related flaws (peeling, spalling, and blistering), and the structural integrity of the hardwood floor structure on the first level. Moreover, the structural integrity of the timber floor was compromised in some areas, making it dangerous for anyone to be within. Some aspects of the floor structure could not be identified by a walk-in survey but were detected through the TLS analysis. Analysed images from the laser scanning detected structural deformation of the floor slab that could lead to collapse (Figure 4). Both surveys detected that the building had experienced a fire, as evidenced by the fire marks on the wall (Figure 5) and the main switchboard. The affected area required repair work.

Fig 4 - (a) Point cloud data for Galeri Kraftangan Seremban; (b) section through scanned image showed deformation on the floor that was alarming; (c) fire marks from the laser scanning photo image

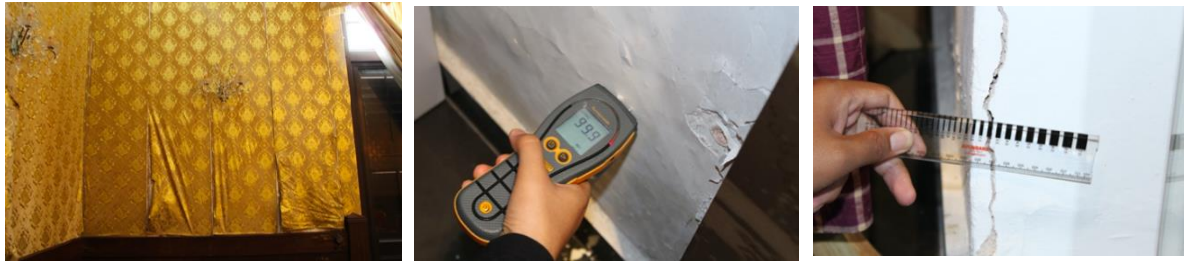
Fig 6 - Defects that were detected during the walk-in survey (dampness) and could be tested using a non-destructive test
