Climatic Influence on Slope Failure: A Case Study at Kem Terendak, Melaka

Raazlizam Lias¹, Ismacahyadi Bagus Mohamed Jais^{2*}, Diana Che Lat³

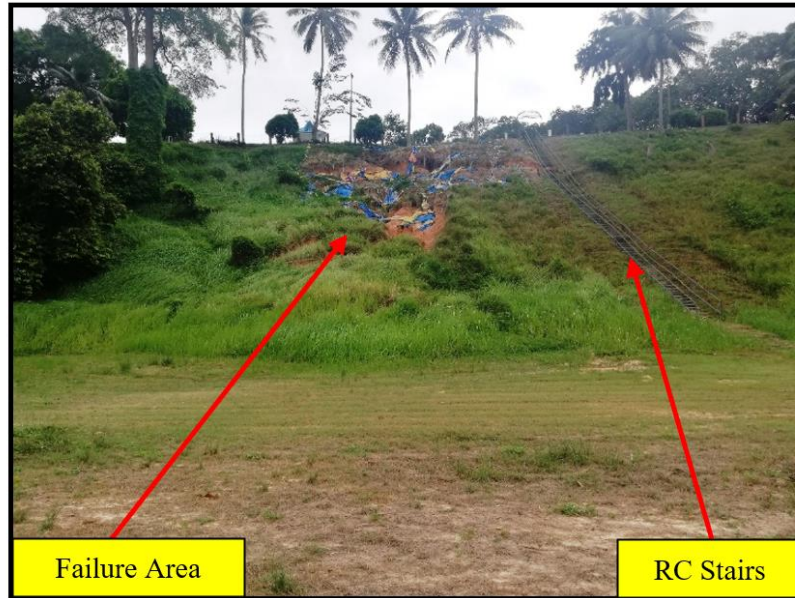
Fig. 4 - View of the slope

The study area is a high slope located on the coast of Kem Terendak, Melaka. The geometry of the landslide is a high slope measuring 21 m high, 50 m wide, and at an angle of 30°. The slope area housed an executive bungalow at the top of the slope, while the bottom of the slope was an exclusive picnic area. The slope is a single-flight slope without any terrace—the entire surface covers with cow grass without trees. There are reinforced concrete stairs on the side of the landslide area used as a path to walk down to the slope's toe (refer to Figure 4). The soil was eroded and slide down within to about 1 m onto the ground, debris from the failed slope accumulated with rill erosions created for water discharging (refer to Figure 5). Landslides also damaged the reinforced concrete stairs to go down the hill and were no longer safe to use.

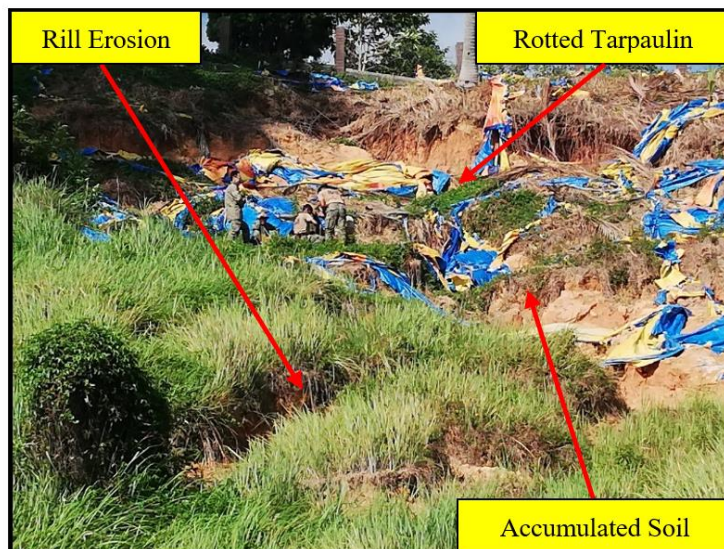
Fig. 5 - The slope condition after landslide

Based on slope stability analyses done, the proposal for remedial works considers strengthening the slope at Kem Terendak, Melaka, as below.

- Existing high slopes can improve by cutting to a gentle slope angle to achieve the required factor of safety.
- Proper slope drainage system must be proposed at the new remedial slope to prevent the water from flowing from the existing building, allowing slope flight.
- Berm come with drain need to be built at every 6 m high slope to shorten the flowing down of water. The surface runoff will accumulate at the berm faster than the original slope and flow down 20 m to the toe of the slope.
- If any, slope strengthening with soil nail can be proposed by installed at a minimum of 9 m nail through the hard bedding soil.

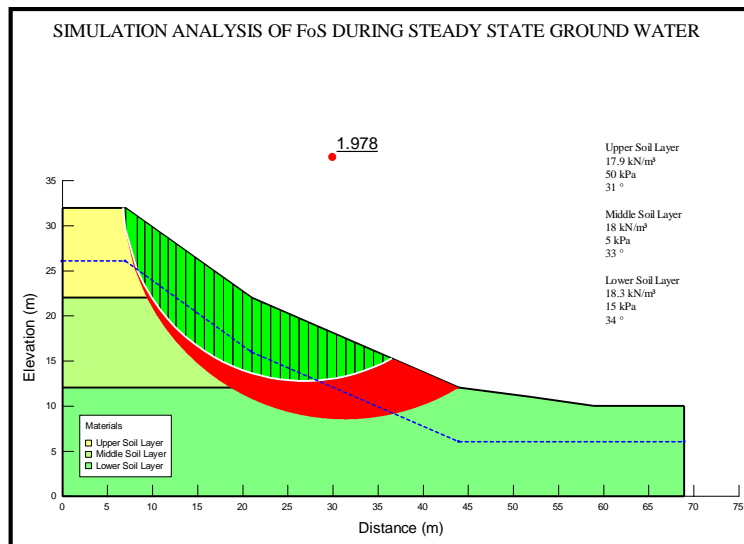
Fig. 9 - Simulation result FoS for steady state of groundwater

Condition	Factor of Safety	Remarks
Pre-Failure Slope Profile	1.978	Safe
Groundwater level increase to the same level of slope flight surface (piezometric line level increase 6.3m to the slope surface)	0.968	Failed
Slope wetting front due to rainfall-runoff infiltration (>5 m into the slope)	0.294	Failed

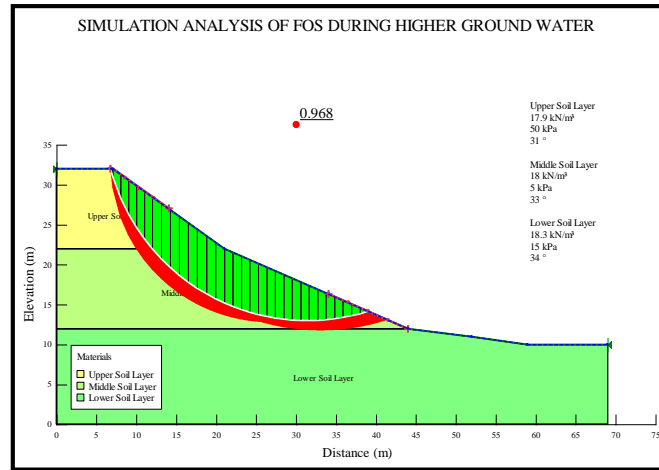
Fig. 10 - Simulation result FoS for rising of groundwater

The results in Table 7 show that the slope failed during water changes, either increasing groundwater or rainfall-runoff infiltration. As shown in the site investigation report, the analysis process can assume that the groundwater level was relatively high (6.3 m). At the same time, heavy rains during the monsoon season have battered the study area, causing high water infiltration into the slope and accumulated without having much time to drain out, causing the slope to become the wetting front. The findings of this study showed that the slope stability is determined by soil characteristics, infiltration flow, and preceding moisture conditions. It was found that saturated hydraulic conductivity and infiltration intensity exert the most influence on stability, which is consistent with the findings reported. Additionally, this research established that the relative location of the hydraulic conductivity function in relation to the infiltration flow is critical. The pore-water pressure behind the wetting may become constant throughout infiltration. Pore-water pressure behind the wetting front is proportional to the amount of the infiltration flux in relation to the hydraulic conductivity function.

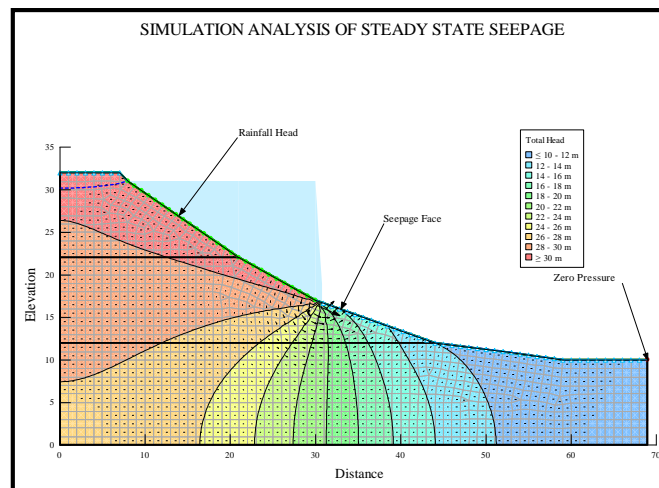
Fig. 11 - Simulation result of total head analysis during rainfall

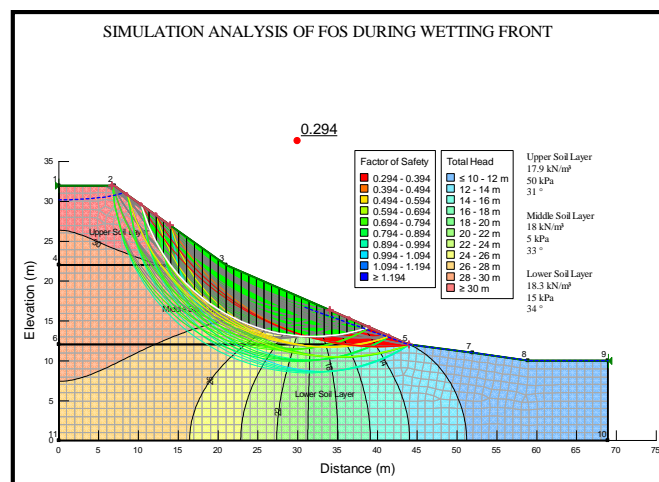
Fig. 12 - Simulation result FoS during rainfall-runoff
