A Case Study on Structural Failure of Reinforced Concrete Beam-Column Joint After the First Significant Earthquake Impact in Malaysia

Keywords: Beam-column joints, Ranau earthquake, seismic activity, soft-storey, strengthening method

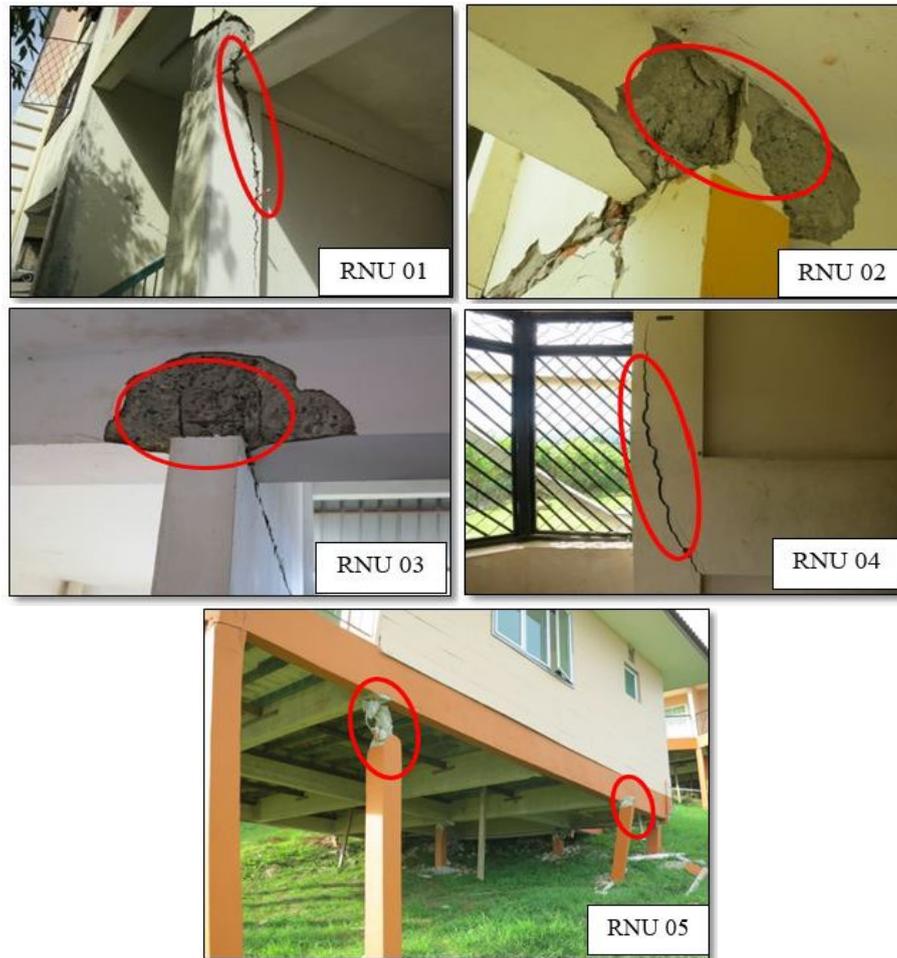
The Ranau earthquake had majorly inflicted damages on the beam-column joints. Enormous cracks and spalling of the concrete cover were noted in those studied areas, as displayed in Fig. 11. It was found that the confinement of reinforcement between the beam-column joints was inexistent in these structures. The reinforcement detailing was found only eligible for gravity load when considering the design buildings based on BS8110-1997. In seismic contemplation, these beam-column joints failed to withstand the lateral load caused by the seismic excitation. In Eurocode 8 [60], Clause 5.4.3.3 states that the horizontal confinement reinforcement in joints of primary seismic beams with columns should be predefined and specified for the critical regions in the columns. Hence, this confinement reinforcement must be placed within the beam-column joints, as proposed for the critical regions in the columns.

A significant increase in ultimate load and ultimate displacement was observed by increasing the amount of confinement reinforcement in the beam-column joints [61]. In some cases, severe cracks were observed at the beam-column joint and elongated to the critical regions in the columns, which caused permanent displacement. The columns seemed to display inadequate strength to resist any lateral load induced by the earthquake. This study has identified that less damage was inflicted at the beam because of the effective presence of good tie beams, but not in the column area, as demonstrated in the 2011 Maden (Elazig) earthquake in Turkey [62]. This condition indicates that most of the case study buildings experienced weak-column strong-beam behaviour, which did not comply with the seismic design provision. This behaviour can be interpreted based on severely-damaged and collapsed RC buildings during the 2011 Van earthquake in Turkey [63]. These joints are considered as the weakest link in a structural system due to the distribution of seismic loadings [64].

Fig. 11 - Severe damage inflicted on beam-column joints

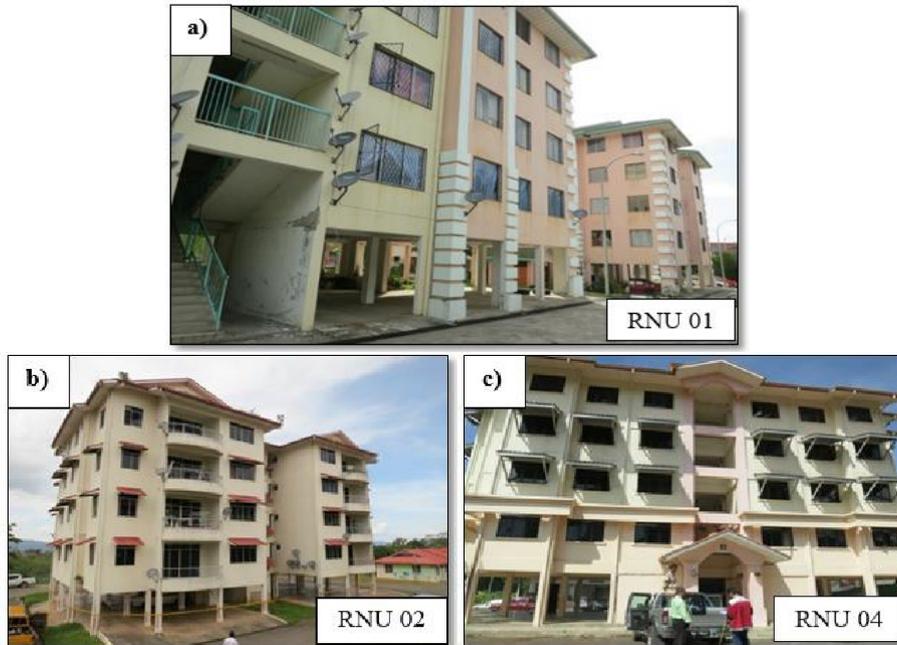
A total of three five-storey residential buildings have been selected and identified to be built without seismic design using RC moment resisting frame. Table 3 summarises the basic structural information, whereas the views are displayed in Fig. 12. These soft-storey buildings, which were coded as RNU 01, RNU 02, and RNU 04, had typical structural configuration with a bare frame located at the bottom part of the building for car park area. These buildings had high influence on soft-storey failure mechanism.

The structural damages on beam-column joints mostly occurred at the bottom storey for all the soft-storey buildings (RNU 01, RNU 02, and RNU 04). This type of failure mechanism was employed when all the inflicted damages were concentrated at the storey (no infill wall or bare frame), which was usually located in the basement area of the building designated for auto stop zone. With the presence of bare frame effect, these storeys had lesser stiffness, when compared with the upper storey with infill wall. Hence, an enormous inter-storey drift ratio could have been experienced by this storey, thus causing severe damages. In a few cases of strong earthquakes, the soft-storey failure mechanism resulted in the total collapse of the bottom storey, as noted in the Kocaeli [65] and Sultandagi earthquakes in Turkey [66].

Fig. 12 - Soft-storey building a) RNU 01, b) RNU 02 and c) RNU 04

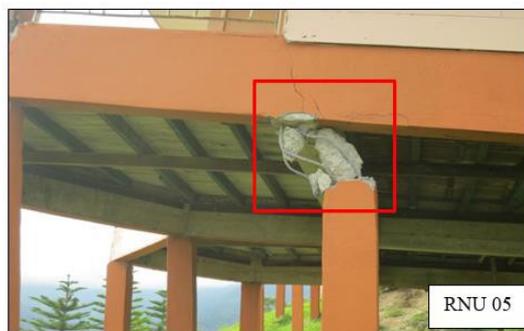
This study points out that RNU 05 had undergone many severe damages and collapse of the RC structural column (see Fig. 13). Poor arrangement in transverse reinforcement (links) was the main factor in the buckling and collapse of the column. According to clause 9.5.3(3) [67], the maximum spacing should not exceed 20 times the size of the smallest compression bar or the least lateral dimension of the column (400 mm). In RNU 04, the lap length found in the column (see Fig. 14) did not adhere to clause 8.7.3 [83], wherein the design lap length between the bars should be greater than 200mm. Thus, this existing structure caused spalling of the concrete in the joint area. Hence, both of the identified failures resulted in a low quality attribute of concrete binding [68]. A proper basic reinforcement design should be countered in detail before engaging in the seismic consideration depicted in Eurocode 8.

Fig. 13 - Improper transverse reinforcement (link space) causing severe buckling and collapse

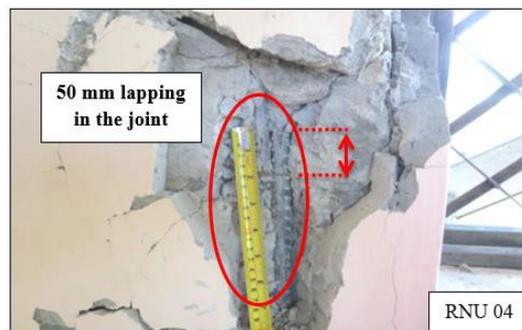
Fig. 14 - Poor and inconsiderable lap length found in joint

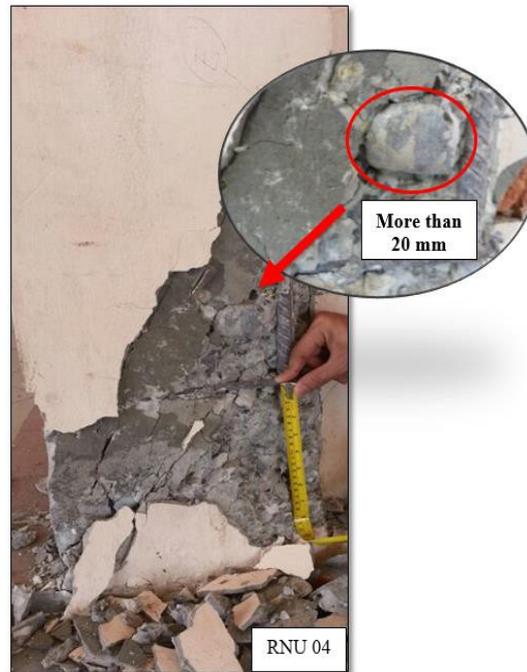
The crack and spalling of the concrete cover were observed in all the case study buildings due to improper size and type of aggregates that were implemented in the structure, as shown in Fig. 15. Although the damages occurred in the existing buildings, the aggregate size for the combined fine and coarse should range between 5 mm and 20 mm [69]. This aggregate does not fulfil the specification in terms of grading, durability, particle shape, surface texture, abrasion and skid resistance, absorption, and surface moisture. The effect of inadequate supervision during the construction period was demonstrated after the main shock, wherein this river stone (smooth surface) did not bond well with the concrete.

Fig. 15 - Inadequate aggregate size found in the column
