# Study of Microstructure and Mechanical Property Degradation of SA210 A1 Boiler Tube

**Keywords:** Degradation, microstructure, mechanical properties, SA210 A1 steel

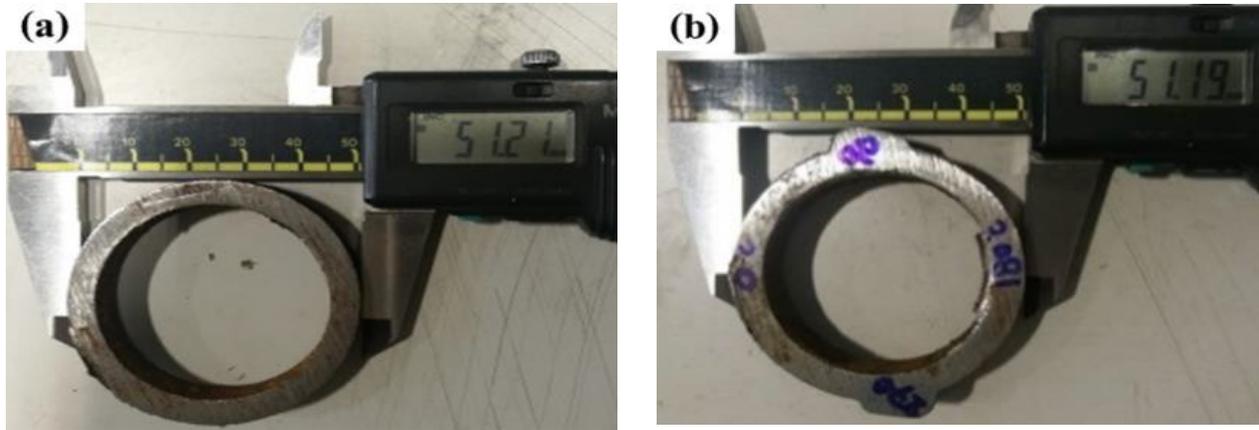
The visual inspection was initially conducted by evaluating the dimension and the present thickness of the used boiler tube by comparing them with those of the unused boiler tube. Result from the dimension check showed that the used tube had no any significant changes in the outside diameter, as shown in Fig.2. Besides, the present thickness of the used boiler tube showed almost no change with respect to that of the unused tube.

**Fig. 2 - The dimension check at the outside diameter (a) unused tube; (b) used tube**

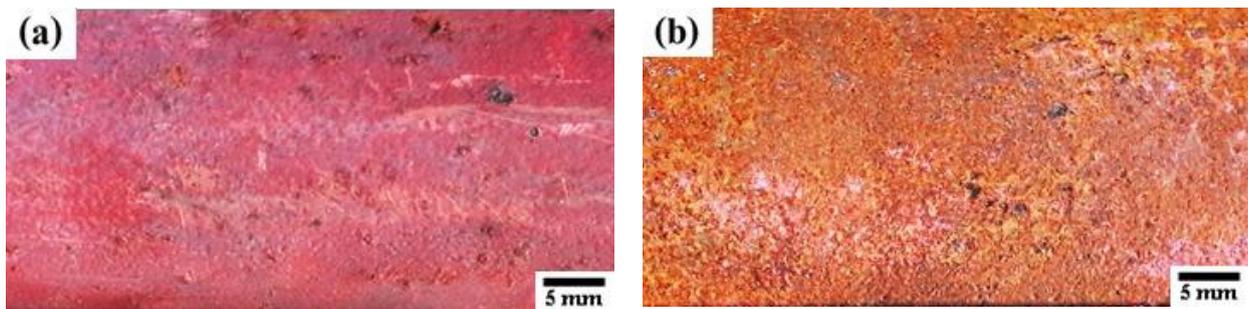
The surface conditions at the outer surface of the used boiler tube were investigated and compared them with those of the unused boiler tube as shown in Fig.3. Results from the inspection displayed no signs of deformations, cracking or any discontinuities on the used tube, but the outer surface of the used boiler tube was rougher than that of the new boiler tube. Usually, steel tubes subjected to the elevated temperature environment for prolonged period of the operating time can be oxidized and form the oxide scales [14]. In addition, the combustion environment from the burning of bituminous coal in furnace zone of the boiler can induce the ash deposits [15]. Thus, the appearance of the rough surface can be attributed to the oxide scales and ash deposits accumulated on the outer surface of the used tube exposed to fire. Normally, the oxide scales or deposits covering on the fire side of the used steel tube can lose adhesion and slowly flake, which could lead to the thinning of the tube wall of the boiler tube in the future [14-15].

**Fig. 3 - Outer surface conditions (a) the unused tube; (b) used tube**

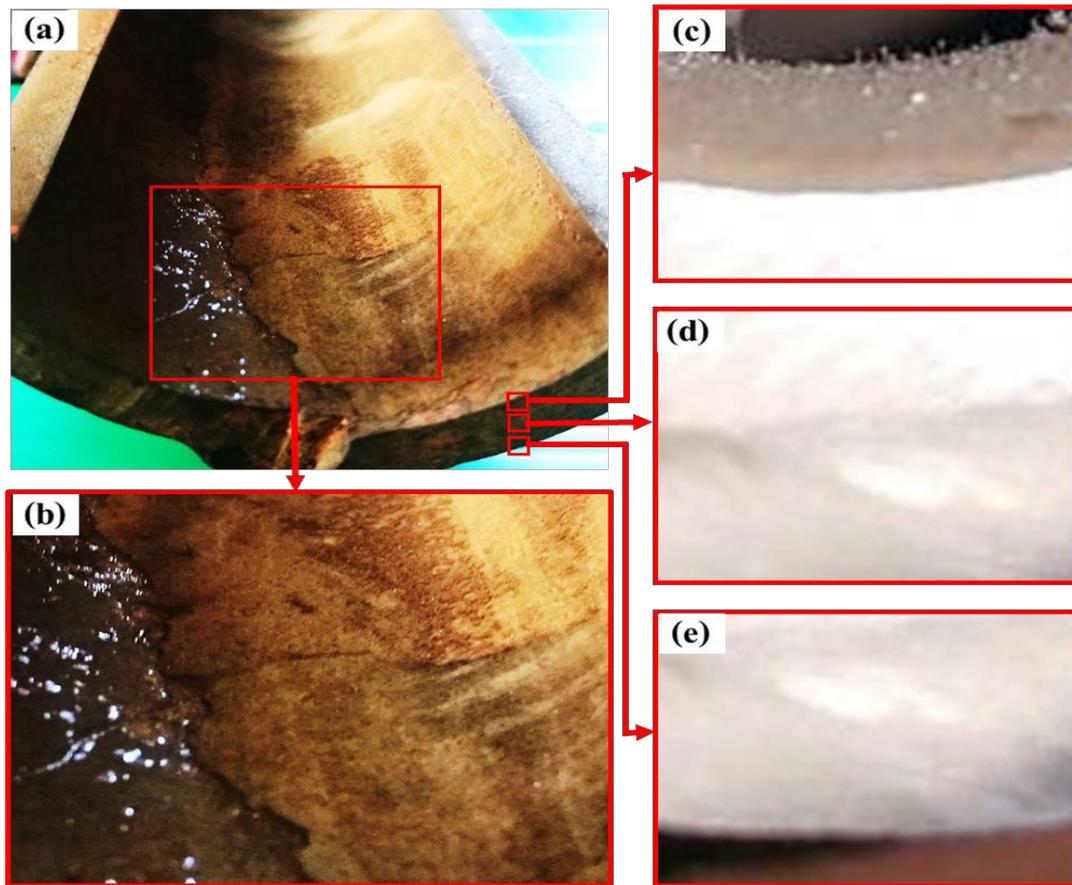
**Fig. 4 - Visual inspection for inner surface conditions of the used tube (a) inner surface; (b-e) high magnification views of inner surface**

The inner surface conditions of the used tube were investigated as exhibited in Fig. 4. Obviously, the inner surface of the used boiler tube showed no signs of corrosion or any damages even though it was partially covered with the thin scale layers as shown in Figs. 4(a)-(b). This finding may imply that the corrosion deterioration would not be the major problem of the steel used in this boiler. Nevertheless, the water quality should be continuously controlled to avoid the formation of the thick scale layers. The thick layers of scales could lead to the corrosion under deposits or scales in the future. The higher magnification views of the cross sectioned tube were exhibited in Figs. 4(c)-(d), indicating that no discontinuities were found within the cross sectioned areas. The magnification view of the cross sectioned area of the used tube in Fig. 4(e) showed no sign of deformation or any discontinuities, which was agreeable to the results of the visual investigation at the fire side of the used tube.

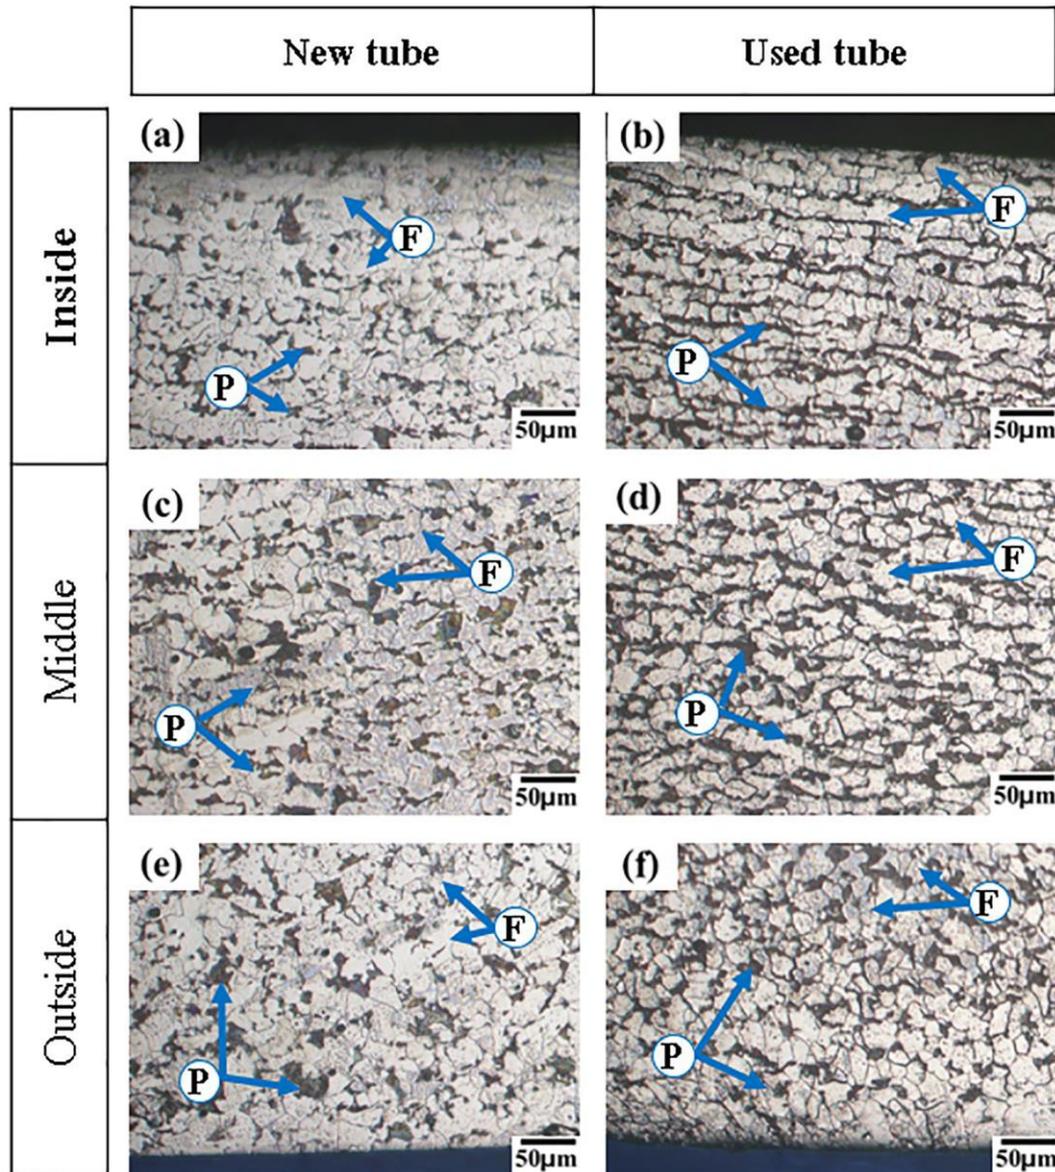
The micrographs of the unused and used tube are shown in Fig.5. The unused tube composed of ferrite grains (white area) and nodules of pearlite structure (dark area), while the used tube was subjected to the microstructure morphology change.

**Fig. 5 - Representative optical micrographs of (a-b) inside of the unused and used tube, (c-d) mid-wall of the unused tube and used tube; (e-f) outside of the unused tube and used tube exhibiting black regions of pearlite (P) and white regions of ferrite ( F )**

As seen from Figs. 5 (d) and (e), the changes in shape and size of pearlite at the inside and mid-wall of the used tube were obvious. These findings mean the first step of the microstructure change and indicates the beginning of the pearlite disintegration. The microstructure morphology observation of the outside of the used tube in Fig. 5(f) exhibited the first step of the pearlite coagulation. Basically, SA 210 A1 is a low carbon steel which contains the mixture of ferrite and pearlite. [16-17] Pearlite is usually considered to be less stable than ferrite, especially when carbon steel is heated for sufficiently long time [18]. Thus, the high temperature service condition in the furnace zone of the boiler causes the degradation in microstructure morphology, resulting in the onset of the disintegration and coagulation of pearlite.

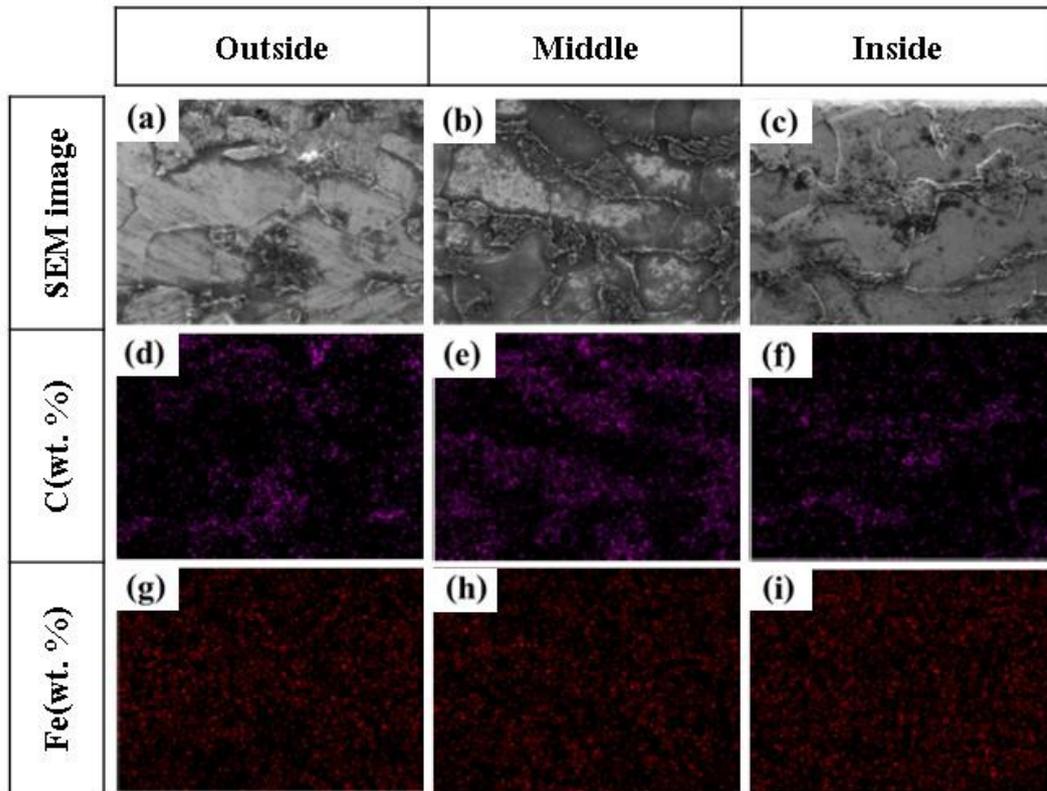
**Fig.6 - SEM micrograph together with EDS analysis of used steel tube (50X) of outside, mid-wall, and inside of the used tube (a -c) SEM image, (d-f) Distribution of carbon; (g-f) Distribution of ferrous**

SEM micrographs of the used steel tube from the outside, mid-wall, and inside are exhibited in Figs. 6 (a), (b) and (c). SEM micrographs of the used tube apparently indicated the changes of the pearlite morphology. Obviously, the pearlite phase containing in the outside of the used tube tended to be coagulated, while the shape of pearlite observed at the mid-wall and the inside of the used tube tended to be disintegrated by distributing at the grain boundary of ferrite. Carbon and ferrous distribution in the used steel at the outside are shown in Figs. 6 (d) and (g) and those of mid-wall, and inside of the used tube are provided in Figs. 6 (e) and (h) and Figs 6 (f) and (i), respectively. Clearly, the ferrous distribution showed the uniform dispersion throughout the matrix of all of investigated areas. However, the distribution of carbon illustrated the accumulation of carbon where pearlite phase exists. At the outside steel tube, carbon tended to locally aggregated. This possibly indicates the change of the pearlite shape and confirms the finding of the beginning of the pearlite coagulation in Fig. 5(f). In the mid-wall and the inside of the used tube, carbon tended to be distributed along the grain boundary of ferrite. This also means the change of the pearlite morphology and supports the finding of the disintegration of pearlite, as illustrated in Figs. 5(b) and (d). The findings of the coagulation and the breakdown of pearlite in the degraded boiler tubes were also discussed by several authors. U.K. Chatterjee et al [19] showed the imprints of the pearlite coagulation and disintegration in the plain carbon tubes used in the boiler. J.Ahmad et al [20] investigated the failure of the carbon steel tubes used at the furnace zone of a boiler unit and found the dispersion of coagulated pearlite throughout the microstructure of the steel. Thus, the findings of the microstructure degradation of the boiler steel tube in this present study are in accordance with results of accepted investigations.

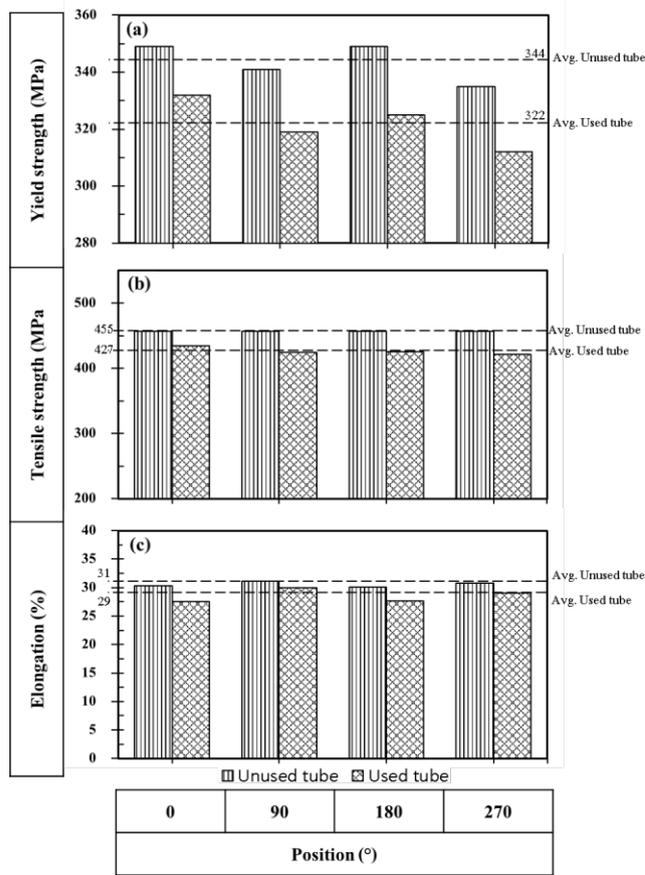
Fig. 7 reveals results from tensile test of samples prepared from the unused and used steel tube. Clearly, tensile strength, yield strength and elongation measured from the used steel tube at 0°, 90°, 180° and 270° were lower than those from the unused steel tube. Usually, tensile and yield strength are two essential properties that can be used to characterize the strength of material [21-22], while elongation is used to indicate the ductility [23-24]. Hence, the steel tube exposed to the high temperature environment of the boiler was subjected to the degradation in the strength and its ductility.

Fig. 7 - Results from tensile test of unused and used tube (a) yield strength, (b) tensile strength; (c) elongation

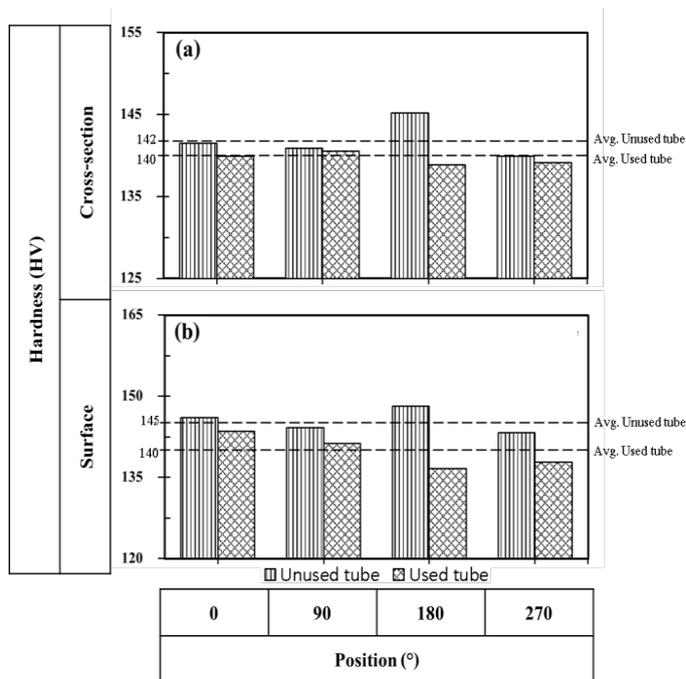
Fig. 8 - Results from hardness test of unused and used tube (a) Cross-section; (b) surface

Hardness test was performed at the surface and the cross section area of the unused tube and used tube. The results shown in Fig. 8 indicated the reduction of the hardness of the used tube with respect to that of the unused tube. All of

the reduction in the mechanical performance of the used steel tube can be attributed to a significant consequence of the changes in the microstructures of the boiler tubes.
