Geotechnical Failures Case Histories of Construction on Soft Soils, Forensic Investigations and Counter Measures in Indonesia

Paulus P. Rahardjo¹

¹Parahyangan Catholic University, Jl. Ciumbuleuit No. 94 Bandung, INDONESIA

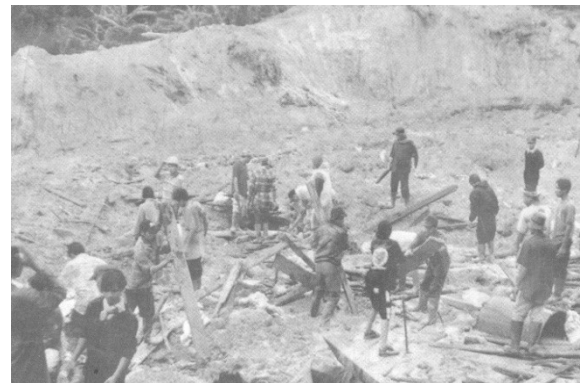
Banten. More than 120 people were killed in these slides in some areas including Desa Lebak Situ, Lebak Gedong, and Lebak Sangka (Pikiran Rakyat, 2001). Fig.1 and Fig. 2 show people looking for their family members in the debris. Tailing dams were regarded costly and in some cases are omitted. Since the tailing material can flow, sliding cannot be avoided even under gentle slope.

Fig. 1 The slide at Lebak that killed about 120 peoples (after Harian Pikiran Rakyat, February 12, 2001).

Prior to the landslides debris flow, the rain intensity was very high. It was predicted that the rain water penetrate into the tailing materials and dykes and causing high water content that result in changes of the soil state into liquid.

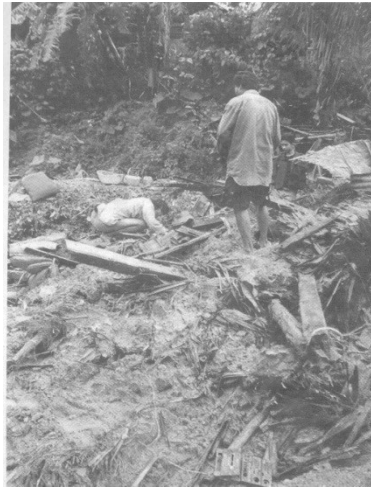
Fig. 2 People of Kampung Kosala - Banten looking for their family members after the slide (after Harian Pikiran Rakyat, February 11, 2001).

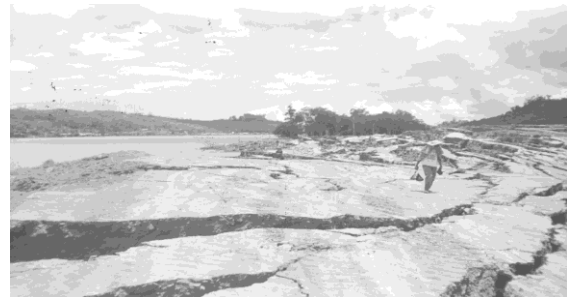
The main reason is the bearing capacity failures of the foundation soils, however in most part of the country, the incidence are generally due to the increase of excess pore water during loading. Most contractors in Indonesia are not aware of these phenomena. Typical example of this type of failure is in the development located north of Samarinda along Mahakam River.

In this particular landslide, deep soft soil exists under the development. The fill material was imported from other borrow area and was to be constructed 17 m high. The contractor fully compact the fill during placement, however no geotechnical design was involved. Sliding took place when the fill reached 15 m high. The slide was a typical deep seated failure.

Fig. 8 Failures of fill constructed on soft soil foundation in Mahakam River, East Kalimantan (photographic documentation, Rahardjo).

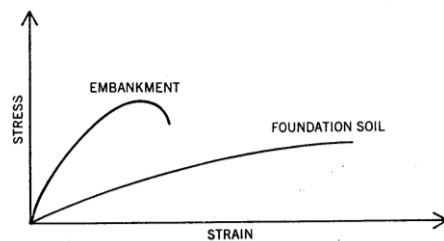
Another important aspect of this slide is because there is significantly different stiffness of the embankment soil and the foundation soil as described in Fig. 12. Since the embankment soil is much stiffer, cracks were developed upon sufficient movement of the foundation soil. This movement was started mainly in the slope and then extending to the upper area. Remedial measures were carried out by re-grading, changing elevation, and leaving the construction until sufficient excess pore water pressure was dissipated.

Fig. 9 Different stiffness of foundation soil and fill material.

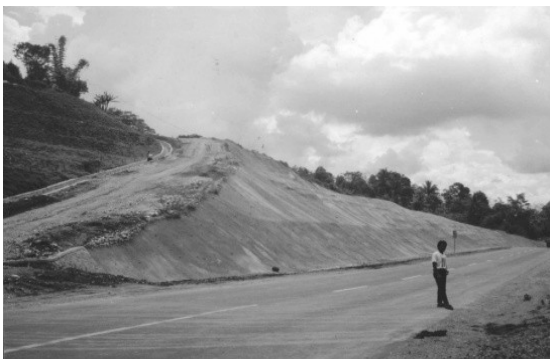
Fig. 10 Protection of the cut slope from severe weathering located at Citatah, West Java (photographic documentation, Rahardjo).

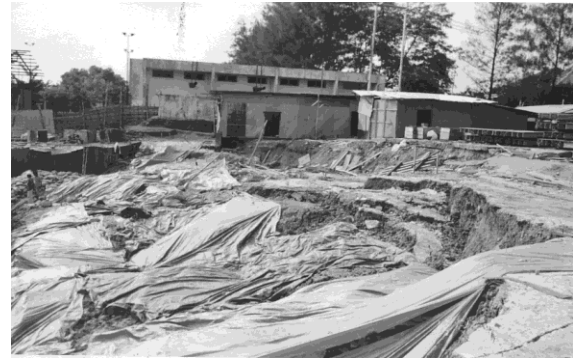
An event of failure in cut slopes occurred in excavation for basement in Surabaya. This excavation was conducted in soft soil protected by sheet piles with a depth cut of 8.0 m. The failure was understood as a result of significant deformation of the sheet piles and failure at the toe (Fig. 14). Emergency action was to avoid water penetration through the cracks by plastic sheet cover. Further action at this event was by constructing soldier piles of 800 mm diameter at an interval of 1.50 m.

Fig. 11 Slope failures during excavation for basement in Surabaya (photographic documentation, Rahardjo)

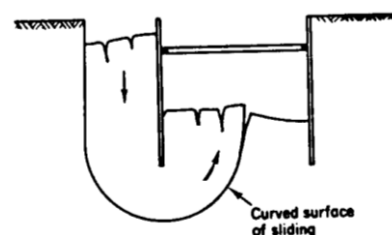
Fig. 12 Failure of sheet piles due to deep sliding of excavated soft soils [16].

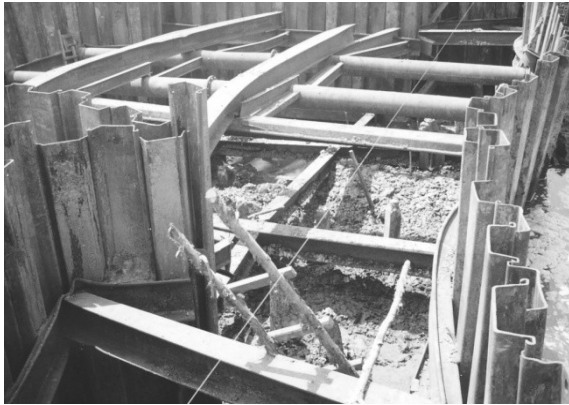
Soft soils are responsible for the failures of many retaining structures. A number of such failures are because the mechanism which is not understood by the designers as well as the contractors. One of these examples is the failure of sheet pile embedded in the soft soils East of Surabaya. The depth of the soft soil layer reaches about 20 m where 12 m of a steel sheet pile were driven. The failures occurred when the excavation was about 3.0 m depth. Heaving was detected one day before the failure indicating deep sliding and the sheet pile underwent kicking out at the toe causing loosening of the strutting system and imbalance in stability. Fig. 15 and Fig. 16 explains the situation of the sliding and failures of the structure.

Fig. 13 Failures of sheet piles in soft soils due to deep sliding underneath the structure in Surabaya (photographic documentation, Rahardjo).

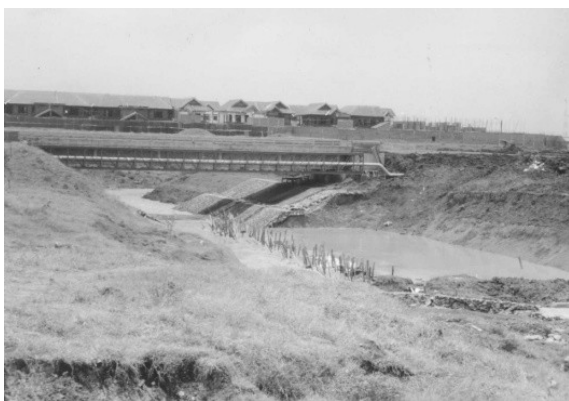
At Cikarang, however, the slope at a bridge abutment failed because of the contact between the expansive soil and water in the main drainage canal. Forensic geotechnical investigation lead to the conclusion that soil softening of the expansive material is in contact with the water caused the failure. The expansive soils, although well compacted, is subjected to absorption of water. This process started from the surface and result in a significant strength decrease.

A study by Rahardjo and Meilani [13] for soils in Padalarang shows that the influence of saturation has a very significant effect on the decrease of soil shear strength. Upon saturation, a natural and compacted sample in Padalarang may loose as much as 70 – 90 % of its shear strength.

Fig. 14 Failures of abutment fill due to soil softening (photographic documentation, Rahardjo).

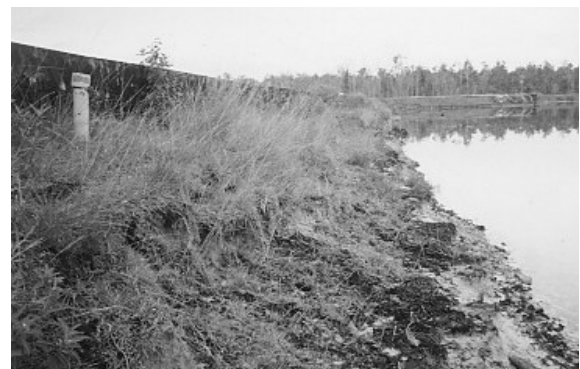
In some cases, embankment has been constructed using dispersive soils such as silts (Fig. 18). Most of the reason is due to the availability of this material near the site and because of the limited budget to import better materials from outside the project area. One of such a case was found in the Samboja Dam, East Kalimantan. This dam was constructed in 1979 and has experience a number of failures during construction. Although the dam is very low (about 8.0 m), the stability is endangered by the erosion due to dispersion of soil in the upstream area. In 1999, a study was performed to increase the safety of the dam. The result of the study recommended that the dam should be heightened by about 3.20 m and this is done using non dispersive material.

Fig. 15 Embankment failures due to soil dispersions at Samboja Dam, East Kalimantan (photographic documentation, Rahardjo).

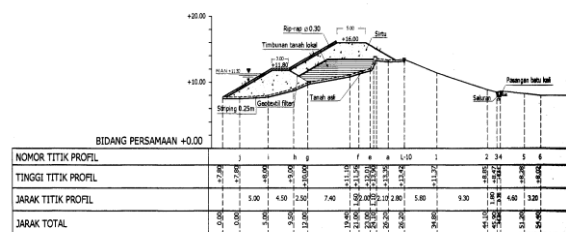
Fig. 16 Slope rehabilitation of dispersive embankment dam in East Kalimantan (after PT. Ganesha Piramida, 1999).

Fig. 19 shows design rehabilitation of these slopes. To protect the dispersive material, a piece of geotextile was laid and gravelly sand was used to cover and increase the height of the dam.

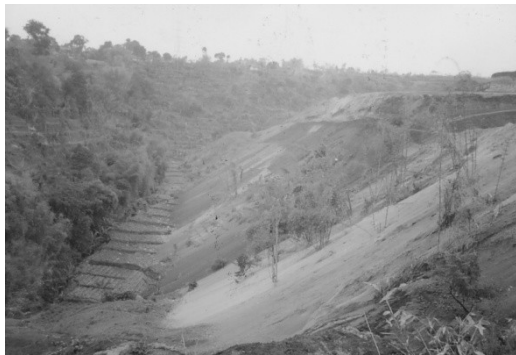
Many slope failures in West Java are caused by uncontrolled fill placement such as in North of Bandung and in Purwakarta. It is shown in Fig. 20, very high fill (about 25 m) was placed without clearing of the original slope and without compacting. The slope failed because of the quality of the fill and the existing soft soils under the embankment. To overcome this problem, the fill was added at the toe of the slope bridging the gap with the other hill across the embankment. Additional fill was added to flatten the slope in a more engineered way.

Fig. 17 Uncontrolled high fill embankment, North of Bandung (photographic documentation, Rahardjo).

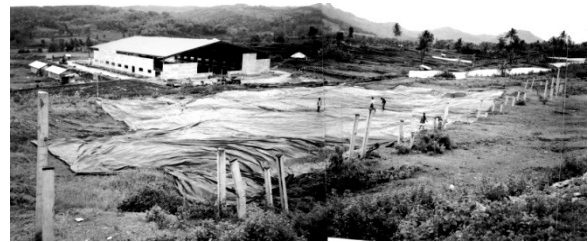
Another example of landslide in poorly compacted fill was found in Purwakarta, where the fill was about 6.0 m thick placed on top of claystone. The fill moved during the 1996 wet season and continued moving until 1999. Emergency action was done by covering the sliding area with plastic sheets to prevent water infiltration into the sliding soil. Fig. 21 shows this emergency action. Forensic geotechnical investigation using CPT revealed that compaction lift was done at very high fill thickness as shown in Fig. 22. In this figure, it is shown that the compacted area shows higher tip resistance revealing the thickness of the lift, which is about 1.50 m. The softer part of the fill has higher void ratio and hence forming accumulation of water during rain.

Fig. 18 Emergency action for handling landslide in Purwakarta by Temporary Cover [14].

This landslide endangered factory building on top of the slope. Action recommended at this part was by constructing rows of bored piles of 400 mm diameter and 10 m depth. Finite element analysis on this slope problem was conducted by Rahardjo (1999) as shown in Fig. 23.

This method is effective and enable to stop movement of the poor fill material. In 2001, the slope was rehabilitated by a contractor, not in accordance with the geotechnical recommendation. The contractor used gabions instead of bored piles. Due to soft layer underneath the gabions, the slides are reactivated. Heaving occurred under the gabions and subsidence due to slides damages the infrastructure. An important lesson is taught by the difference in the concept since the contractor has used conventional slope stability analysis assuming the soil a rigid body, which is not true for soft soils. It has to be noted that the equilibrium condition of rigid body and deformable body shall be further studied.

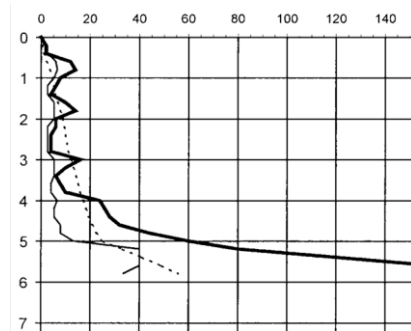
Fig. 19 Indication of compaction considerable thickness lift [14].

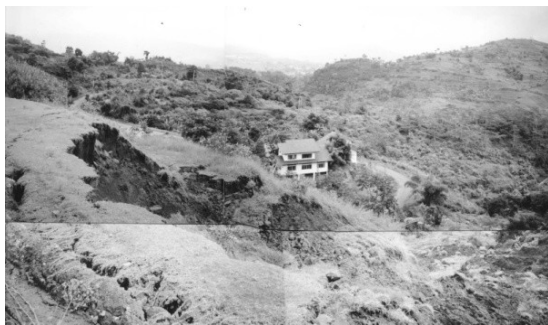
Poorly compacted fill material has been responsible for the failure in a development area in Cipanas (Fig. 24). This area is hilly and many cuts and fill were conducted to meet the landscape for the development. The amount of fill reached more than 2 million m³ and placement were done during rain. The fill material has very high water content. After 1 year of placement, the fill started to form many cracks, which are easily penetrable by rainwater. The slide occurred in the following rainy season. This lesson is very important that compacting under high water content has the risk of cracking and later on, water infiltration.

Fig. 21 Sliding of poorly compacted fill material in Cipanas, West Java (photographic documentation, Rahardjo).

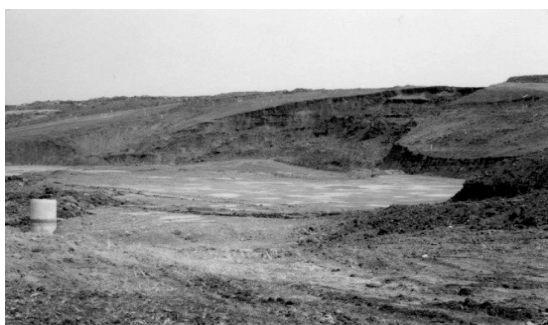
Embankment of sandy soil, which is not protected against water penetration has resulted in 1995 failures as found in Karawang along Jakarta – Cikampek Toll Road (Fig. 25). The slope is gentle, having an inclination of H : V = 3 : 1. The slides occurred during a long run, where due to the high permeability of the sand fill material, water penetrated into the embankment and water percolation inside the body of the embankment cannot be avoided. The relatively flat position of the slope was one of the main cause to ease the water penetrate into the embankment since insufficient surface drainage was available.

Fig. 22. Failures of slopes consisting of sand fill materials (photographic documentation, Rahardjo)

The result is, internal erosion took place and the sand was eroded to the toe of the slopes. Initially small spring appeared at the toe and this spring became wider and finally causing the slides. This has initiated further failures of the embankment as shown in the figure and water has accumulated at the toe.

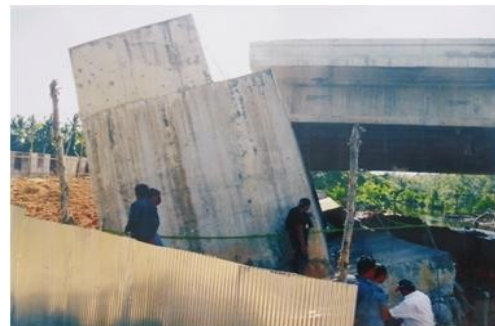
The following figures (Fig. 26 and Fig 27) show the failure of bridge abutment during the backfilling behind the abutment of about 4 m. The soft soil underneath the foundation of the abutment move laterally causing excessive displacement of piles.

Fig. 23 Failures of bridge abutment [21]

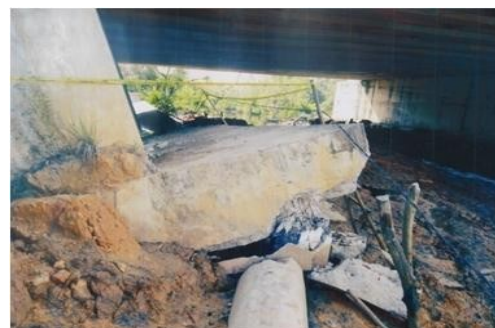
Fig. 24 Lateral displacement of bridge foundation [21]

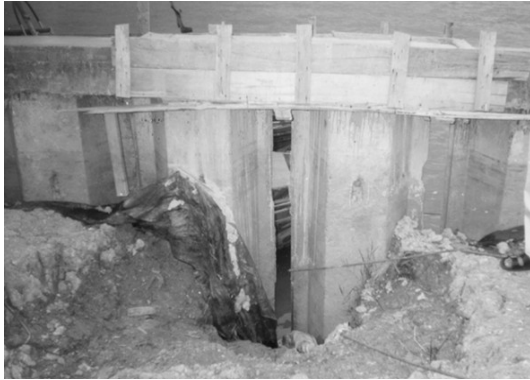
2000 and 3.0 m – 5.0 m fill was placed one year later. The failure is due to the excess pore pressure developed during filling (Fig. 28). This pore pressure is estimated to be about 50 – 60 ton/m³ as the placement was carried out in relatively very short time. Either textbook or conventional method of calculation does not take into account this excess pore pressure, which should have been controlled by staging the fill placement.

Fig. 25 Failures of sheet piles due to excess pore pressures during fill placement in Palembang (photographic documentation, Rahardjo).

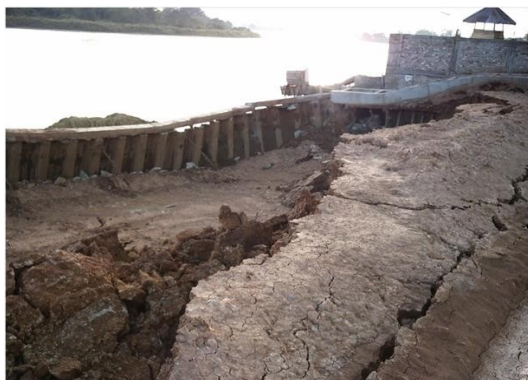
A similar situation was also due to the failure of sheet piles in Jambi, Sumatera where the failure was induced by excess pore pressure generated by the backfill (Fig. 29). In the geotechnical forensic investigation, it was found that the design did not include the magnitude of excess pore pressure nor any method proposed to dissipate the pore pressures such as installation of vertical drains or staging fill placement.

Fig. 26 Failures of sheet piles due to excess pore pressure during fill placement.

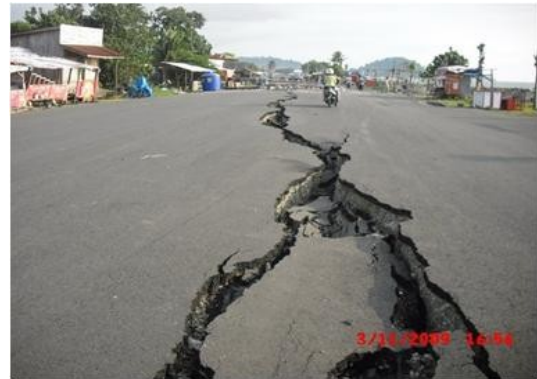
Sliding due to earthquake induced liquefaction is the main event causing failures as encountered at Padang Pariaman (Fig. 30) earthquake 29 September 2009 and in the coastal area of Maumere City during the 12 December 1992 earthquake in conjunction with liquefaction mechanism.

Fig. 27. Lateral displacement in Padang earthquake (photographic documentation, Rahardjo)

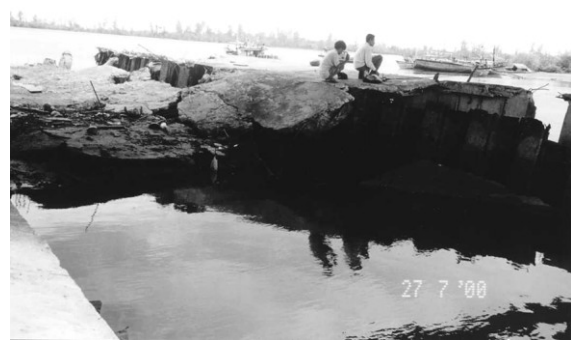
Another phenomena of this type of slide occurred during the Bengkulu earthquake of the year 2000 where sheet piles with silty sand backfill failed during the earthquake (Fig. 34). The failure is due to slide at the toe as well as the increase pore pressure acting on the sheet piles.

Fig. 31 Failures of sheet piles due to liquefaction (photographic documentation, Rahardjo)

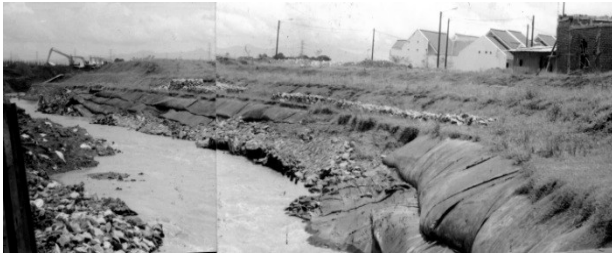
The second major project of geotextile reinforced earth failures occurred at Cibubur, West Java, where the very high slope was constructed up to 27 m. The slope was made from 14 layers of geotextile encased soil compacted in the field. The failures were initiated by sliding of the toe, which is indicated as bearing capacity failures. The failure was at the lower layer where the soil used for fill was red clay, which after compaction is expected to achieve cohesion value of 0.5 kg/cm². However, theoretically, even if this strength is achieved, the bearing capacity of the bottom layer will not be sufficient to carry the load of the fill. Another expected cause of this slide may be the existence of ground water, which flow freely under gravity and were blocked by the fill placement. This action causes accumulation of the ground water behind the reinforced earth structure and soften the fill material as well as generating water pressure on the structure. Based on study by Rahardjo [19], an indication of the bearing capacity failure is revealed through modeling of the staging of construction using finite element analysis (Fig. 36).

Fig. 32 Failures of earth reinforced embankments (photographic documentation, Rahardjo).

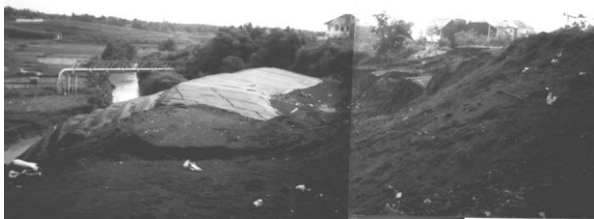
Fig. 34 View of the slope failures from the river (photographic documentation, Rahardjo).
