# Geological Terrain Mapping using Geographic Information System (GIS) and Drone Photogrammetry

**Abstract:** The research area was conducted within the Bukit Persekutuan, Kuala Lumpur, and it was located at the latitude 3° 8'32.93"N and longitude 101°40'32.80"E. The researcher carried out geological terrain mapping to evaluate the research area in accordance with the geological terrain classification attributes of each thematic map produced, namely, Terrain map, slope gradient map, erosion, and instability map, as well as construction suitability map. The occurrence of landslide events within the research area becomes a major contributing factor to thoroughly conducting an investigation by field mapping and analysing using the Geographic Information System (GIS) technology. The application of Geographic Information System (GIS) and drone photogrammetry images play an essential role to analyze and process the data, thus, generate the thematic maps. The research area indicates that about 79.11% of the overall area was not appreciable with erosion, 8.58% contribute to the erosion, 11.00% of recent general instability, and 2.97% represent a landslide event. The suitability for develo

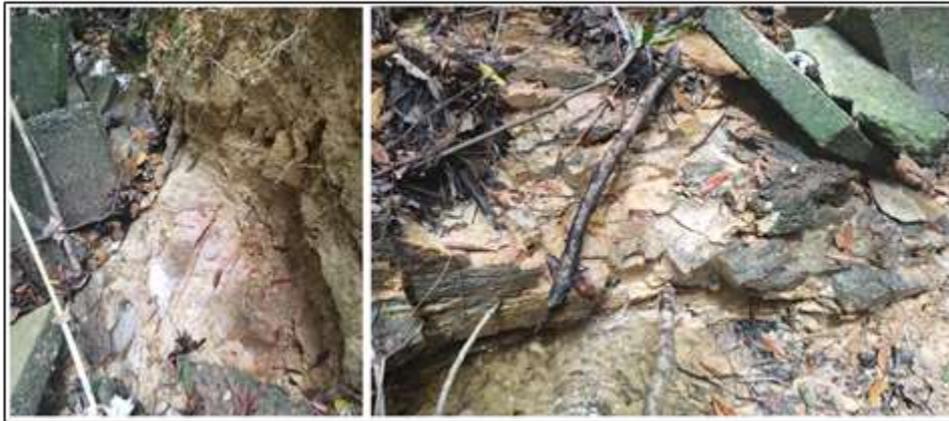
Fig. 3 - The foliated highly weathered phyllite exposed at drainage due to the water scouring erosion

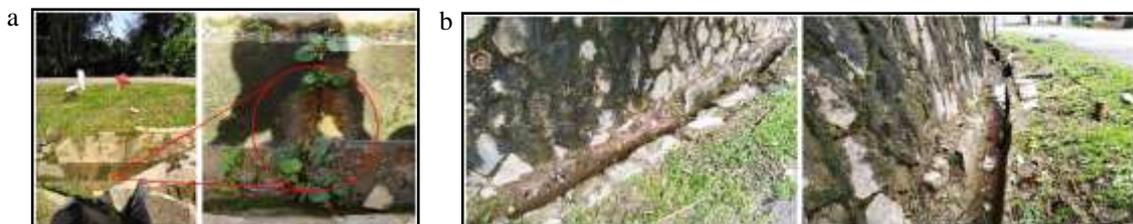
Fig. 5 - (a) Water flow due to the buried pipe leaks observed at the research area; (b) Continuous water flowing in the drain due to pipe leakage at the top of the slope near the landslide area

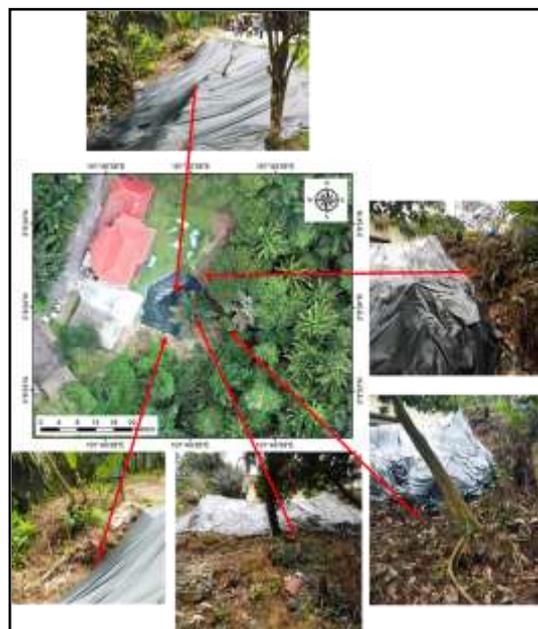
Field mapping identifies landslides events that occur in the project area. In Figure 7, the landslide size area of about 150m<sup>2</sup> and involves residual to completely weathered phyllite. The rotational failure of soil mass displaced the tree in an inclined state. The rotational failure landslide depicted the movement of soil mass on a concave slip plane. Figure 8 shows the water scouring erosion that occurs along the existing drainage. The water scouring erosion has been worsened due to the high intensity of rainfall. From field observation, the geometry and shape of the slope failure resemble much of a deep rotational landslide with a subcircular sliding plane and curved crown.

Fig. 7 - The rotational failure of soil mass movement at the site. The displacement of a tree in an inclined state, an indicator for slope movement

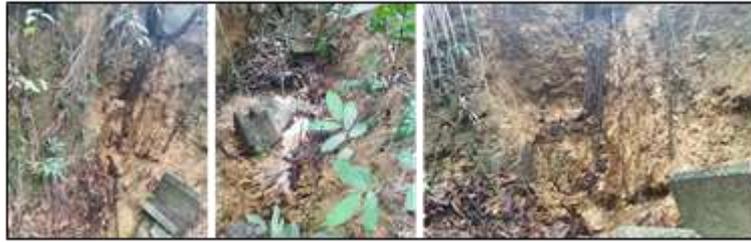
**Fig. 8 - The water scouring occurs along the broken cascade drain. The water scouring causes the instability of the ground and could be triggered an enormous landslide**

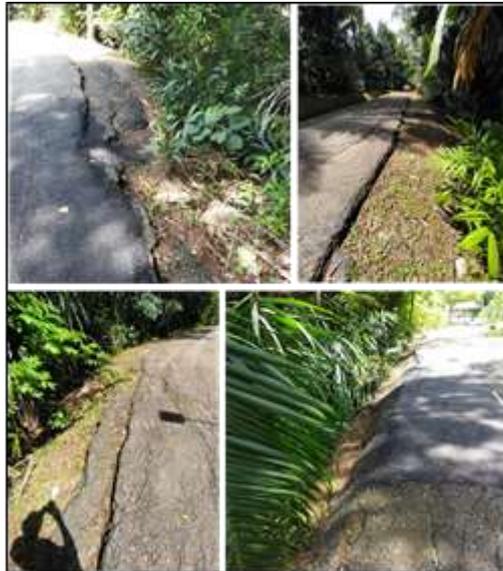
Figure 9 shows the tension cracks along the pavement edge, indicating side movement towards downslope. Figure 10 shows recent instability at the roadside slope where the existence of tension crack at the upper part of the natural slope and possible to contribute to the landslide event. Besides, at the Figure 10, it shows the geodynamic events at the site where crack features were present at the drain's sump and stone pitching wall. There was also slope displacement as an indication of localizing landslides. All the signs events as discussed above show high potential for the landslide. Thus, an instance preventive measure was needed to avoid a large-scale landslide.

**Fig. 9 - Some pavement distress indicates the slope movement resulting in the displacement of the pavement. The tension cracks appear along the road**

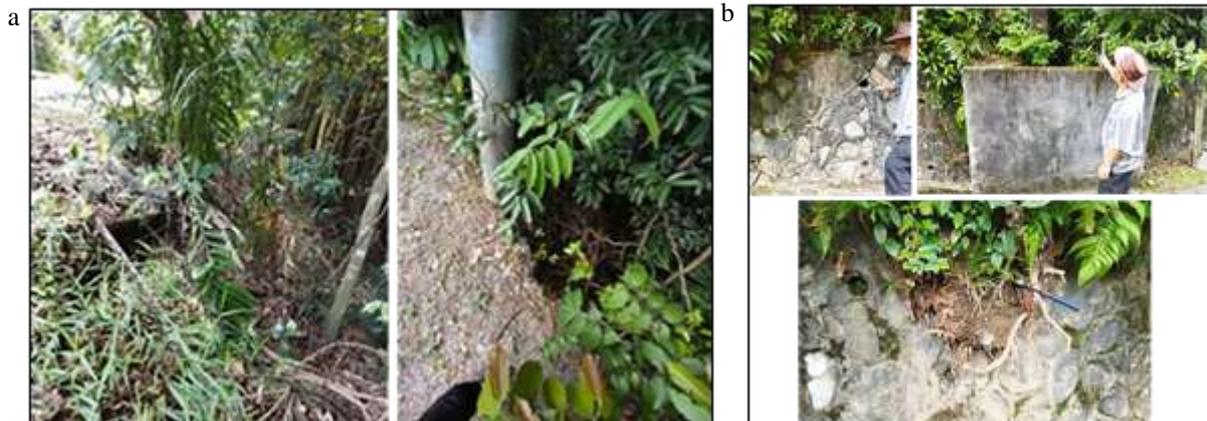
**Fig. 10 - (a) The recent instability occurred at the roadside area where the existence of tension crack at the upper part of the natural slope can contribute to the landslide event; (b) The geodynamic events occurred at the site where the crack features at the drain's sump and stone pitching wall. There was also slope displacement as an indication of localizing landslides**

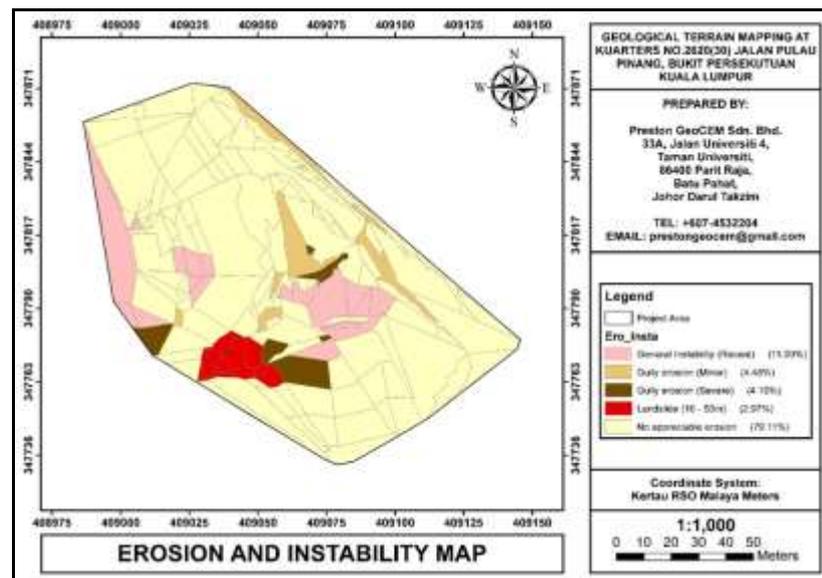
The erosion and landslide failure affect the project site. There was one type of erosion: gully erosion with different degrees of severity. Other than erosion, some indicators of severe landslides were significantly depicted at the project site. The size ranged from 20-60m. Landslide mainly occurs at the slope with more than 25° angle, especially at grade V-VI materials. The erosion and instability map are presented in Figure 12. The erosion and instability map shows that 79.11% of the project site's total area was not appreciable with erosion, while 8.58% of erosion area, 11.00% of instability area and 2.97% experienced landslide events.

Fig. 12 - Erosion and instability map generated based on input from field mapping conducted previously at research area
