Visual Inspection of Roofs in Heritage Buildings using the Photogrammetry UAV Method

This study was conducted to capture and process images using the photogrammetry UAV technique as well as to analyze the type and extent of defect to the heritage roof of Hang Tuah Museum located in Hang Tuah Centre, Kampung Bridge Duyung, Melaka.

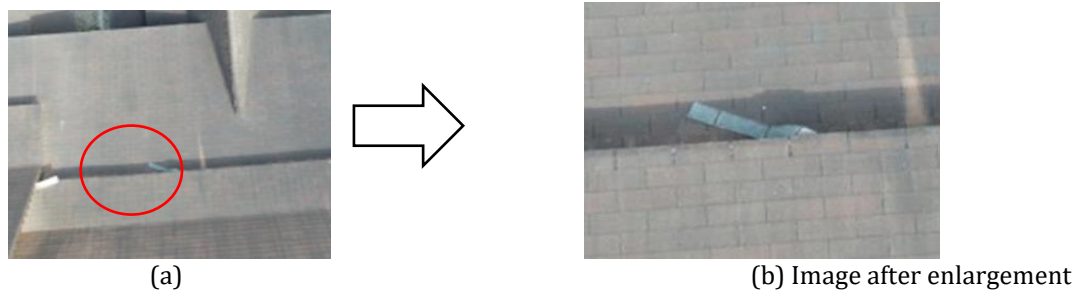
Fig. 4 Image magnification to determine the type of defect, (a) Image before enlargement, and (b) Image after enlargement.

Fig. 4 shows one example of a way to determine the location, type, and extent of defect in more detail. The image of the defect before being raised shows the initial location of the defect on the roof and the image after being raised shows the defect more clearly.

The coordinates for defect 1 i.e. 2°11'57.9630"N, 102°17'54.0258"E are derived from the Global Mapper detail to determine the exact location of the defect. The defect is classified at level 3 which is dire in nature. Priority assessments are classified at level 2, which is routine as there are minor defects that can be serious if left unchecked. The value of the matrix obtained is 6 as a result of the state value multiplied by the priority value i.e... The resulting colour match is yellow because the value of 6 is located on the yellow match based on $3 \times 2 = 6$ **Table 1**. This colour match consists of three colours, namely red, green, and yellow, which are used to distinguish three parameters based on the total score. The overall condition of the building can be assessed using the matrix value found which is 6 indicating that it needs monitoring of the situation.
