# Case Study: Road Safety Inspection Along Federal Route FT23 in Bandar Tangkak Using Unmanned Aerial Vehicle

<sup>1</sup> Department of Civil Engineering, Centre for Diploma Studies

Universiti Tun Hussein Onn Malaysia, Pagoh Higher Education Hub, 84600, Pagoh, Johor, MALAYSIA

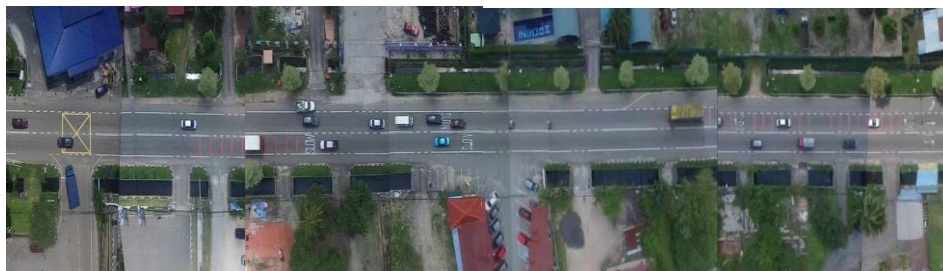
**Fig. 3** Aerial View of FT23 Segment

Fig. 3 illustrates the starting point of the study. The UAV image was used to model the road surface structure from different viewing angles, enabling faster and more detailed analysis. Several issues were identified from the UAV observations. The absence of footpaths along the road forces pedestrians to walk on the roadway, particularly near commercial areas. Furthermore, some road markings were faded or improperly located, reducing their visibility to road users.

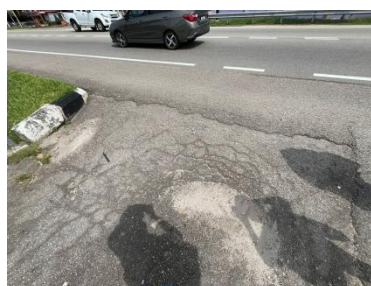
**Fig. 4** Observed issues (a)Obstructed Tactile Path; (b)Surface Cracking; (c)Damaged Curb

A total of 30 different elements were identified in this study, resulting in 76 inspections. The most observed issues were surface wear and cracking (8 inspections), damaged curbs (6 inspections), and obstructed tactile paths (6 inspections) as shown in Fig. 4. Although these problems occur frequently, they do not present an immediate high risk. Nevertheless, proper maintenance and corrective actions are required to prevent further deterioration and potential safety hazards.

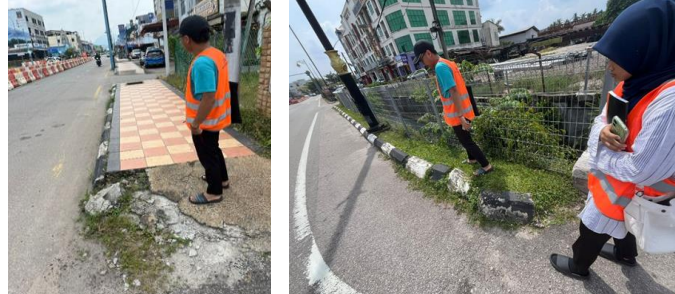
**Fig. 5** Pedestrian Path

The most concerning issues are those that are less frequent but pose significant safety risks. Missing accessibility features and a lack of pedestrian paths (Fig. 5) were found in 1 or 2 inspections, and these are especially dangerous for pedestrians and cyclists, as they limit mobility and increase the risk of accidents. As a conclusion, while frequent issues like damaged curbs and walkways need repair, the most dangerous issues are the gaps in infrastructure that affect accessibility for vulnerable groups. Addressing these issues should be a priority to improve public safety.

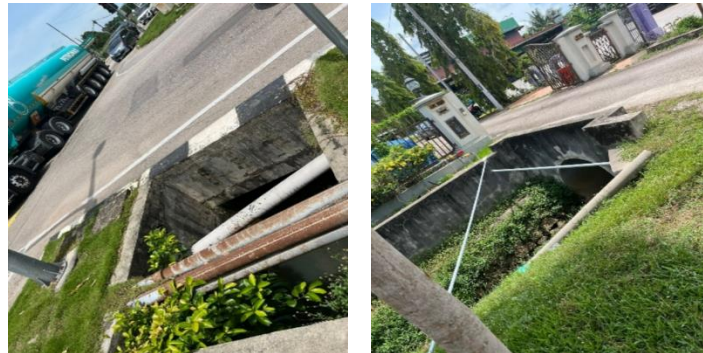
**Fig. 6** Exposed Drainage

There are a few exposed drainage systems near the pedestrian path that present a significant safety risk (Fig. 6). The open drainage and absence of proper barriers or covers could lead to pedestrians, cyclists or motorcyclists accidentally falling into the drain resulting in injuries. Additionally, the exposed drain and surrounding grass area may obstruct pedestrian movement particularly for those with limited mobility. The lack of visible warning signs or barriers increases the chances of accidents.

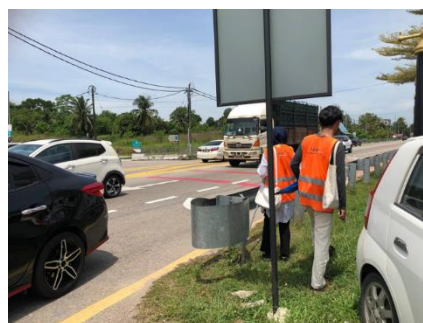
**Fig. 7** No Proper Guardrails Extension

The metal guardrail ends without proper transition or extension (Fig. 7). There's no clear termination treatment like flared ends, energy-absorbing terminals or pedestrian deflection panels. The guardrail is placed close to the road edge but without a designated footpath behind it, meaning pedestrians may be forced to walk on the grass, which can be uneven or slippery.
