Condition Assessment and Non-Destructive Testing on Concrete Structure at Pasar Awam Pagoh

Nik Hafiz Nik Abdul Majid¹, Mariah Awang^{1*}, Mohammad Ashraf Abdul Rahman¹

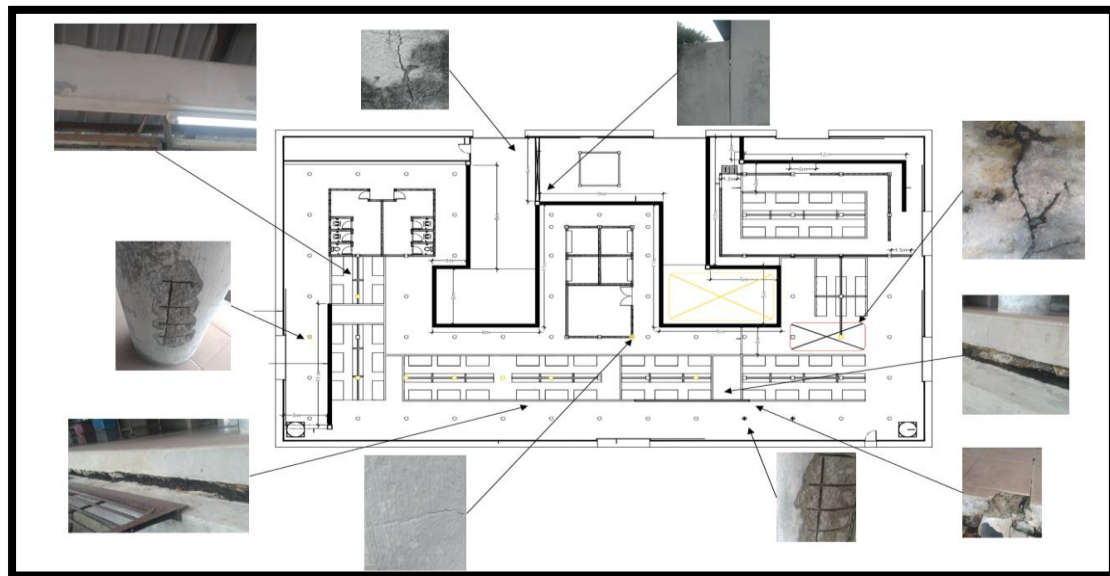
Figure 5: Defect mapping of Pasar Awam Pagoh

Besides, Figure 4 shown that the wet market has covered an area about 1363 square meter not including parking space. of Pasar Awam Pagoh. According to Figure 5 shown that position of building defect has been marked and label with color where red marked as floor crack and yellow as column cracked through Visual Inspection.
