Vibration Analysis on Centrifugal Pump in UTHM Biodiesel Plant

Taranjit Singh¹, Nurhafizzah Hassan^{1*}

¹ Faculty of Mechanical and Manufacturing Engineering
Universiti Tun Hussein Onn Malaysia, Parit Raja, 86400, Batu Pahat, Johor, MALAYSIA

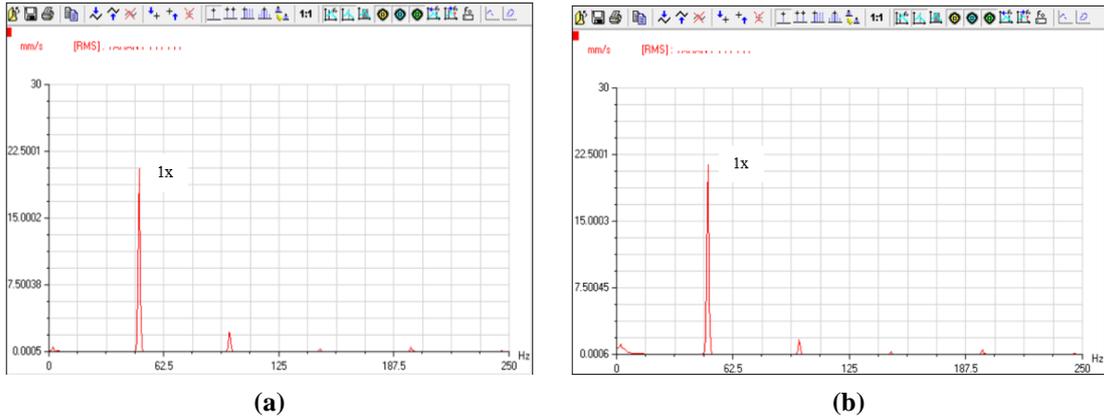
The vibration spectrum for points 1 and 2 horizontal directions in Fig. 9 indicates the pump shows vibration issues related to structural looseness which can be compared to Figure 10 FFT. The FFT spectrum guide shows the peak properties of the structural looseness issue, which generates a strong 1x vibration in the horizontal direction. The harmonic generation of the structural looseness can form 2x, 3x peak generation indicating the severity of the looseness with respect to the frequency at 1x.

In Fig. 9, the FFT spectrum is a structural looseness issue due to the properties of the spectrum whereby there is a strong 1x peak running speed in horizontal direction. This is because the 1x peak running speed in horizontal direction is higher than 1x running speed of pump in vertical direction that indicates it is structural looseness [15]. To support this statement, a comparison of the FFT spectrum is made in Fig. 11 in which the red line indicates point 1 spectrum in horizontal direction and blue line indicates the point 1 spectrum in vertical direction. It shows that the red line peak is higher than blue peak which further proves that it is structural looseness. This type of looseness is caused by structural looseness or weaknesses in the machine's feet, baseplate or foundation [16]. It can also be caused by deteriorating grouting, loose hold-down bolts at the base and distortion of the frame or base (known as 'soft foot') [17]. The recommendation action is by tightening loose bolts, checking wear on nuts and washer, proper mounting of base by adding shim plate to minimize distortion and strengthening foundation support.

Fig. 9 (a) Point 1(Horizontal spectrum); (b) Point 2 (Horizontal spectrum)

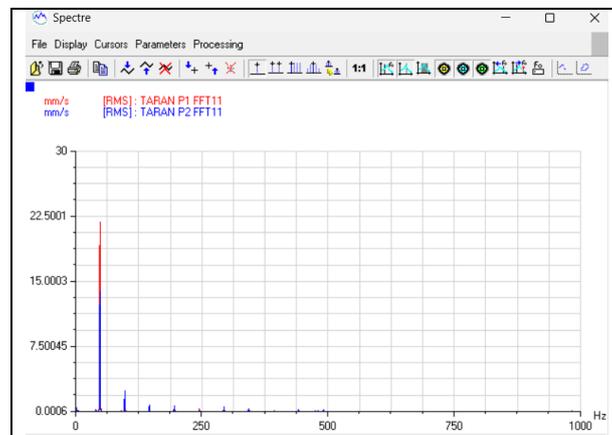
Fig. 11 FFT Point 1 horizontal (red) and Point 1 vertical (blue)

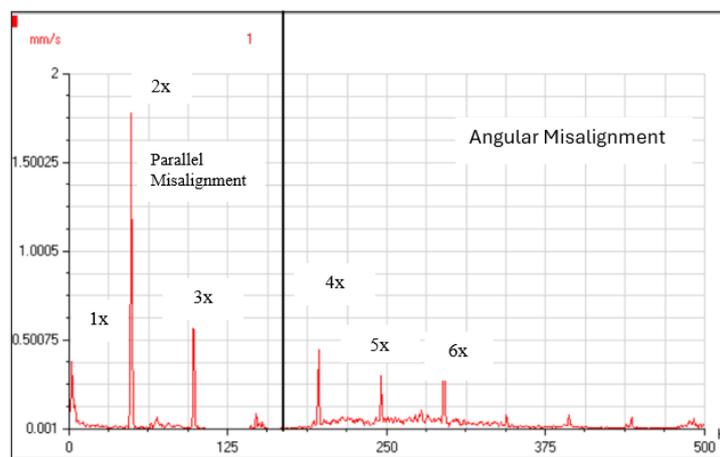
The vibration spectrum for point 3 in axial direction indicates the pump shows vibration issues related to misalignment. The spectrum properties in Fig. 12 can be compared to Fig. 13 for type of misalignment issue. The FFT spectrum guide in Fig. 13(a) indicates the peak properties of common misalignment issues (combination of angular and parallel misalignment) which it generates a harmonic spectrum generation in axial direction or radial direction with 2x peak generation is stronger than 1x peak then followed by decreasing peak from 4x to 6x. The Fig. 13(b) shows angular misalignment properties with 1x peak generation in axial direction near the coupling of motor and pump followed by decreasing peak 2x and 3x. Fig. 13(c) shows parallel misalignment issue with strong 2x peak generation compared to 1x peak generation followed by decreasing peak 3x after strong 2x peak frequency.

In Fig. 12, the FFT spectrum is a misalignment issue due to the properties of the spectrum whereby there is a strong harmonic generation from 1x to 6x peak running speed in axial direction near the motor coupling. The peaks properties show a combination of parallel and angular misalignment. The parallel misalignment shows can be seen at the first three peaks (1x, 2x and 3x). Parallel misalignment shows a predominant 2x peak relative to 1x followed by a decreasing 3x peak. The angular misalignment can be analysed from 4x to 6x peaks. Angular misalignment shows a predominant 4x peak then with decreasing peak of 5x and 6x. The possible causes of this combination misalignment are that shaft centre lines are parallel but spaced apart either vertically, horizontally, or in both directions. Coupled units are not in the same vertical and horizontal planes. This can also be inexperienced students handling the alignment process, such as dismantling the coupling and motor fastener. The recommendation action is by realignment of the coupling using dial indicators before and after for verification. Adding shim plates and adjusting motor height to minimize offset and gap value.

Fig. 12 Point 3 (Axial spectrum)

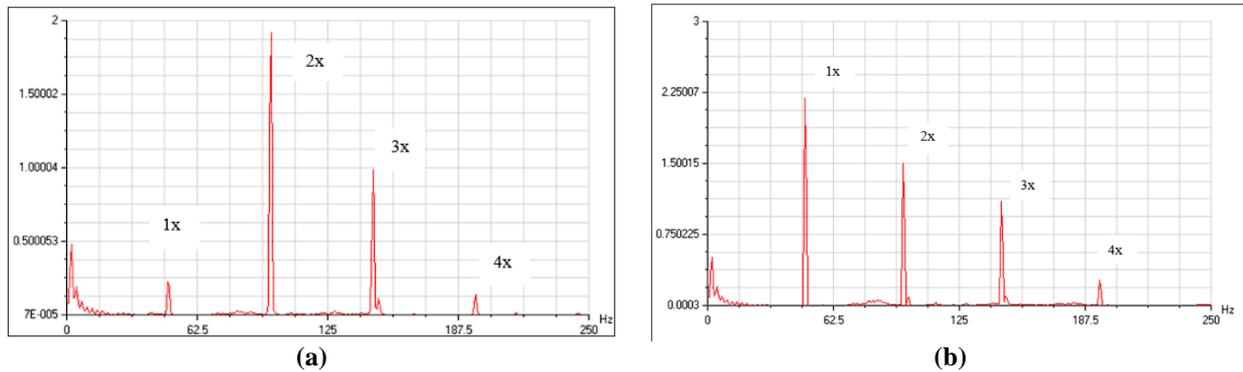
The vibration spectrum at point 2 in vertical direction in Fig. 14(a) indicates that the pump has misalignment. This is due to the properties of the spectrum whereby there is a strong harmonic generation from 1x to 4x peak running speed in vertical. The peaks properties show specific misalignment issue which is parallel misalignment which can be referred to Fig. 13(c) for the peak properties as explained earlier for the misalignment issue at pump P001. Parallel misalignment shows a predominant 2x peak relative to 1x followed by decreasing 3x and 4x peak. The possible causes are the couplings are parallel to each other, but the center line forms offset.

The vibration spectrum at point 3 axial direction indicates that the pump has angular misalignment. This is due to the properties of the spectrum whereby there is a strong harmonic generation from 1x to 4x peak running speed in axial direction as shown in Fig. 14 (b). These peak properties are similar to the FFT spectrum in Fig. 13(b). Angular misalignment shows a predominant 1x peak relative to 2x followed by decreasing 3x and 4x peak. The possible causes are the coupling are not parallel to each other but are angle to each other.

The other possible causes general causes of misalignment for both angular and parallel is also can be due to improper installation of alignment coupling during maintenance. This can also be inexperienced students handling the alignment process, such as dismantling the coupling and motor fastener. The recommendation action is by realignment of the coupling using dial indicators before and after for verification. Adding shim plates and adjusting motor height to minimize offset and gap value. Close coupling method by connecting pump and motor with minimal distance to minimize long shaft or coupling spacer.

Fig. 14 (a) Point 2 (Vertical spectrum); (b) Point 3 (Axial spectrum)

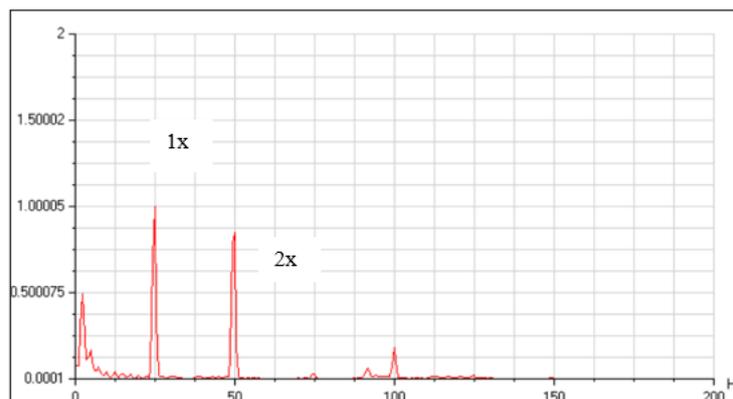
The vibration spectrum for point 3 in horizontal direction indicates the pump shows vibration issues related to looseness in Fig. 15 which is like the peak properties explained in Fig. 9 for pump P001. This is due to the properties of the spectrum whereby there is a strong 1x peak running speed at in horizontal direction as shown in Figure 11 without harmonic generation. The specific type of looseness is structural looseness in which the 1x peak running speed in horizontal direction is higher than 1x running speed of pump in vertical direction that indicate it is structural looseness which is similar to the looseness in pump P001. The cause of the structural looseness is similar as the looseness explained in pump P001. The recommendation action is by tightening loose bolts, checking wear on nuts and washer, proper mounting of base by adding shim plate to minimize distortion and strengthening foundation support.

Fig. 15 Point 3 (Horizontal spectrum)

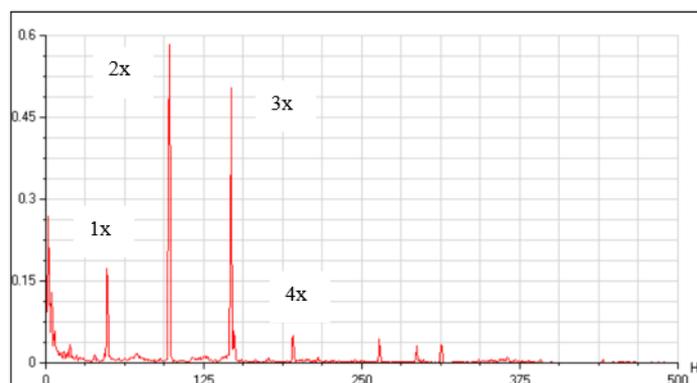
The vibration spectrum at point 2 in the vertical direction indicates that the pump has misalignment. This is due to the properties of the spectrum whereby there is a strong harmonic generation from 1x to 4x peak running speed in the axial direction as shown in Figure 16. The peaks properties show a specific misalignment issue which is parallel misalignment. Parallel misalignment shows a predominant 2x peak relative to 1x followed by decreasing 3x and 4x peaks. This similar to the peak properties as explained in pump P202 for the misalignment issue. The possible causes are parallel to each other, but the center line forms an offset.

The other possible causes are general causes of parallel misalignment due to improper installation of the alignment coupling during maintenance. This can also be inexperienced students handling the alignment process, such as dismantling the coupling and motor fastener. The recommendation action is by realignment of the coupling using dial indicators before and after for verification. Adding shim plates and adjusting motor height to minimize offset and gap value. Close coupling method by connecting the pump and motor with minimal distance to minimize the long shaft or coupling spacer.

Fig. 16 Point 2 (Vertical spectrum)
