Assessing the Strength and Quality of Timber Construction in Masjid Kampung Patah Pedang and Masjid Kampung Parit Lapis Bangas Using Non-Destructive Testing

Fathin Najihah Ramali¹, Nor Azizah Adnan^{2*}

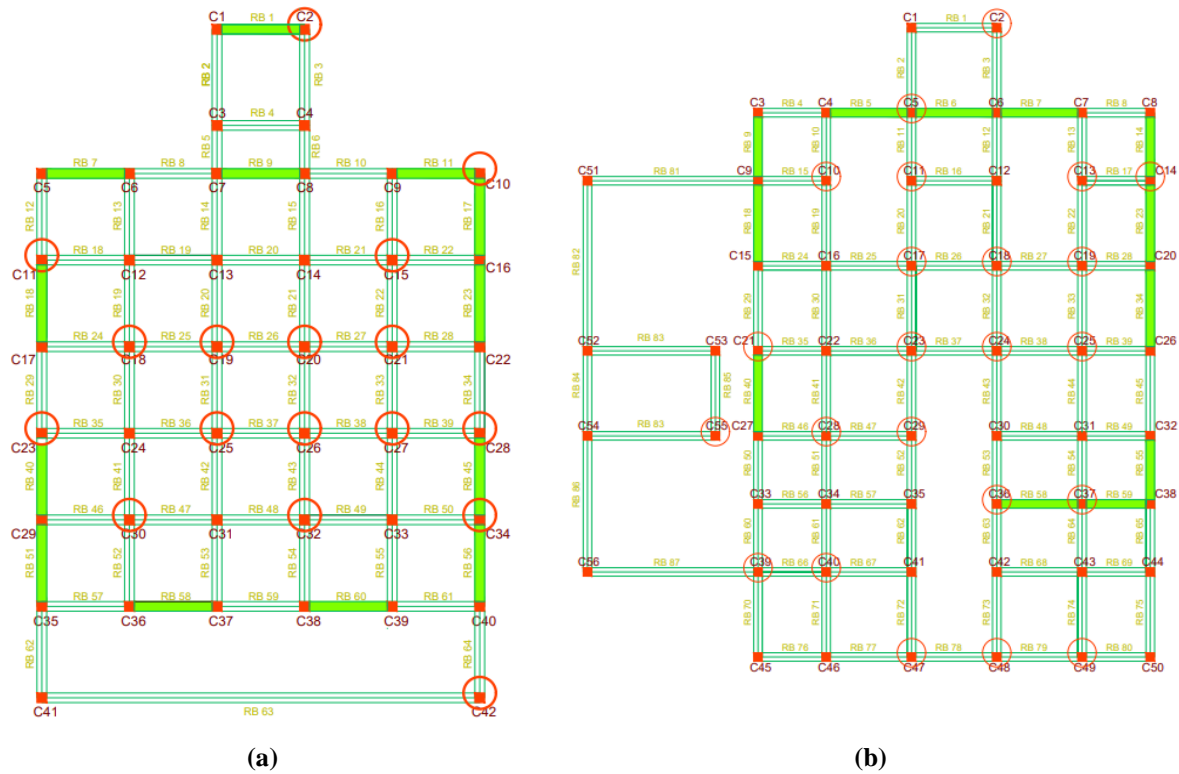
The types of timber structures used in Jamek An Nur Kampung Patah Pedang Mosque are Ponak Wood while Kampung Parit Lapis Bangas are using Chengal Wood. Based on Schedule of Timber Species in Accordance with Strength Grouping (S.G) according to [15], Ponak Woods are in SG4 and Chengal Wood are in SG1. For this study, a total of 5 readings were taken for each structure to get the average and there are two methods delivering that been used for UPV Test in both mosques which is Direct Method and Indirect Method. Direct Method is used for column while Indirect Method is used for roof beam. Direct method is the transmitting and receiving transducers are placed directly opposite each other on opposite sides of the test object. While, Indirect Method is placing both the transmitting and receiving transducers on the same surface of the test object. There are about 30 damaged structures which is 17 column and 13 roof beams in Jamek An Nur Kampung Patah Pedang Mosque while in Kampung Parit Lapis Bangas Mosque, there are 23 column and 12 roof beam which involved in UPV test as shown in Fig 2. The total structures that involved in this testing are 65 damaged structures for both mosques.

Fig. 2 The location for UPV test (a) Jamek An Nur Kampung Patah Pedang Mosque; (b) Parit Lapis Bangas Mosque. C=Column, RB= Roof Beam

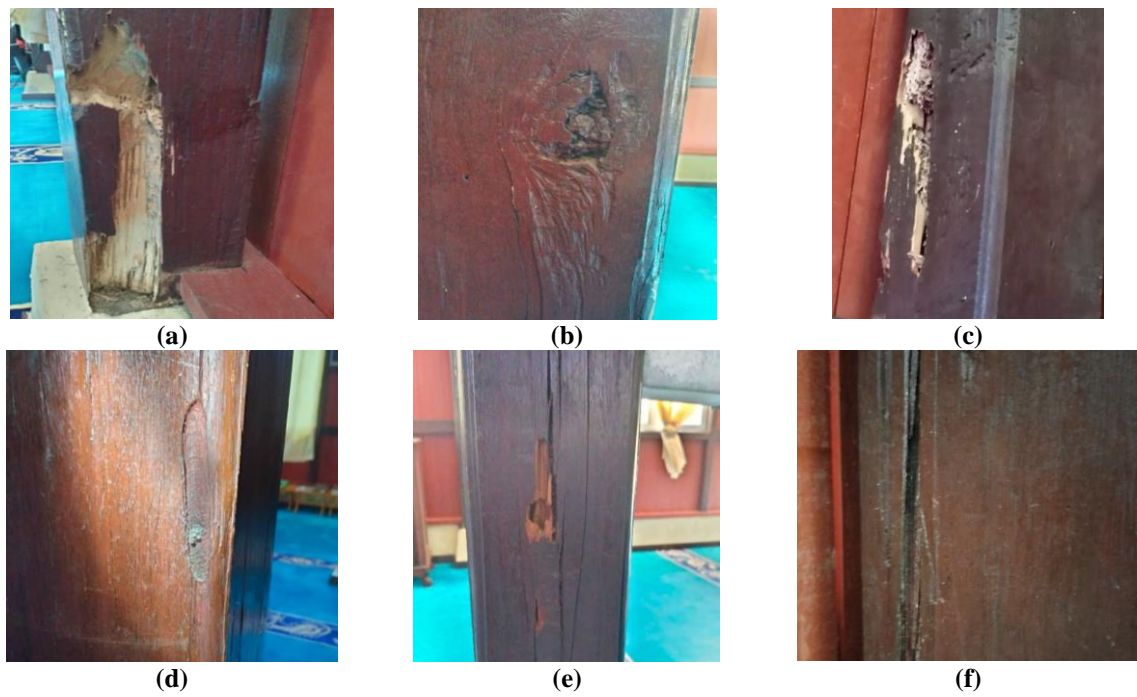
There are several damaged that were found on the structures (column and beam) in both mosques. Fig 3. illustrates the structural damaged that found in Jamek An Nur Kampung Patah Pedang Mosque and Fig. 4 shows the structural damaged in Kampung Parit Lapis Bangas Mosque.

Fig. 3 Structural Damaged in Jamek An Nur Kampung Patah Pedang Mosque (a) Decay; (b) Knot; (c) Beetles; (d) Termites; (e) Decay + Crack; (f) Crack.

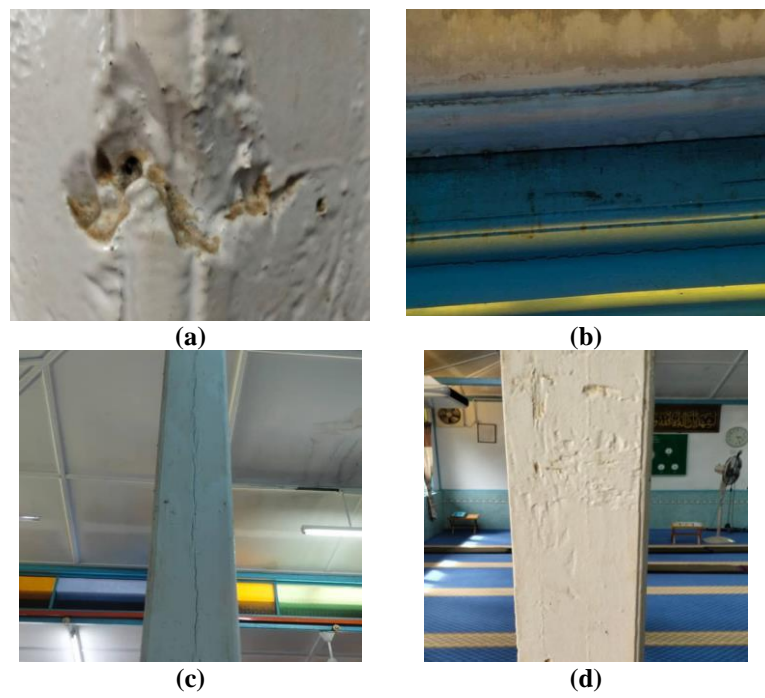
Fig. 4 Structural Damaged in Kampung Parit Lapis Bangas Mosque (a) Termites; (b) Leakages; (c) Crack; (d) Beetles.

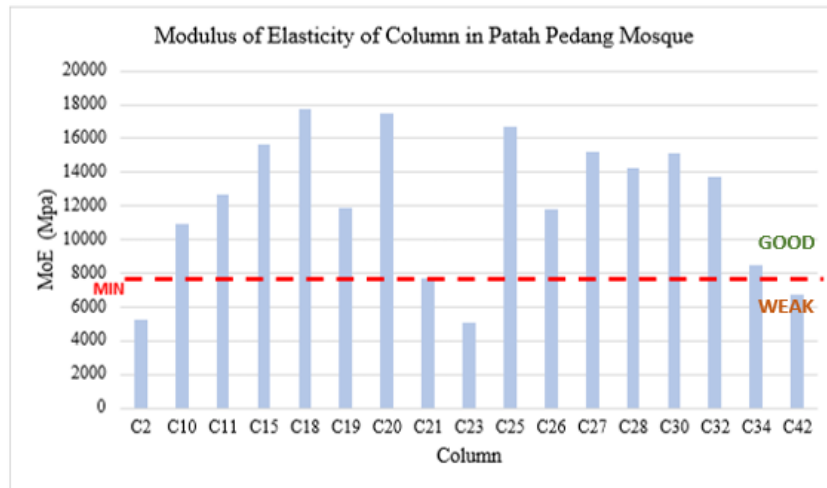
Fig. 5 Graph for UPV Test on Column in Jamek An Nur Kampung Patah Pedang Mosque.

In addition, there are three columns in Jamek An Nur Kampung Patah Pedang Mosque are in a weak condition because these columns does not exceed the minimum MoE value of SG4 which is 7600 Mpa based on Malaysia Standard (MS 544-2:2017)[17] which are C23, C2 and C42 with the lowest MoE reading values recorded are, 5058 Mpa, 5240 Mpa and 6691 Mpa. These columns C23, C2 and C42 have the same damages which is decay. However, all the structures (column and beam) in Kampung Parit Lapis Bangas Mosque are in a good condition as it recorded the higher MoE value and exceeded the minimum MoE for SG1 which is 14 000 Mpa even though there is a damage on each structure but the damage does not affect the strength of the timber for that mosque.

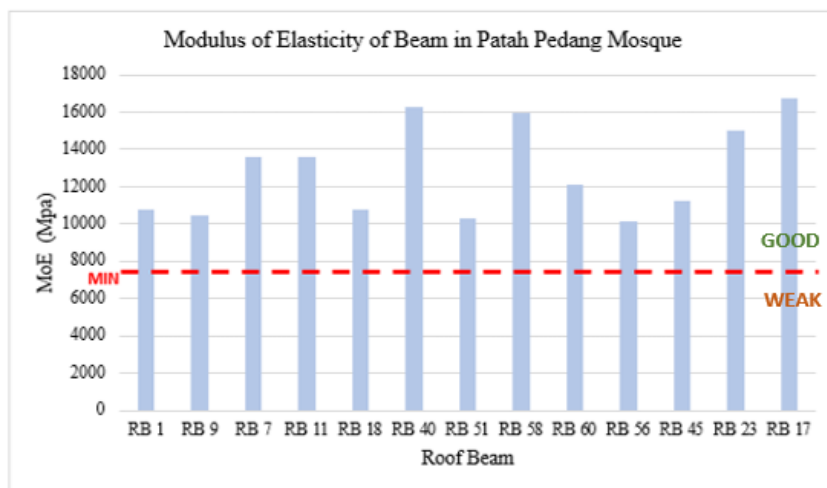
Fig.6 Graph for UPV Test on Roof Beam in Jamek An Nur Kampung Patah Pedang Mosque.

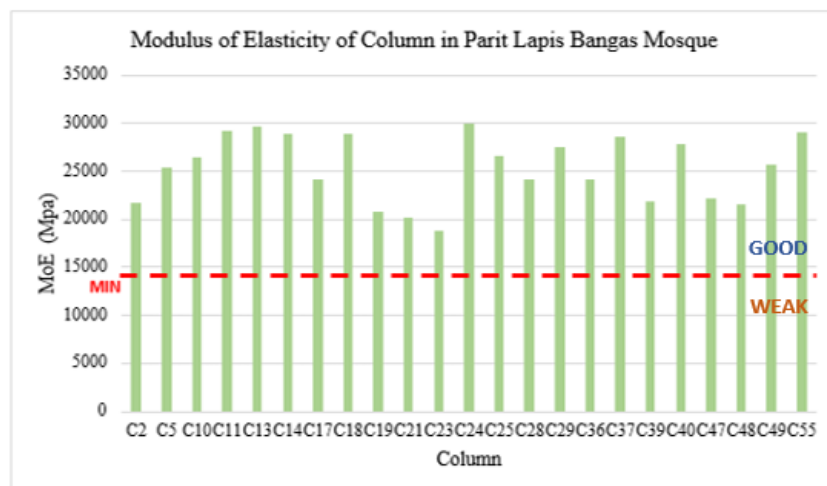
Fig. 7 Graph for UPV Test on Column in Kampung Parit Lapis Bangas Mosque.

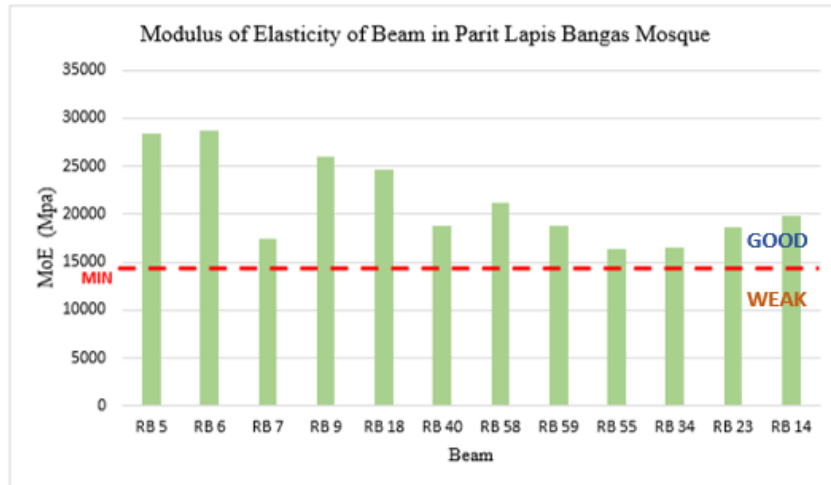
Fig. 8 Graph for UPV Test on Roof Beam in Kampung Parit Lapis Bangas Mosque.
