Building Conditions Assessment of Timber Mosques at Batu Pahat

This research aims to assess the condition of the timber mosque at Masjid Jamek An Nur Kampung Patah Pedang and Kampung Parit Lapis Bangas Mosque, Batu Pahat. The study will use a Building Condition Assessment (BCA) checklist to identify any signs of structural damage or deterioration in the timber components of the mosque. The research will also evaluate the quality and condition of the structure of the mosque using the BCA checklist and propose recommendations for repairs or replacements for any deteriorated or damaged components of the timber mosque.

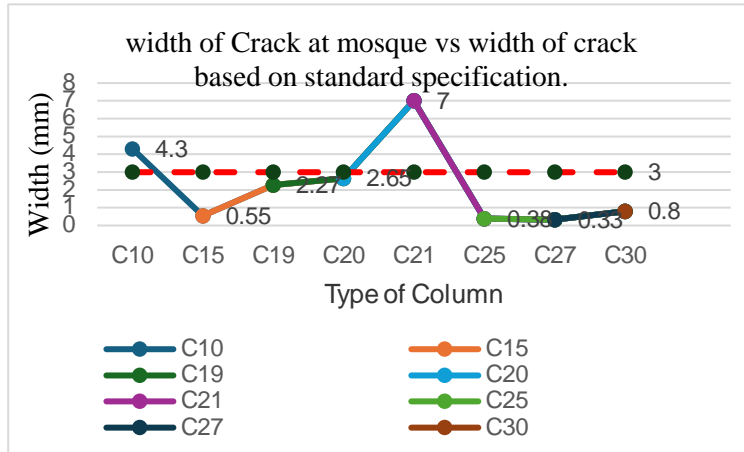
Fig. 8 Frequency vs Type of Defect.

Figure 8 below illustrates the width of cracks at the mosque. The lines on the chart indicate that the highest width of cracks is at the C10 position, measuring 4.3mm, and C21 has a width of 7mm, exceeding the allowable crack line permitted for timber building, which is 3mm. The dark blue represents C10, yellow corresponds to C20, blue-black indicates C27, orange represents C15, maroon is for C30, grey corresponds to C19, green is C25, and finally, red represents the allowable crack based on the Australia Standard

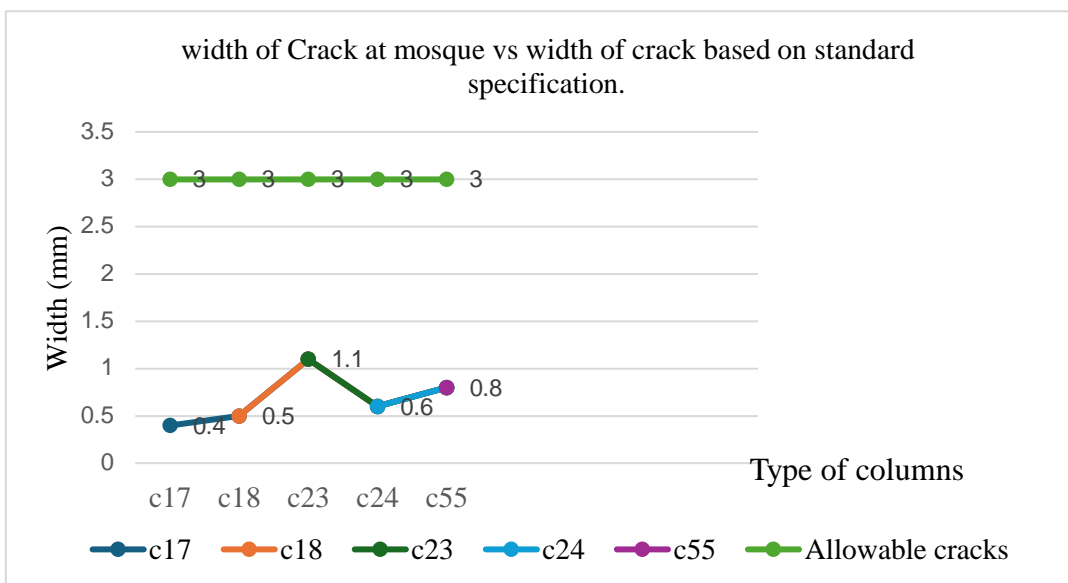
Fig. 14 width of Crack at mosque vs width of crack based on standard specification.

The following Figure 14 below provides an overview of the width of cracks at the mosque. Upon examining the line chart, the width for all columns 'C' does not exceed the allowable cracks based on the Australian standard which is 3mm. The highest width of cracks is only 1.1mm, followed by 0.8mm at positions C23 and C55. Therefore, for this mosque, the condition of the wood remains safe for use and does not require replacement in the near future.

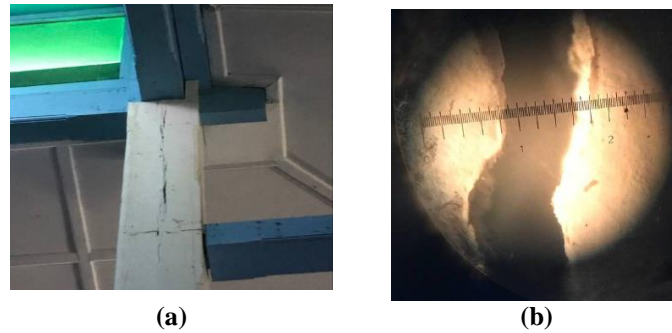
Fig. 15 (a)C23; (b) Crack Meter Reading.

Figure 15 and Figure 16 below show the picture of timber crack among the highest crack width but not exceed the allowable crack which is 3mm at Kampung Parit Lapis Bangas Mosque.

In contrast, for Kampung Parit Lapis Bangas Mosque, the highest recorded crack width was a safe 1.1mm, with other positions like C23 and C55 measuring 0.8mm. Therefore, the wood at Kampung Parit Lapis Bangas Mosque remains in a satisfactory and safe condition. However, monitoring, maintenance, and repairs are necessary for Jamek An Nur Kampung Patah Pedang Mosque to address the identified timber defects.
