Assessment of Building Roof Defects Using Unmanned Aerial Vehicle (UAV) and Condition Survey Protocol (CSP) 1 Matrix System

Muhammad Rusyaidi Mohd Azri¹, Syed Burhanuddin Hilmi Syed Mohamad^{2*}

^{1,2}Faculty of Civil Engineering and Built Environment,
Universiti Tun Hussein Onn Malaysia, Batu Pahat, 86400, MALAYSIA

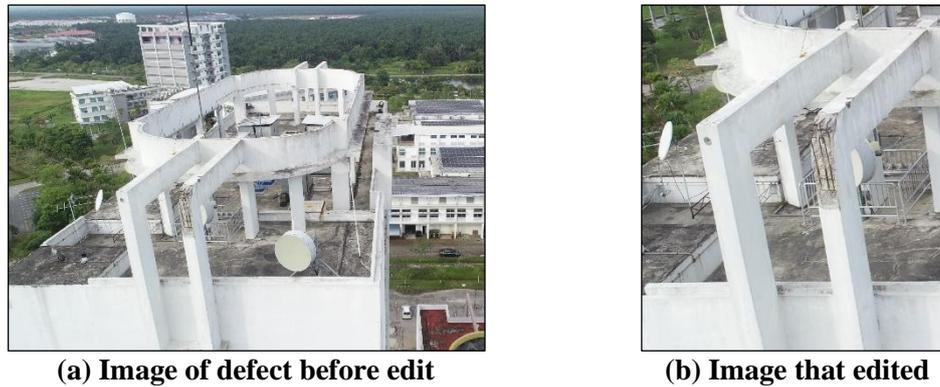
Figure 5: Editing process for image of defect

Images of the defects that have been capture manually by UAV need to edited obtain images of defect that clear as shown in Figure 5 (a-b).
