Measurement of Riverbank Erosion Rates of Pusu River Using Erosion Pins Method

Nur Aqilah Mohd Rosli¹, Saerahany Legori Ibrahim^{1*}, Rabitah Handan², Md Noor Salleh¹

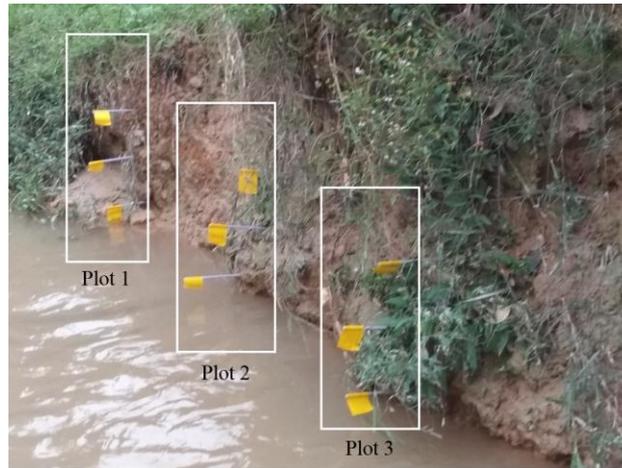
Fig. 2 - Erosion pins installed at plot 1 until plot 3 of site B

Fig. 2 shows the erosion pins installed at plot 1 until plot 3 of site B. Erosion pins exposure were measured approximately four times a week and after every rainfall event. The rate for each plot was measured starting from February 2019 to April 2019. Measurements were taken from the tip of the rod to the bank surface to account for material removal. Pin resetting was done after each storm event to avoid loss of pin. Field observation were also made to identify the factors affecting the rates of bank erosion.

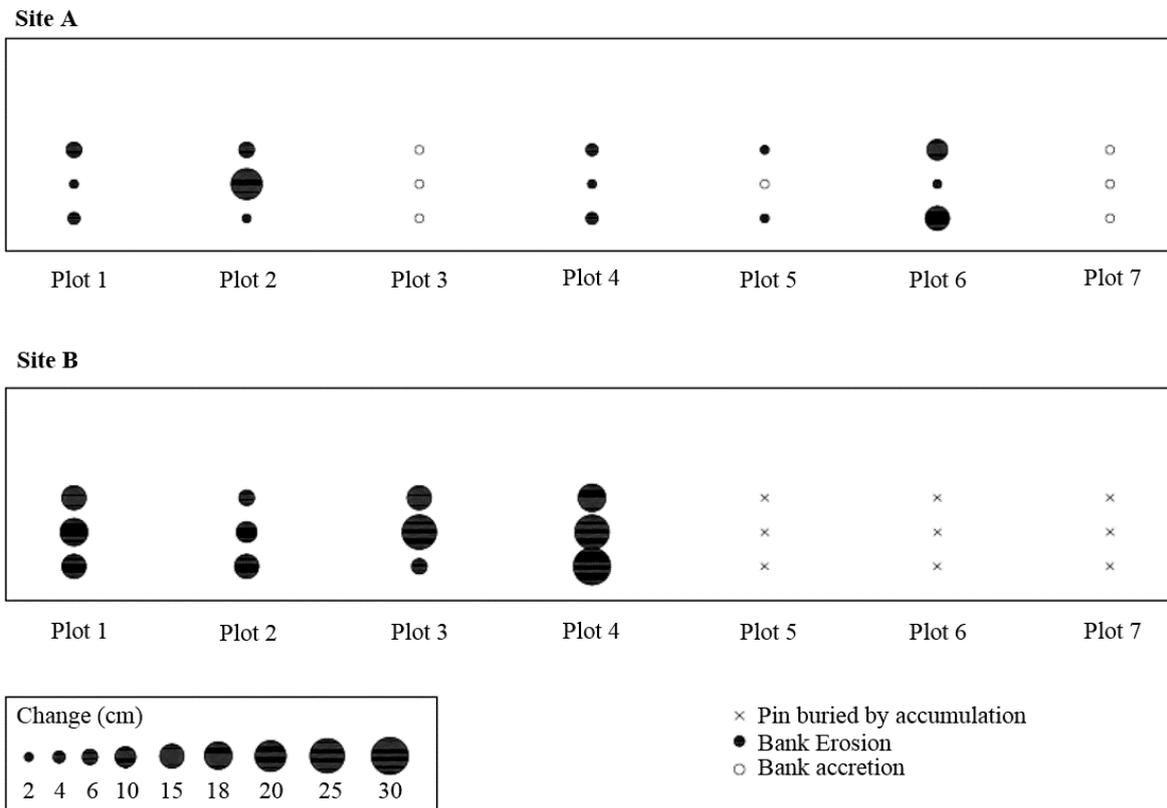
Fig. 3 - Spatial variation of bank erosion at the end of measurement period

The bank erosion rates with respect to each pin for both sites at the end of measurement period were represented in the spatial variation shown in Fig. 3. The bank erosion rates were illustrated by proportional circle representation of erosion pin data. The size of the circle represents the change in erosion pin length over the period of measurement. The maximum erosion at site A can be found at plot 2 and 6 with the highest pin net change value of 15.70 and 20.70 cm. Plot 3, 5 and 7 of site A were experiencing deposition and it was observed that there is also an increase in the density of vegetation at these plots. Although it was hard to identify the exact cause of aggradation at these plots, there are some possible causes which include deposition of sediment during high flows, soil expansion, as well as parallax error when the readings were taken. Based on field observation, after every heavy rainfall event, bank sections without riparian vegetation will undergo net erosion while bank section with riparian vegetation will undergo net deposition. The vegetation may have trapped the coarse sediments that are deposited at the bank during high flow. Site B was found to be experiencing more erosion compared to site A Plot 3 and 4 at site B recorded the highest pin net change value of

27.30 and 30.20 cm. Bank failure was also found at site B after 47 days since installation of pins where 9 out of 21 pins at the site were buried by accumulation. Site B which is situated on the outside bend undergone massive erosion as the results of high flow velocity directed to the bank. Due to high amount of soil deposited at the site after heavy rainfall event, there is a significant difference in the depth of the river over the period of measurement.

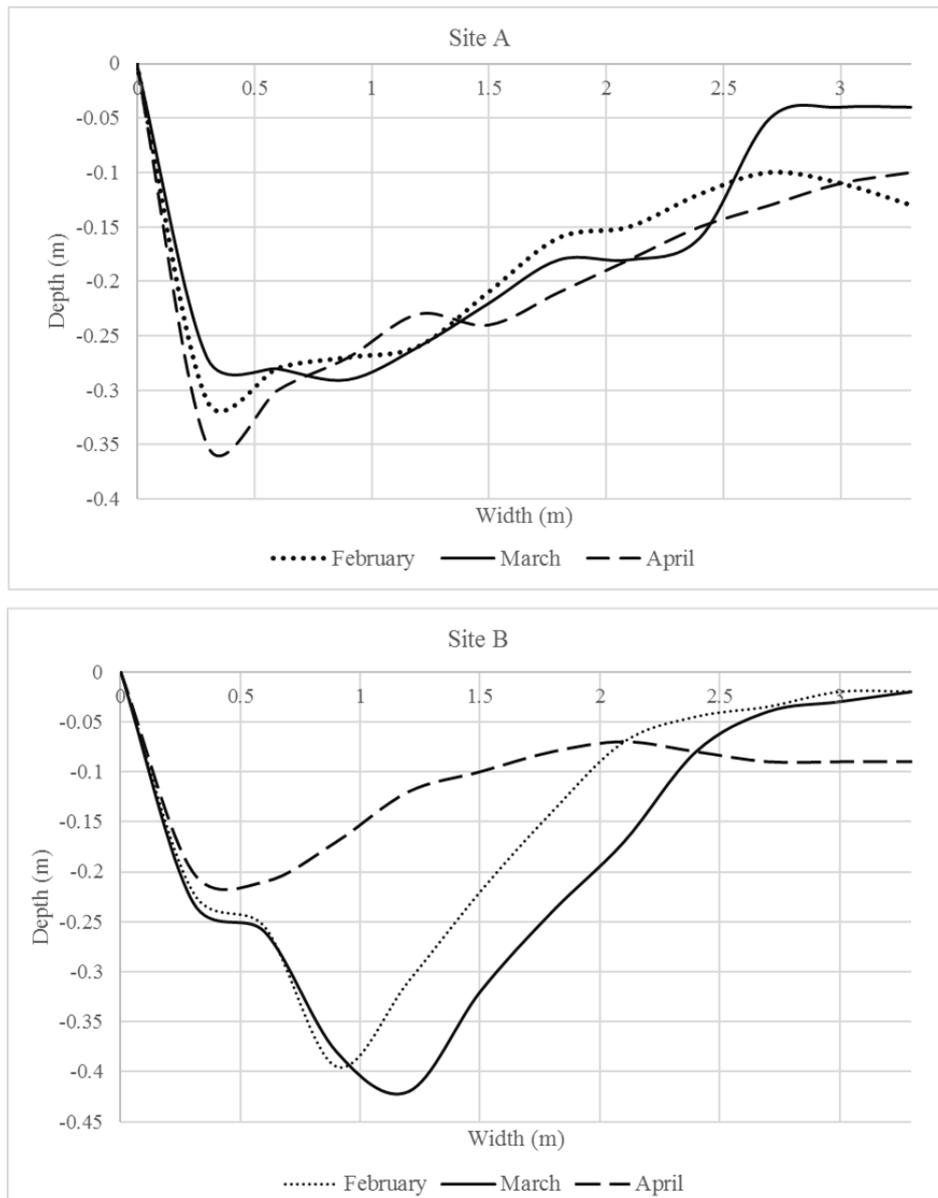
Fig. 4 - Cross section profile of site A and site B from February 2019 to April 2019

Fig. 4 shows the cross-section profile measured at site A and site B over the three month of measurement period. Subtle changes in channel depth can be seen at site A over the three months where the depth increases from February until April. Based on field observation, the depth of river increases after heavy rainfall event due to basal erosion. The right side of the channel is shallower as deposition of sediment occurs here while erosion occurs at the left side of the channel. There was a small change in depth between month of February and March at site B. However, an abrupt change in depth can be seen in the month of April after heavy rainfall event. Huge amount of sediment was deposited at the site after the heavy flow, causing the depth of river to decrease significantly. The pattern of the cross-section profile for all three months were the same where the outside of the bend was considerably deeper compares to the inside of the bend where decomposition of sediments occurs. However, the trend of site A and site B were contradicted where the channel depth at site A increases over the period of measurements while the channel depth at site B decreases. This was mainly due to the series of heavy storm events that occurred at the end of March 2019 until end of April 2019. Both sites recorded higher erosion rates in this period as reflected in the cross-section profile of site A where the channel depth increases due to basal erosion. On the other hand, bank failures occurred in site B causing the bank materials to enter the river and deposited at the bed.
