Implementation of UAV for Pavement Functional Performance Assesment

Yackob Astor¹, Retno Utami^{1*}, Yasuyuki Nabesima², Atmy Vera Rouly Sihombing¹

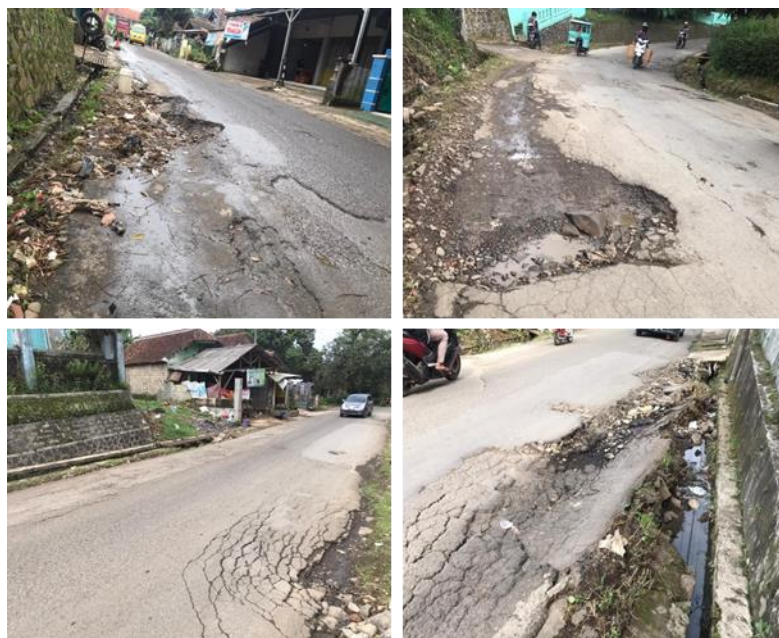
Fig. 2 - Pavement distresses in Cikalong-Cipeundeuy road

Thus, combination between visual inspection and the use of UAV should be done in filling the gap for more practical and reliable pavement inspection method. In this study, a PCI method of pavement assesment will be used to assess pavement through both manually surveyed and 3D model calculation with the use of Agisoft application. Later on, statistical test will be carried out such as ANOVA and correlation to determine the relationship between pavement condition obtained from two different survey method as well as the comparison in identifying pavement distresss, PCI value and pavement condition. Location of this study as follows on figure 1. This study is on 1 km of road length, where high to medium severity of pavement distress occurs. Pavement distress in location study as seen on figure 2.

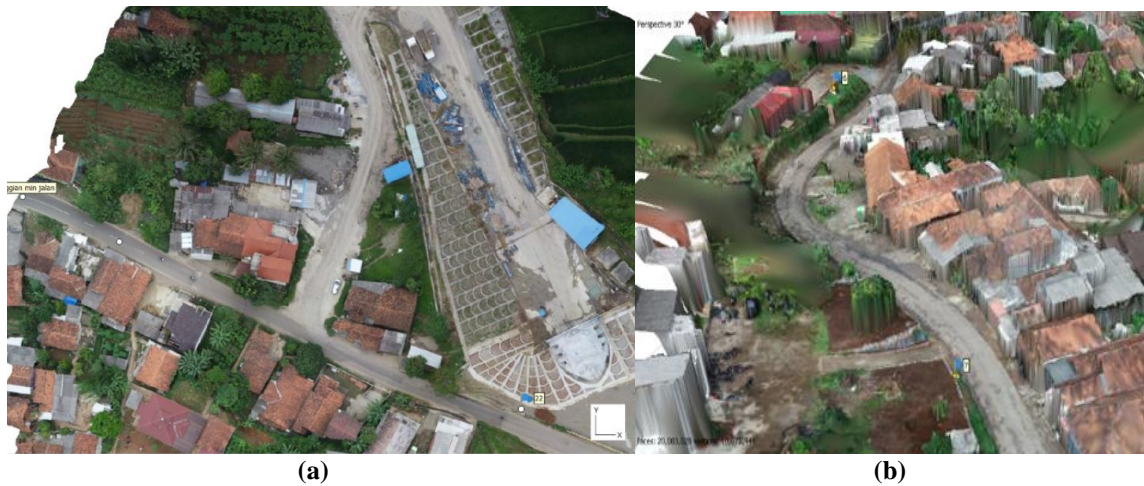
The following is a 3D model produced in this study shown from the top view (Figure 4a) and side view (Figure 4b).

Fig. 4 - (a) 3D Model (top view); (b) 3D Model (side view)

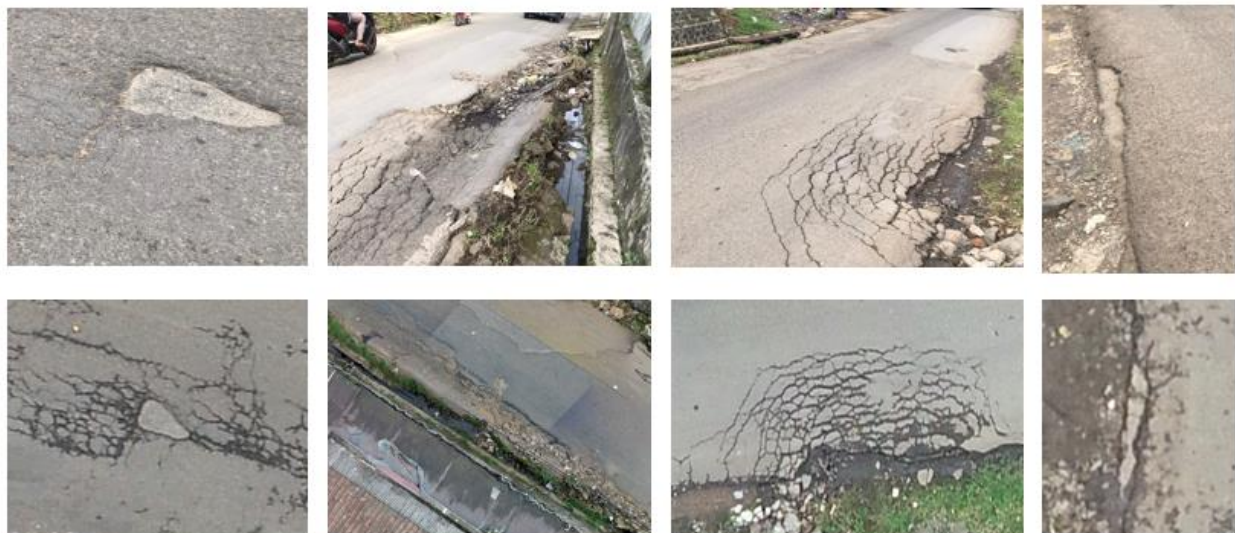
In the 3D model, interpretation and identification of the types of pavement distress are carried out. Furthermore, a comparison of the appearance of the type of damage in the 3D model with the conditions in the field is carried out. Figure 5 shows that the 3D model can show the condition of pavement distress clearly so it is very easy to identify the types of pavement distress that exist in the research location.

Fig. 5 - The results of the identification of the types of pavement distress in the 3D model (below) to the real conditions in the field (top). Left – Right: pothole, depression, edge cracking
