# Field and Laboratory Investigation of a 60-Year-Old Precast Prestressed Concrete Building in Japan

**Abstract:** In Japan, the application of the prestressed concrete (PC) system has become quite popular, especially in bridge and building constructions. Since it was first introduced in the early 1950s, the number of buildings using the PC system has substantially increased. However, following a certain period in the service life of the PC system, the serviceability of such structures especially following an earthquake has become a primary concern, especially when exposed to severe corrosion-prone environments. In this research, the City Hall building of Nandan Town, Awaji Island in Japan, was chosen to investigate the influence of corrosion on the durability of the building structure, which was initially constructed in 1957 as the first building that used PC members for beams. This paper describes the building and results of the field crack inspection and corrosion test results on concrete core samples from the building. Accordingly, the study found that the building had material deteriorations due to its corrosive surrounding environment and severe damage on the concrete cover

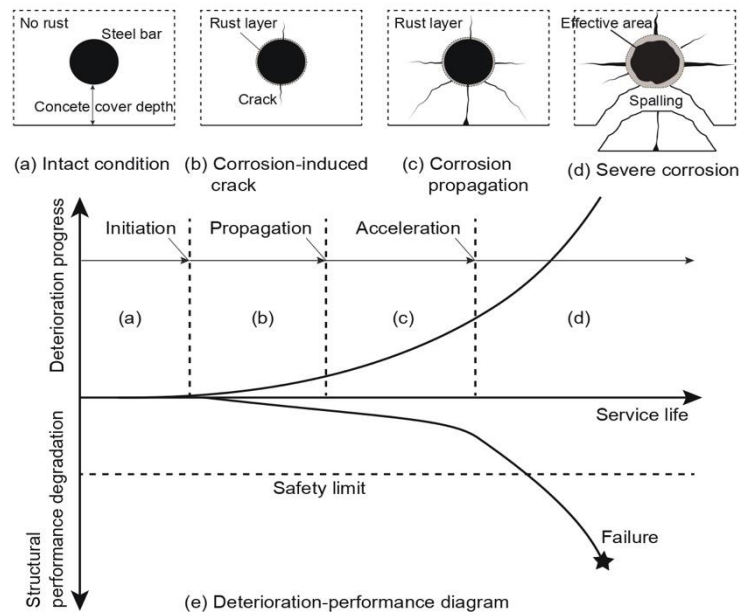
**Fig. 1 - Conceptual view of the deterioration progress (Modified diagram from JSCE (2007))**

Similarly, physical changes may also range from hairline cracks to significant cover concrete spalling that exposes the reinforcement to the outer elements. As such, the structural performance of a deteriorated RC member could significantly decrease its structural stability even under gravity loads. A conceptual relationship between material deterioration and the degradation of structural performance is schematically illustrated in Fig. 1. As shown in the figure, as deterioration increases between the initiation stage and acceleration stage, structural performance decreases.

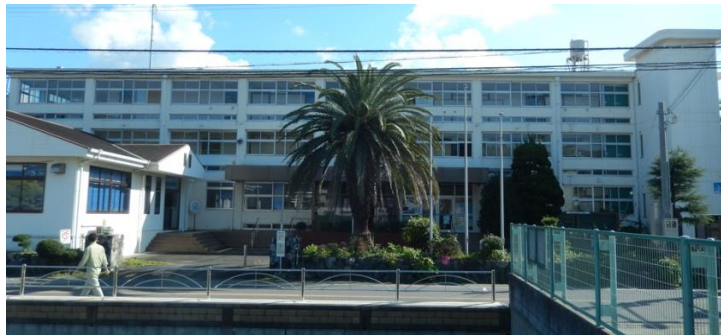
**Fig. 2 - Front view of former Nandan Town Hall**

This study investigates the former Nandan town hall, as shown in Fig. 2 (Kamaruddin et al., 2018). Originally, the structure of the town hall was a 3-story PCaPC building. The location of the building is illustrated in Fig. 3. The building was constructed in 1957 and was the first building in Japan to incorporate PCaPC beam elements. The building structure consisted of two reinforced concrete (RC) moment-resisting frames with nine 5-m bays in the longitudinal direction. In the transverse direction, the load-bearing structure of the building consisted of six moment-resisting frames with 11-m long PCaPC beams and four RC frames with RC walls along the staircases. The locations of the beams, columns, and walls on each floor are shown in Fig. 4. Other structural details of the building can be found in Ref. Kamaruddin et al. (2018).

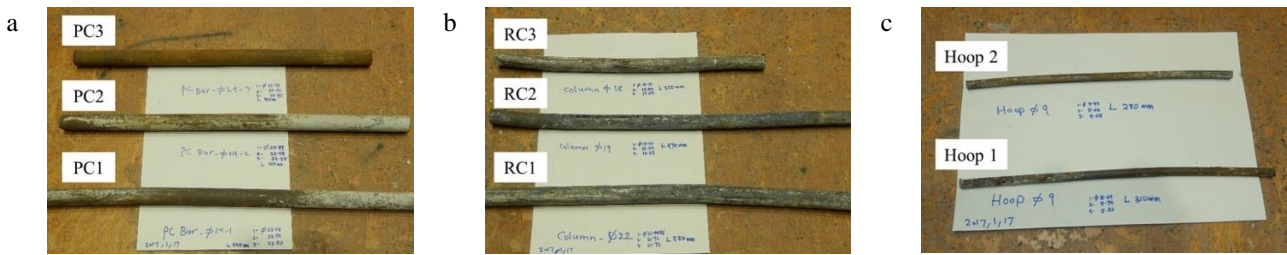
Fig. 7 - Samples of (a) PC steel rods; (b) column RC bars; (c) shear reinforcement

The mechanical properties were investigated by the compression test and tensile test. The compression test results were compared with the designed strength of concrete of this building which is 17 MPa for RC and 49 MPa for PC. Samples of PC steel rods, reinforcing bars, and shear reinforcement, as shown in Fig. 7 were subjected to a tensile test. Distortion of the steel bar was measured by the attached strain gauge.

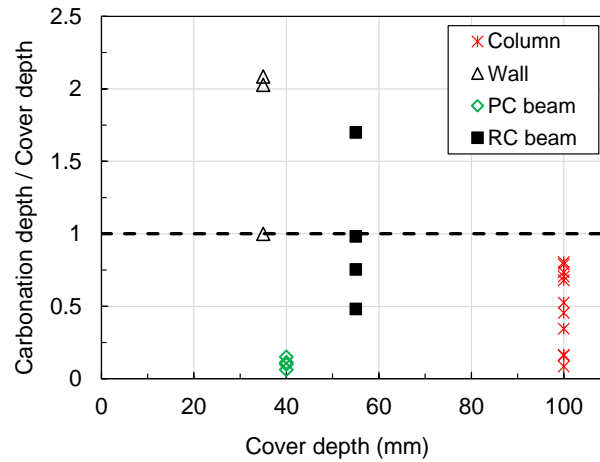
The measured average depths of concrete carbonation of collected samples were as shown in Table 1. The relationship between the carbonation depth and the cover depth of each element is plotted in Fig. 14. As can be seen in the figure, in most cases, the carbonation did not exceed the cover depth. In other words, it can be implied that during these 60 years of service, the confining concrete sustained the alkali environment for the steel reinforcements and did not contribute significantly to the corrosion.

Notably, if the building were designed for the conventional cover depth (30-40 mm), serious corrosion due to the reinforcement depassivation would be very likely to occur (Teply, 2002). Also, the PCaPC beams had the smallest carbonation depth values which could be attributed to the relatively low water-cement ratio and low concrete porosity of high strength concrete (Fattuhi, 1986). From Table 1, it is evident that the lower floors experienced less severe carbonation.

Fig. 14 - The ratio of carbonation depth to cover depth

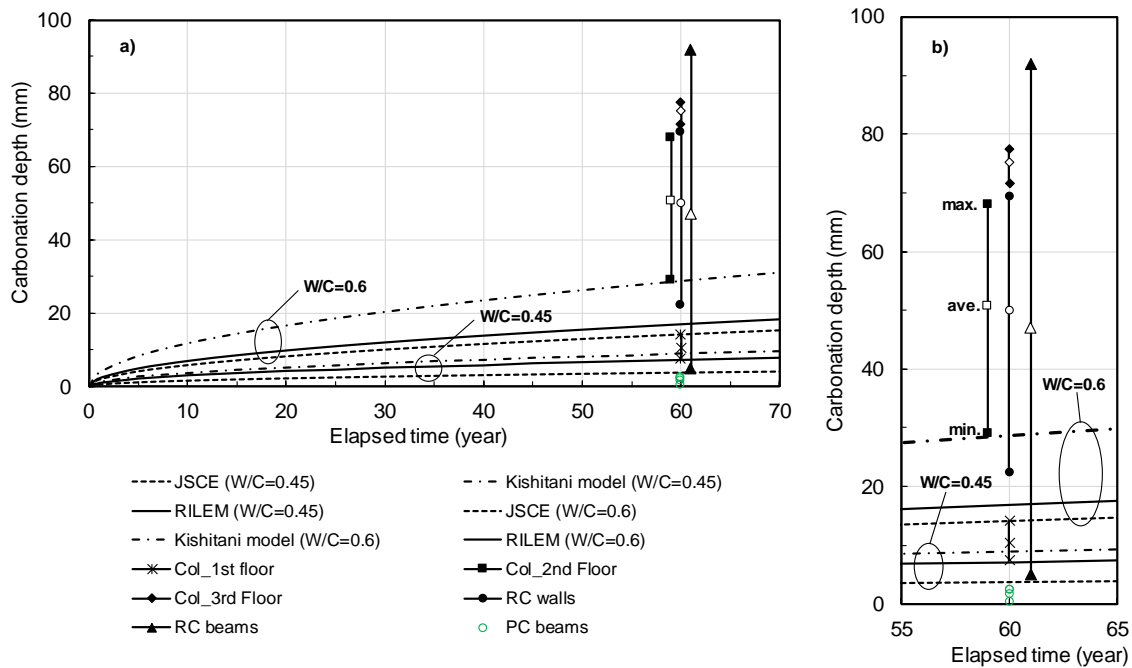
The models recommended by Kishitani, JSCE, and RILEM have been used to compare the model predictions vs. the experimental results. The parabolic curves predicted by the model vs. the test results are plotted in Fig. 15.

Fig. 15 - Carbonation depth prediction vs. test results

Notably, the critical parameter in the employed carbonation depth models, as mentioned above, is the water-cement ratio. These ratios were approximated as  $W/C = 0.60$  for the RC beams, shear walls, and columns, and  $W/C = 0.45$  for the PC beams based on the design compressive strength in this study. As such, the larger the  $W/C$  ratio, the higher the carbonation depth is predicted. The ratio of predicted values over the test results are listed in Table 1. For a better comparison, the test results and the model curves are plotted in Fig. 15a and 15b. As shown in the figures, the average values obtained from the  $W/C = 0.6$  samples have tremendously exceeded the model predictions. Moreover, the distinct discrepancies between the maximum and the minimum measured values should be noted.

On the other hand, the measured carbonation depth values of  $W/C = 0.45$  PC beams were smaller compared to those of the model predictions. Among the three employed models, the JSCE model predicted less conservative values regarding the maximum measured values of the PC beams. Also, given there were no previous records regarding the carbonation depth of different members of the building during its service life available, the validity of the model predictions over an extended time cannot be judged accurately. Therefore, special care is needed for forensic assessments based on model predictions.
