# Historical Building Inspection using the Unmanned Aerial Vehicle (Uav)

**Abstract:** Building inspection is very much required for all buildings especially those historical ones to maintain the structure condition and the safety of the people around. Visual inspection is commonly conducted using manual descriptive information carried out by the inspector personally. The problem with this technique of assessment is that the time needed to write all the defect description on site and to access difficult area can be hazardous. The aim of performing historical building inspection on Tan Swee Hoe's historical mansion is to evaluate the overall condition of the building with Unmanned Aerial Vehicle (UAV) image assisted inspection and Condition Survey Protocol 1 (CSP1) method. From this drone assisted inspection, it shows that the time spent on site is less than half an hour and the data collected being evaluated with CSP1 method defined that the building is dilapidated. The overall building condition is in red class and require serious attention to avoid any injuries to the visitors. To prevent a possible failure of a building in the coming years, a suitable condition inspection has b

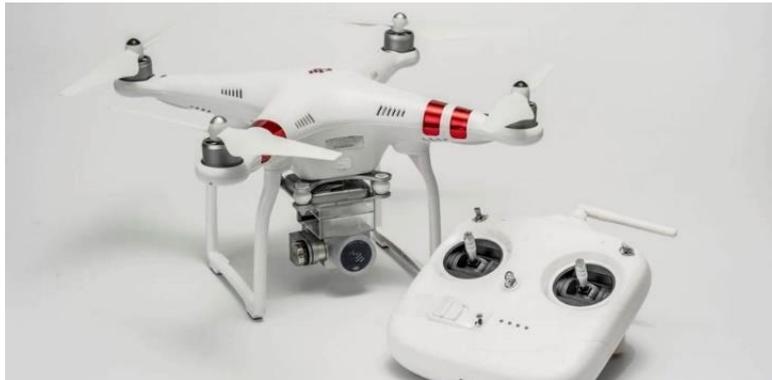
Phantom 3 Standard is one of the UAV model that has been used in visual inspection. This drone equipped with Global Positioning System GPS system and has a core design that lifts the centre of gravity closer to the centroid, improving balance and making it more agile and impressively precise. Fig. 2 shows phantom 3 fits with the criteria needed and makes flying remarkably intuitive and easy. From take-off to landing, it's completely under control, responding to commands while automatically handling the most complex aspects of safe and stable flight. Data collection will be used with the camera 1520p high definition image and video basically everything the camera see plus can zoom and still observe clearly. It makes it very easy to fly at 5m/s to high ground approximately 6000m above sea level and collect data at that altitude (DJI Phantom, 2015).

Fig. 2 - Phantom 3 standard (DJI Phantom, 2015)

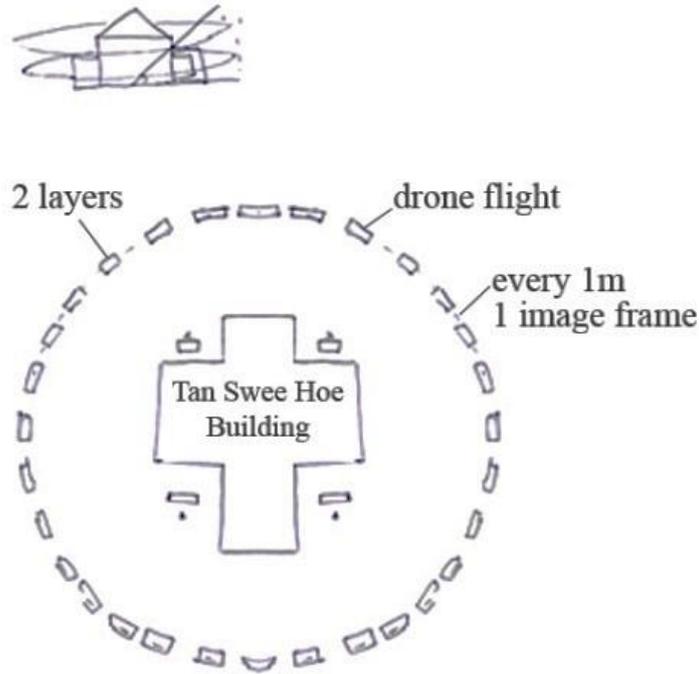
Two different data collections were done on the site visit at the building. The first one is manually collecting data through observation and measurement. The second one is by collecting data by UAV. Firstly the software application is downloaded to be used for drone visual camera to examine camera angle. Fig. 3 shows the sketched flight plan illustrated for the UAV to fly and the angle of camera pointed to the building as required by Agisoft Photoscan software for best data analysis result.

**Fig. 3 - Sketch illustrated for flight plan of the drone**

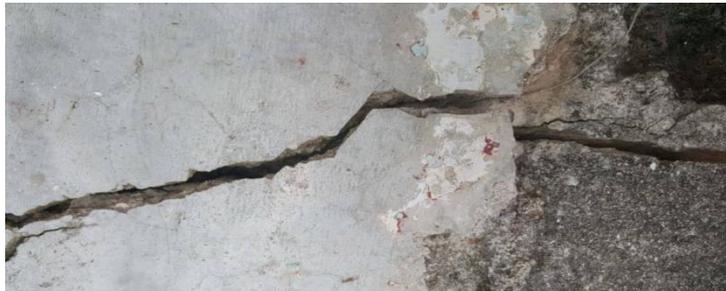
An investigation was done at Tan Swee Hoe's building for the inspection of severity of damage ranking parameter which is cracking. This inspection was done by using visualization and categorized the class using form assessment. Fig. 5 shows the severity of damage for cracking which is ranked 2 and priority assessment ranked 1. Both assessment is multiplies giving the value of 2. The application of matric assessment bringing the severity of damage to category green.

Fig. 5 - Modified assessment form for inspection (PWD, 2002)

As can be seen evaluated from the data, the cracking all around the building are mostly class green which is not require a serious attention. There are also many cracking which categorized class yellow which need a serious attention. There are about 90% of the cracking class green, 10% class yellow and no recorded class red cracking for the entire building.

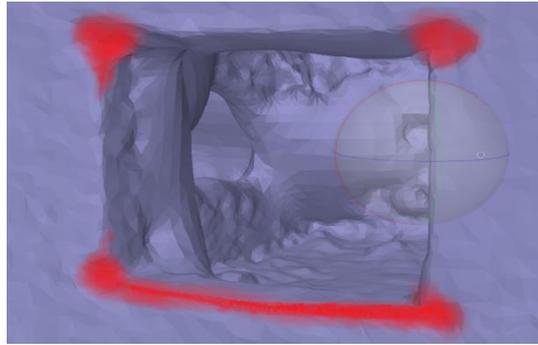
As mentioned in the literature review, several indication related in building defect. One of them is spalling which is investigated from the data collected by using UAV visualization and categorized them into three classes. The most interesting finding was that shown in Fig. 6 whereas the spalling ranked category red which require serious attention. The severity of damage is ranked 5 and priority assessment is 4. It has the maximum damage available in the matrix assessment system. Fig. 6 shows the picture taken then rendered in Agisoft Photoscan to measure the severity of damage. From average 5 points in red conditions, 25 points in yellow and the rest in green condition. Although majority of spalling is still in good condition which just effect the visual condition of the building.

**Fig. 6 - Spalling class red located in one of the wall of window frame**

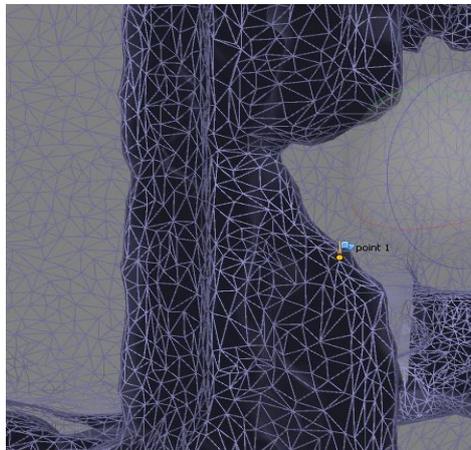
Based on the results, overall exposed reinforcement is categorized as class green while few as class red condition. This is mainly occurring at the structural component that carries heavy load such as beam and column. It is tricky to identify the reinforcement due to the material type of reinforcement used for old building plus many of the section areas are covered with mold and vegetation. From the visual inspection, it should be done more carefully by identifying the depth of the exposed reinforcement. Fig. 7 shows the condition of exposed reinforcement on the wall.

**Fig. 7 - Exposed reinforcement from the damage column.**

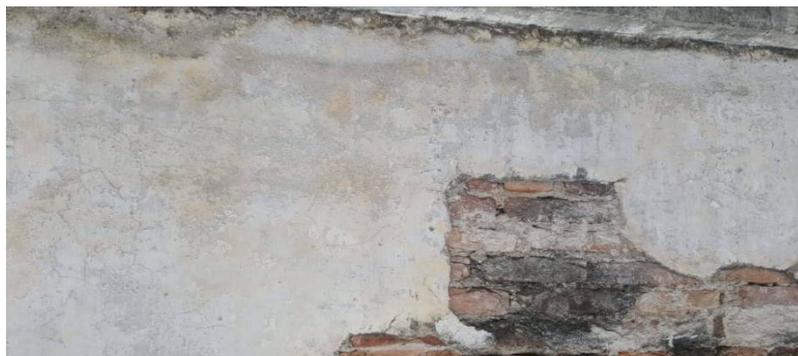
The results show that concrete delaminated is in poor condition. Overall, data indicates that almost every angle of the structure is detected but mainly at class yellow which the area is small but in large volume. As for visual inspection it really turns of the architecture of the building. Delamination cannot be seen from further away as it only can be seen closely. The inspection of delamination part indicate the manual inspection is better and more accurate. The present results as shown in Fig. 8 are in condition monitor, significantly higher than red class.

**Fig. 8 - Delamination occur after side by side with spalling**

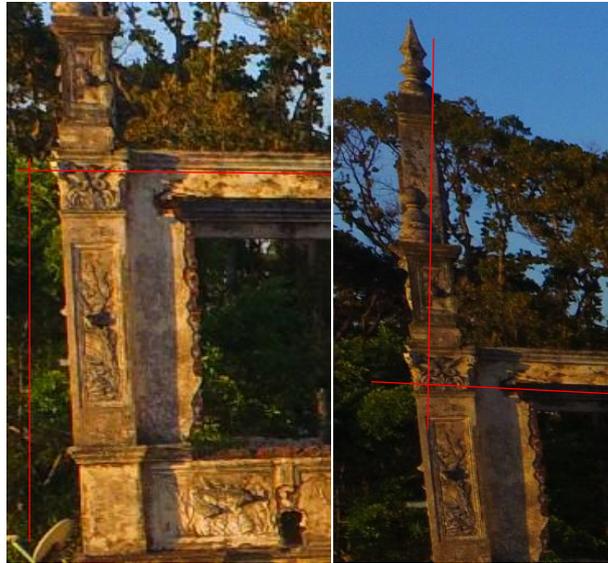
The most difficult finding is to identify if the structure is tilting. Because of the component is mostly dilapidated or spalled half of the structure it is difficult to emerge from the analysis. From the software generated it can be labelled the y axis and x axis then the tilt can be seen obviously. From the inspection carried out, only one case which is located at the landmark of the building all the way to column supporting the landmark. It is analyzed as two different condition ranking. The tilt is about less than 10 degree and it has no support to hold the structure. It is evaluated that the severity of damage is rank 5 and priority assessment is 4 which is the maximum the damage can go which is calls red require serious attention. So that, probability for it to collapse are in high level. As we can see in Fig. 9, the degree of tilt can be quite seen with the naked eye.

**Fig. 9 - Damage of the landmark and column supporting below**

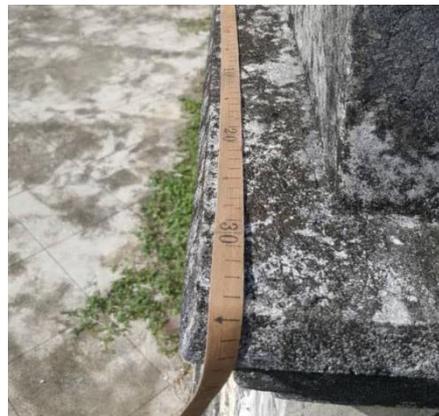
Regression analysis was used to measure the accuracy of measurement from at site and in the software. Agisoft software rendered the Image and producing a scale of 1:1 to the actual size of the model. From the software the value of a certain point need to be created for the software to compare the value. Fig. 10 we can see the picture of one sample set of data being measured to be compare with in the software. From the comparison it found that the accuracy is up to 10mm to the original measurement. For the method of this project the ranking assessment range to 500mm in length and up to 1500mm of range data. Fig. 10 below shows the measurement of 350mm the length of column while compare to software the measurement is 343mm. The other comparison is the measurement of window width 2140mm on site a 2129.66mm in software. To be exact the average accuracy of software is plus minus 10mm.

**Fig. 10 - Measurement taken at site to be compared with in the software**
