# Coastline Dynamics and Its Influence on Community Activities at Tanjong Lobang Beach, Miri, Sarawak

Coastal management, coastal dynamics, shoreline mapping, recreational activities

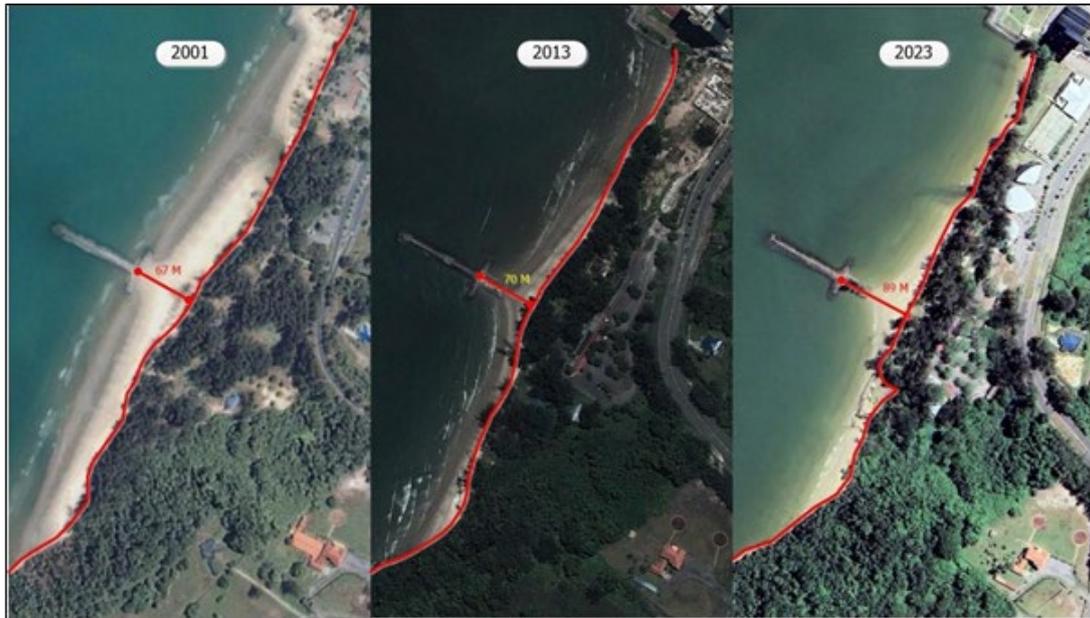
**Fig. 2** Pantai Tanjung Lobang for three time series

The transformation of the Tanjung Lobang shoreline has undergone remarkable changes in its geographical layout, as illustrated in Figure 2. Back in 2001, the distance from the center of the jetty junction to the shoreline measured a mere 67 meters, indicating a relatively short span. Fast forward to the year 2013, an examination of the vegetation within the designated measuring area revealed a lack of significant alterations. This observation suggests that the trees within the research site have experienced growth and have been well-preserved, showing resilience against the erosion activities. In the year 2023, the observation of the vegetation's condition revealing a notable decrease in its spatial coverage serves as a clear indication of the ongoing erosion processes occurring along the perimeter of Tanjung Lobang Beach during the recent years. The alteration in distance recorded from 67 meters as of 2001 to 89 meters by 2023 has resulted in a shift of the coastline by a significant 22 meters at the specific measuring location. This phenomenon also elucidates the fact that the shoreline modifications are predominantly directed towards the mainland.

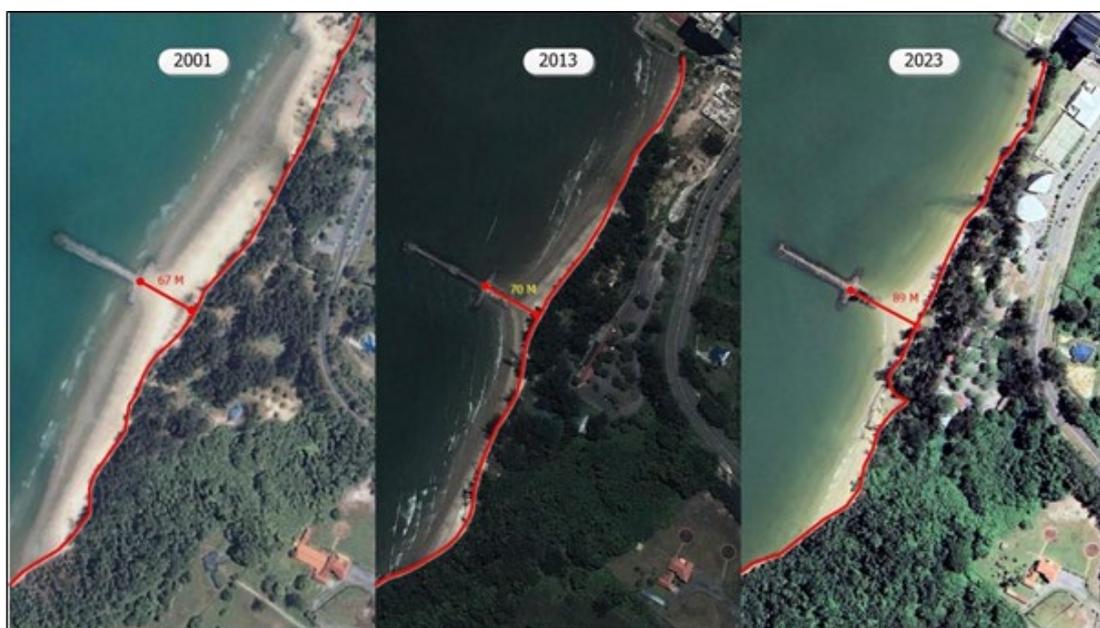
**Fig. 3** Pantai Tanjung Lobang for three time series

The changes in the shoreline can be observed more distinctly by referring to the visual representation provided in Figure 3a. Upon careful examination of the diagram, it becomes evident that the southern region of Tanjung Lobang Beach has undergone more pronounced alterations compared to its northern counterpart. To elaborate, the extent of change in the coastline of Tanjung Lobang in the southern section surpasses that of the northern segment over the span of 22 years, specifically from 2001 to 2023. This observation inherently suggests that the level of erosion along the southern stretch of Tanjung Lobang Beach exceeds that of its northern vicinity. In a comprehensive assessment, the collective area that has succumbed to erosion measures at 21941 square meters, which is approximately equivalent to 5.42 acres as delineated in Figure 3b. It is worth noting that the eroded area holds significant importance in facilitating recreational activities.

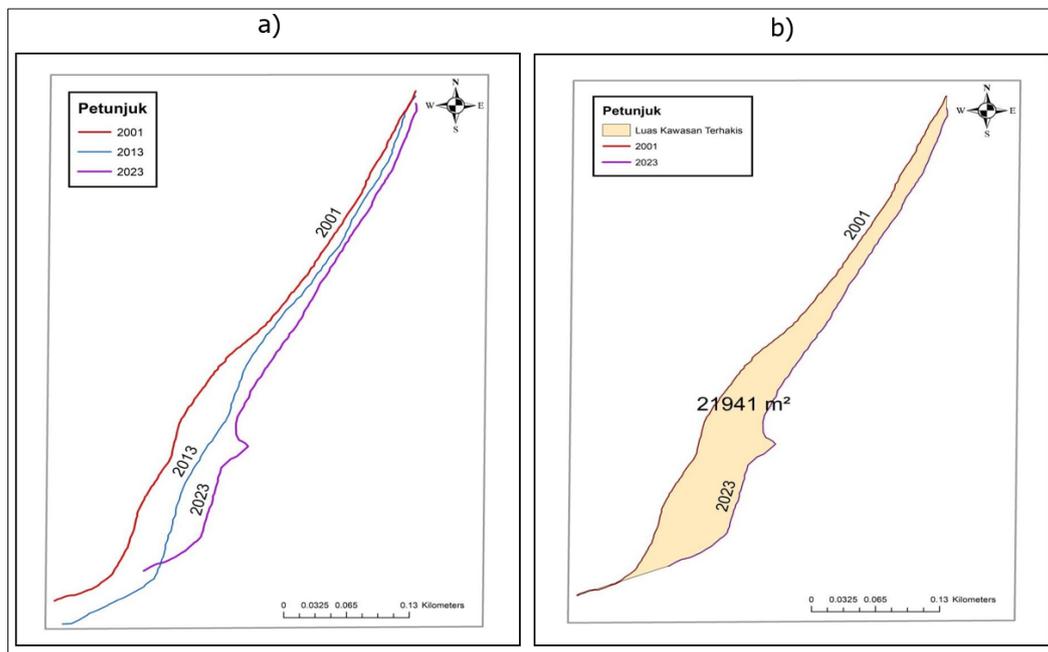
**Fig. 4** Shoreline changes due to erosion process
