# Repair of Pier Bridge Model Post-Earthquake

**Abstract:** This study concentrates on the bridge pier model which was damaged by the earthquake and repaired using grouting and carbon wrapping materials. This research consists of a one pier bridge model with two steps of testing, namely step 1 in the form of a cyclic test of the pier bridge model which will be followed by step 2 in the form of structural repairs with grouting and carbon wrapping materials and retesting to evaluate the performance of the structural repair technology used. This research will show the cyclic test results using the repair material applied to the same sbr latex concrete material test object. The test object used is a pier bridge model with dimensions of 0.25×0.25×1.68 meters. The material specifications used are concrete  $f_c$  30,  $f_y$  400 MPa deformed longitudinal reinforcement and stirrups  $f_y$  240 MPa. The test was carried out with a constant axial load of  $0.2.f_c.A_g$  and a cyclic lateral load. Structural performance analysis was carried out according to ACI 374.1-05. Step 1 cyclic test was carried out until the drift ratio was 3.5%. The lateral peak strength achieved was 8.606 tonf with

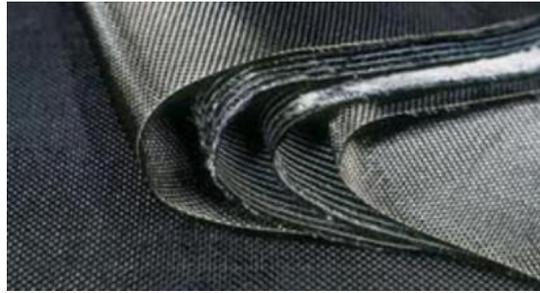
**Fig. 1 - Carbon wrapping [12]**

Carbon wrapping is a repairing material used in reinforced concrete by applying non-metallic composite materials in cloth-like sheets. Carbon fibre is a fibre that contains at least 90% carbon by weight. Carbon fibre shows no corrosion or cracking at room temperature. The function of repair with the CFRP system is to increase strength or provide increased flexural, shear, axial, and ductility capacities. The way to install CFRP is to wrap it around the surface of the reinforced structural element using an epoxy resin adhesive. The working system is the same as conventional transverse reinforcement [6]. Carbon wrapping has several advantages, including being more accessible to install, having high tensile strength, and can be installed on concrete, steel, or wood surfaces. Carbon wrap is usually applied as shear reinforcement in columns and beams. Estowrap 300 is a packing material in carbon fibre sheets with high tensile strength and modulus of elasticity. Estowrap 300 was specially developed by PT. HISSAN Indonesia. Estowrap 300 can improve the structure's performance by strengthening and increasing the shear strength [8]. Estowrap 300 specifications can be seen in Table 2 and Fig. 1.

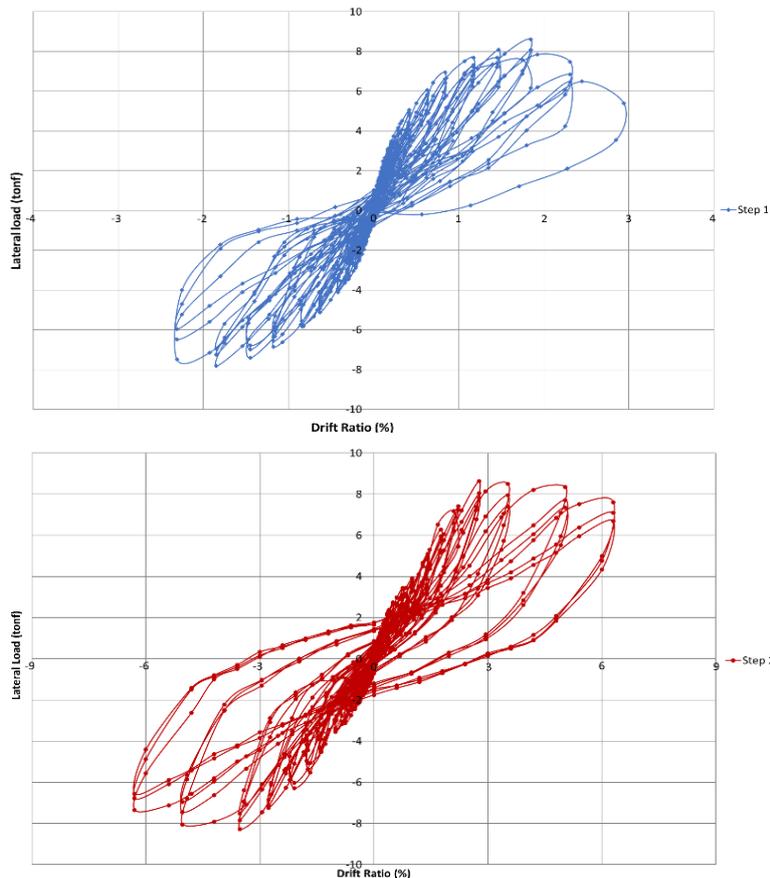
**Fig. 2 - Hysteretic curve**

According to ACI 374.1-05, To provide adequate initial stiffness, the test model must achieve a lateral load equal to or greater than the nominal lateral load ( $E_n$ ) before the drift ratio exceeds the initial drift ratio consistent with the permissible drift limits of IBC 2000. The initial stiffness is calculated as a drift ratio equal to  $\Delta a / \phi \cdot C_d \cdot h$  where  $\phi$  is the strength reduction factor according to the conditions, bending or shear, which controls the design of the test module by 0.9. For  $\Delta a / h$  equal to 0.015, a  $C_d$  deflection amplification factor of 5.5 is required [11]. The initial stiffness is calculated based on the hysteretic curve at the last drift ratio after the load is stopped in the third cycle, as shown in Fig. 2.

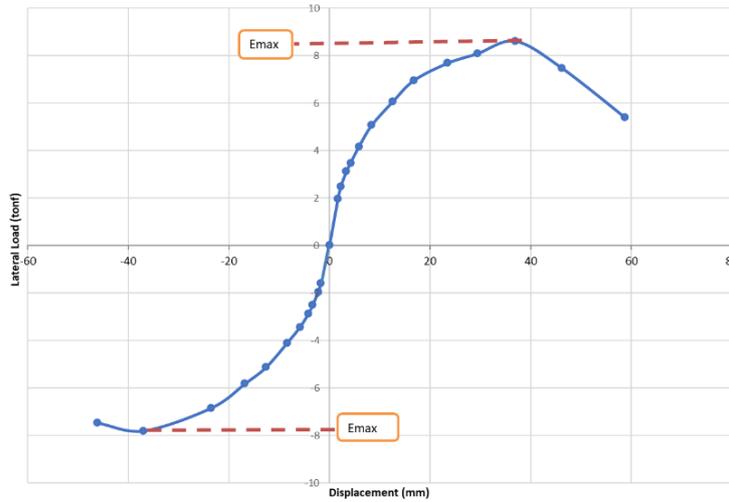
Fig. 3 - Peak strength

Peak strength ( $E_{max}$ ) is the maximum lateral load of the model specimen determined from the test results. Peak strength can be obtained from the maximum lateral load before softening conditions on the load-displacement graph presented in the backbone curve. Peak strength can be seen in Fig. 3.

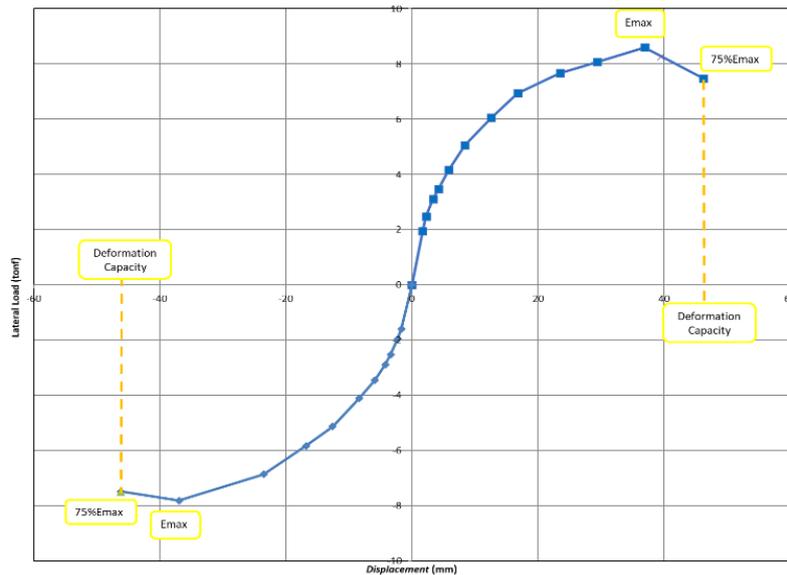
Fig. 4 - Deformation capacity

The deformation capacity is calculated when the lateral load is terminated in softening condition or not less than 75% $E_{max}$ . The deformation capacity can be seen in Fig. 4.

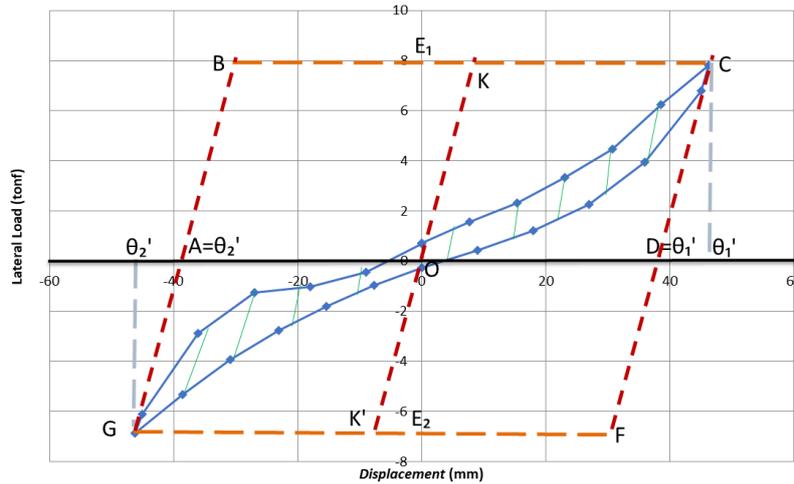
Fig. 5 - Energy dissipation

Energy dissipation is the ability of a structure to absorb energy in the plastic area. When a cyclic load is applied to a structure, the energy absorbed in one cyclic load is the amount of energy absorbed when receiving a tensile load and a compressive load. The total energy dissipated during loading is the area (hysteresis loop) of the third cycle for each drift ratio value [12]. This study's energy dissipation calculation uses the ACI 374.1-05 concept, as shown in Fig. 5, expressed by the following equation.

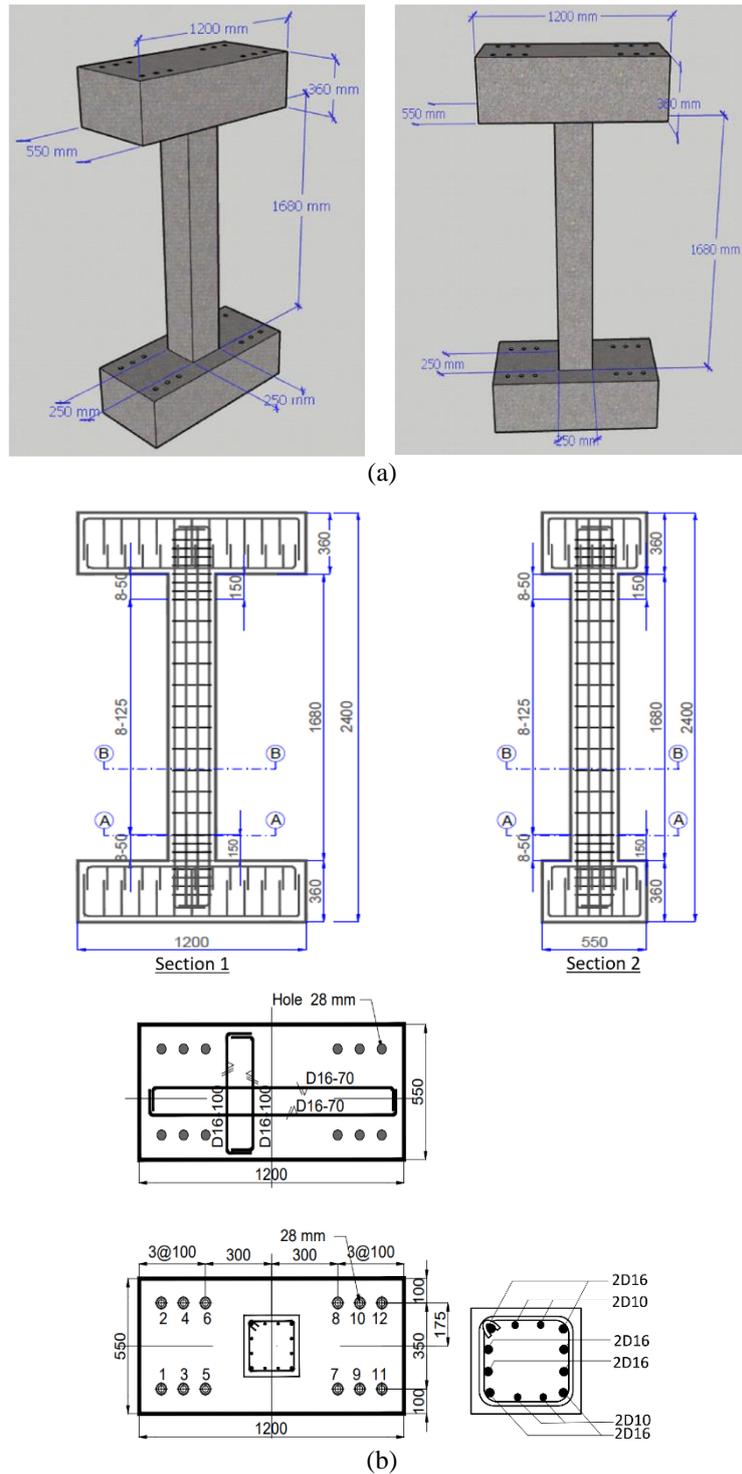
Fig. 7 - Pier models (a) illustration of pier model, and; (b) details of cross-sectional reinforcement of the model

In this study, the property and geometry data for the pier model were determined based on previous experiments conducted by Puji et al. [10]. The bridge pier model was made in one piece with a column cap size of 1200 mm long, 550 mm wide, 360 mm high, and 250 mm × 250 mm pier cross-sectional dimension with a height of 1860 mm. In this study, the designed concrete was  $f_c = 30$  MPa. The quality of the reinforcing steel was  $f_y = 400$  MPa with the number of longitudinal bars 4D10 and 8D16, and the grade of steel for the transverse reinforcement was 240 MPa with a diameter of reinforcement  $\varnothing 8$ mm with a distance between bars of 75 and 125 mm. Fig.7 is a complete specification of the test object as follows.

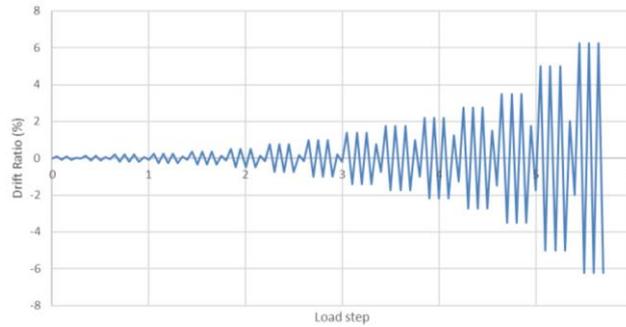
**Fig. 8 - Cyclic lateral loading pattern**

Cyclic testing follows ACI-374-1-05. The pier model specimen is mounted on the loading frame. Furthermore, the pier model specimen is installed with Linear Variable Displacement to identify the displacement at several pier points when the lateral load is applied. The load used is a static axial load of 30 tonf, and a lateral load is a cyclic displacement. The load is given in the form of displacement in an alternating direction. In the early step, the load is set so the structure behaves linearly elastic. For each deviation value given in three cycles, the deviation increase is given by 0.25 - 0.5 times compared to the previous deviation. The cyclic test is stopped at a load level of about 80% of the peak load so that the specimen is in a softening condition. Fig. 8 below shows the loading pattern. Tool settings, test illustrations, and locations of cyclic testing LVDTs can be seen in Fig. 9.

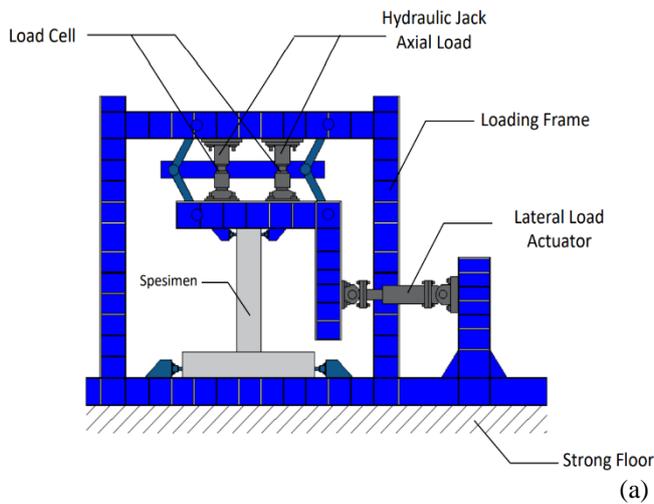
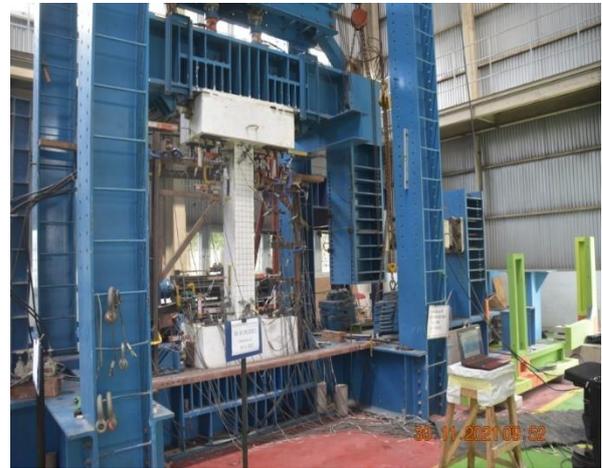
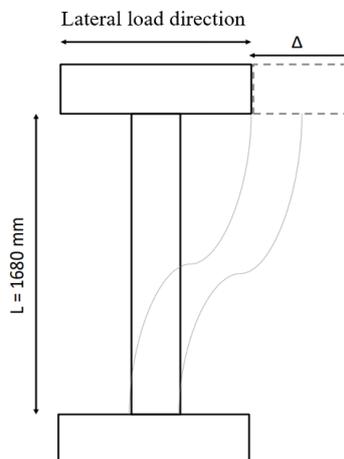
**Fig. 9 - Set-up of pier model (a) schematic of test setup, and; (b) illustration of cyclic testing**

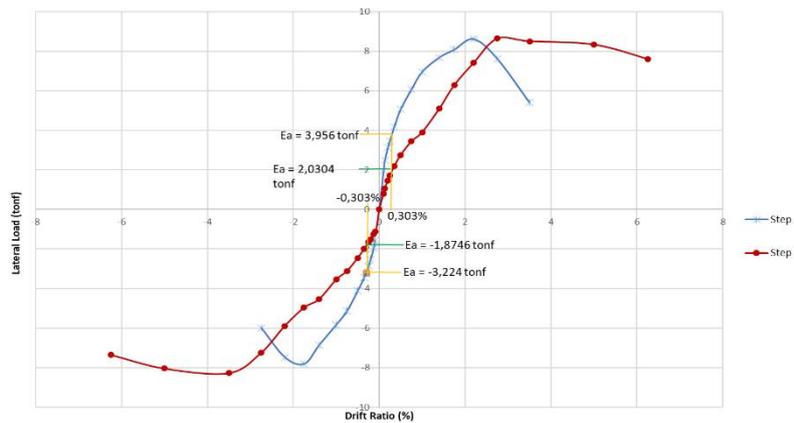
**Fig. 10 - Initial stiffness**

The initial stiffness ( $K_o$ ) is the ratio between the force and the displacement at the initial lateral load with the hysterical slope of the curve at the displacement interval +0.35% to -0.35% drift ratio. In contrast, the stiffness degradation is determined from the stiffness secant in the third cycle when the last drift ratio is tested. Stiffness reduction is taken into account where the stiffness of the secant connecting the point is a drift ratio of -0.0035 to a drift ratio of +0.0035. The initial stiffness results are represented in Table 3 and Fig. 10. The results of the Stiffness calculations for the two test phases are shown in Table 4 and Fig. 11.

Test results on the second step of the pier model have a lower initial stiffness than the first step test, namely 94.92% of the push direction and 71.98% of the pull direction. The test results show that the second step of stiffness degradation has a higher rate of 111.16% in the push direction and 26.73% in the pull direction compared to the first step testing the pier model.

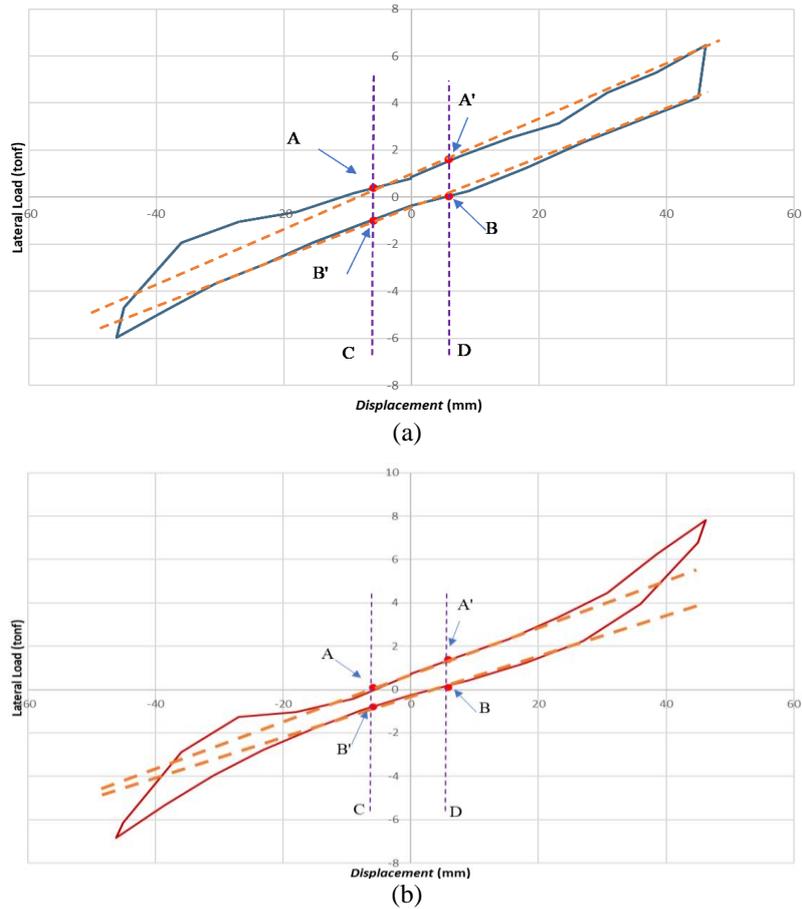
**Fig. 11 - Stiffness degradation (a) hysteresis curve for stiffness degradation of first step pier model (A = 0,4 tonf; A' = 1,6 tonf; B = 0,05 tonf; B' = -1 tonf; C = -5,88 mm; D = 5,88 mm), and; (b) hysteresis curve for stiffness degradation of second step pier model (A = 0,1 tonf; A' = 1,4 tonf; B = 0,1 tonf; B' = -0.8 tonf; C = -5,88 mm; D = 5,88 mm)**

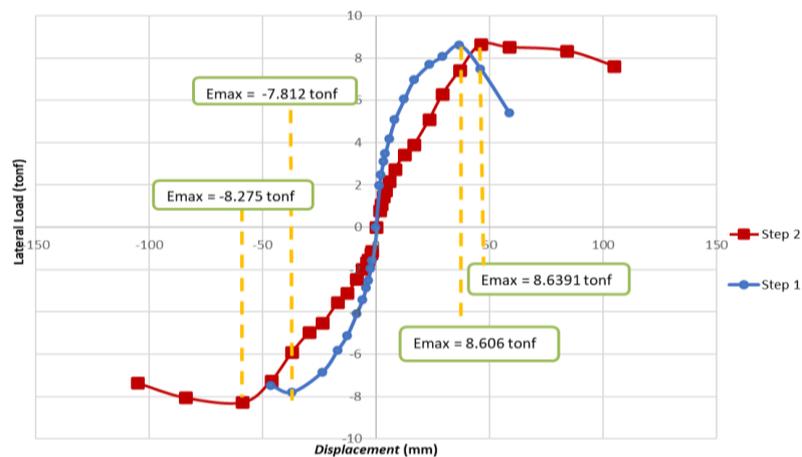
**Fig. 12 - Backbone curve for peak stiffness of the pier model in the first step and the second step**

The magnitude of the peak strength is obtained from the peak lateral load ( $E_{max}$ ) on the load-displacement graph presented in the backbone curve. The peak strength is observed when the maximum load has been reached before experiencing strength degradation (softening condition). The peak load in this test can be seen in Fig.12. Fig. 12 shows that the pier model in the second step has a higher peak strength than the first step of testing, which is 0.39% in the push direction and 5.93% in the pull direction.

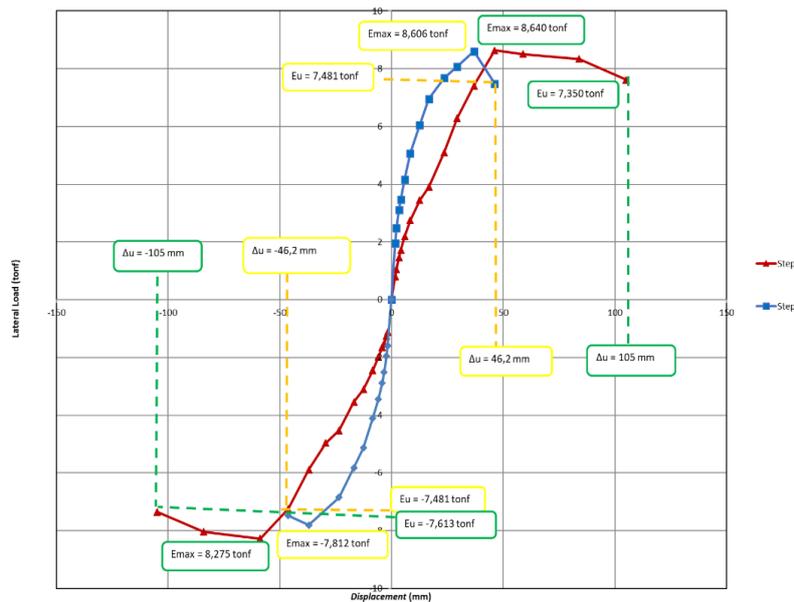
**Fig. 13 - Backbone curve for deformation capacity of the pier model the first step and the second step**

According to ACI 374-1-05, specimens tested with cyclic loads are required so that the deformation capacity occurs when the deformation capacity of the specimen is not less than 75% of the maximum lateral load (Emax) value in the same loading direction. The deformation capacity at both steps of this test can be seen in Table 5 and Fig.13.

Tests at the two steps that have been carried out show that the results of the deformation capacity on the pier model are not less than 0.75Emax in the push and pull directions, as seen in Fig. 13. The second step of testing shows a higher deformation capacity than the first step of testing, namely 120, 51% in the pushing direction and 90.476% in the pulling direction.

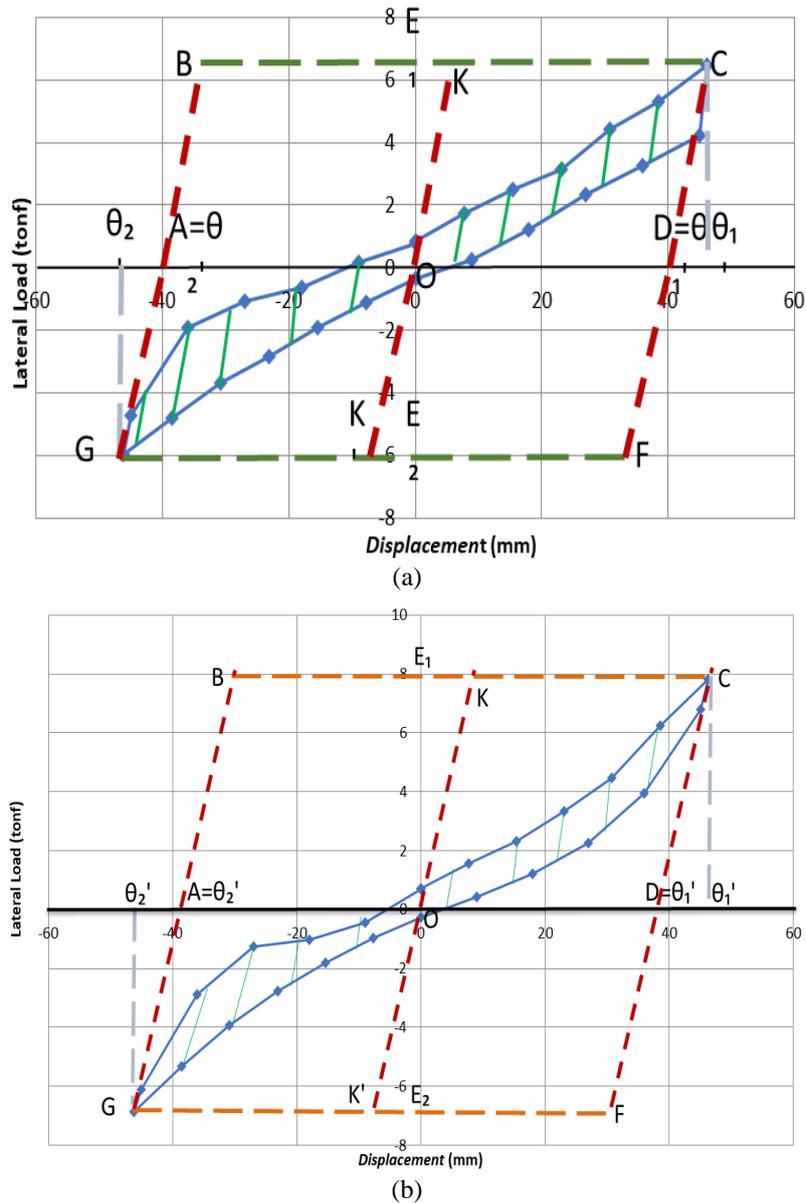
**Fig. 14 - Stiffness degradation (a) hysteresis curve at drift ratio 2.75% cycle to 3 for energy dissipation first step pier model, and; (b) hysteresis curve at drift ratio 2.75% cycle to 3 for energy dissipation second step pier model**

The energy dissipation of the pier model at each drift ratio level is calculated as the area of the loop cycle (shaded area). The area of the loop in each loading cycle can be calculated based on the difference in the displacement values that occur multiplied by the average load value. Energy dissipation is defined as the area of the ABCD parallelogram, where the results of calculating the loop area for both test steps are presented in Table 6 and Fig. 14. Based on Table 6, it can be seen that the cumulative dissipation energy in the second step is smaller than in the first step which is equal to 18.66%.

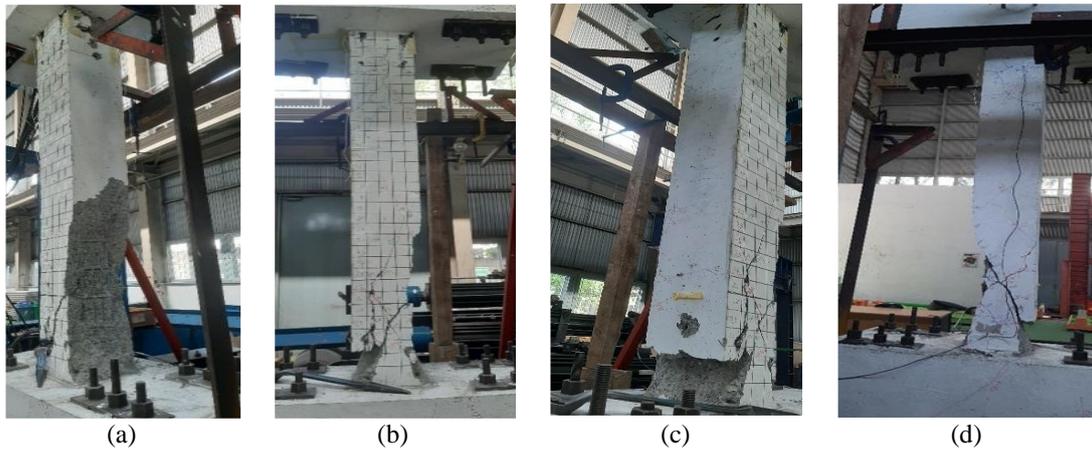
**Fig. 15 - Damage pattern in the first step of testing: (a) left side, (b) front side, (c) right side, and (d) back side**

At the initial loading of the cyclic test in the first step, a relatively small lateral load is given so that the first crack has not formed. Then, the lateral load was increased so that the pier specimen experienced the first crack in the form of a micro crack at the base of the pier when the drift ratio was 0.20%. It starts with a shear crack on the right side of the pier surface and develops on each side of the pier. Shear cracks dominate the crack pattern that occurs in the pier. The cracks that occur continue to increase along with the increase in the load given to the pier test object. Extension or widening of the crack appears in the test object's pier in the first step of the test when the load increases to approach the maximum load. The crack width was still very small before the drift ratio was 3.5%. When the drift ratio was increased to 3.5%, the strength of the pier continued to grow until the pier dropped and the concrete cover began to peel off (cover spalling). The pier model first experienced cracks at the column's bottom with a shear crack pattern, followed by a flexural crack. These shear cracks occur primarily in the column base area to a height of about 50 cm - 100 cm from the column base. Testing of the pier model reached the limit at a load of 8.606 tonf with a displacement of 36.96 mm (drift ratio 2.20%). When the test object was almost destroyed, the cracks got longer and broader, appearing in new places on the sides of the pier. When the load reaches the maximum pier, it collapses suddenly. The damage in the first step resulted in a decrease in the structural performance of the pier model. The damage to the pier model in the first step of testing can be seen in Fig. 15.

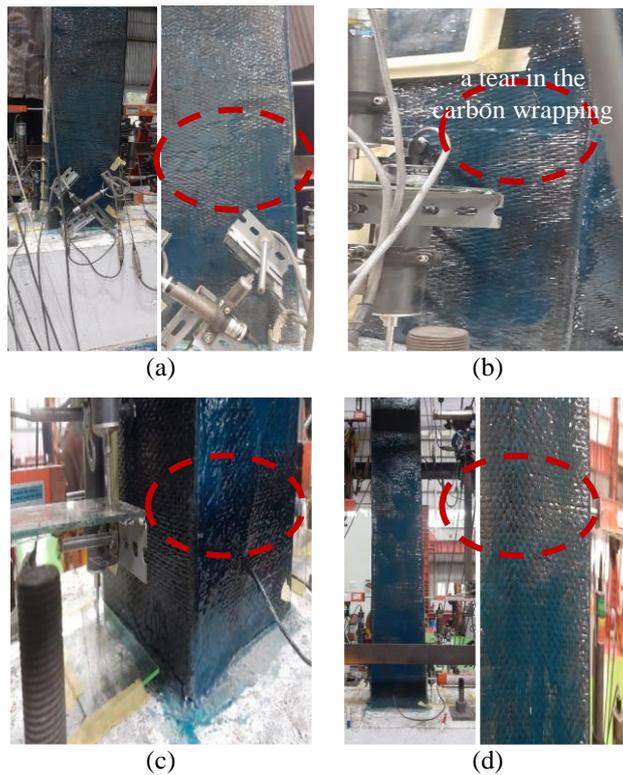
**Fig. 16 - Damage pattern in the second step of testing: (a) front side; (b) right side; (c) left side, and; (d) back side**

In the first step, the pier model experienced a decline in structural performance, so to restore structural performance, repairs were carried out by grouting and wrapping materials to restore structural performance. In the first step, the damaged pier model, which had experienced a decline, was repaired to restore or improve performance. After the pier model has been repaired, it continues with the second stage of testing. The second stage of testing uses the same pier model as the first stage pier model, which has been repaired. The second stage of testing on the pier model, which was repaired by grouting and wrapping the cracks or cover spalling caused by the first stage of testing showed damage to the end of the pier on the front side of the pier, which was marked by fine tears in the dressing that spread to the side of the pier and cracks in the direction transverse. Flexural cracks dominate these cracks. The test object experienced the first crack, which occurred at a drift ratio of 1%. The cracks start from a drift ratio of 1% to 6.25% with marked fine tears in a transverse direction. The pier model specimen experienced the first crack at the column base with a flexural crack pattern. These flexural cracks occur mainly in the column base area to a height of about 30 cm - 50 cm from the column base. Testing the second step of the pier model resulted in an ultimate load occurring at a load of 8.640 tonf with a deflection of 46.20 mm (drift ratio 2.75%). The damage to the pier model in the second step of testing can be seen in Fig.16.
