Visual Inspection and Non-Destructive Test (NDT) on ASTM A36 Welded Joints Produced by GMAW

Abstract

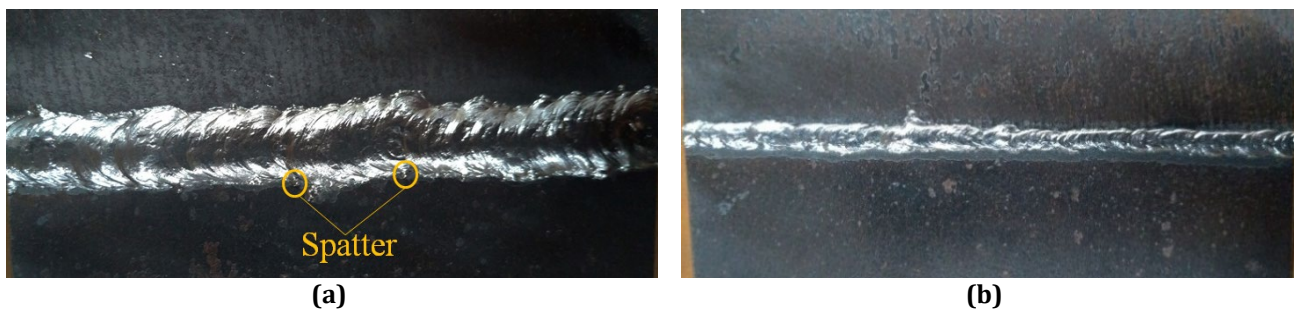
The results of welding on specimen 2 can be seen in Figure 5 in the form of surface and root weld results. Figure 5a, it shows an excess weld metal of 2 mm. If you look at the acceptance criteria in Table 7, then h is 3.175 mm, where h is measured at 2 mm, so accept. In addition, there are imperfections in the form of splatter; there are two spots. If you look at the acceptance criteria in Table 7, it is stated that they are adjusted to the application, so they are accepted.

In Figure 5b. imperfection in the form of excess penetration, if you look at the acceptance criteria in Table 7, then h max is 4 mm, where h is measured at 1 mm, so it is accepted.

**Fig. 5** (a) Visual weld surface area specimen 2; (b) Visual weld of the root area specimen 2

The data shows that the visual inspection on specimen 2 is accepted so that it can be continued for the first stage of the NDT process, namely the penetrant test.

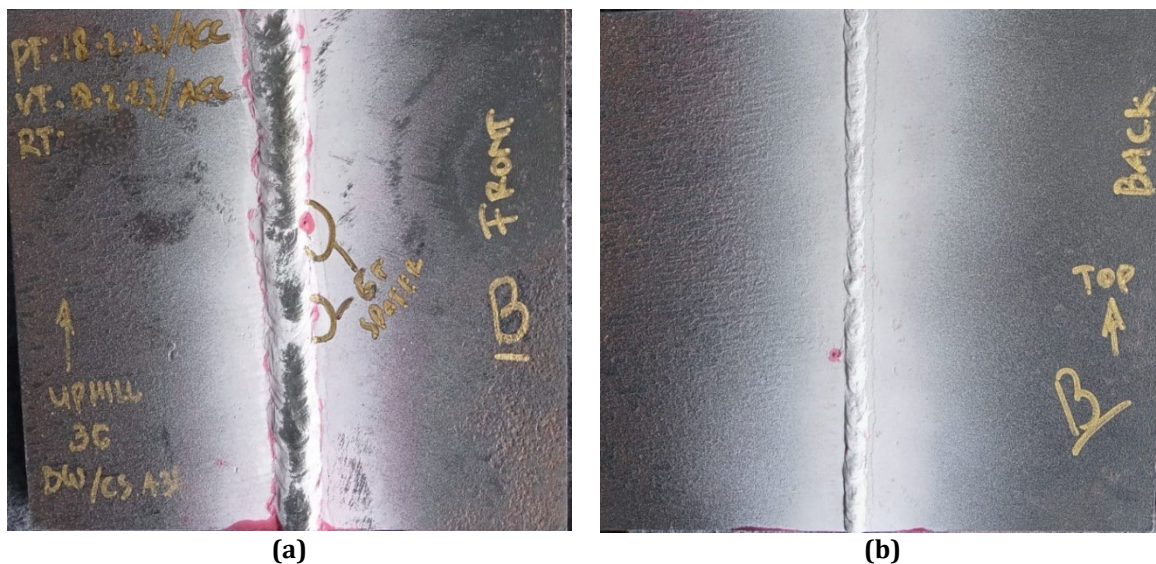
Interpretation of the penetrant test on specimen 2 can be seen in Figure 7a. There is an imperfection in the form of a spatter (2 spots) on the surface area. The reason is that the voltage at the root weld, as seen in Table 7, is too large [12][16] namely 22–23 V if seen in Table 6, another cause is that the gas flow rate is not constant due to dirty gas nozzles [19], adjusted to the application, so it is accepted. In Figure 7b, there are no weld defects in the root area.

Fig. 7 (a) Penetrant interpretation surface area of specimen 2; (b) Penetrant interpretation root area of specimen 2

Whereas in specimen 2, after visual and NDT tests in the form of a penetrant test and radiography x-ray test, it shows that there is an imperfection in the surface area, namely in the form of spatter (2 spots), which is caused by the voltage at the root pass being too large, another cause is that the gas flow rate is not constant due to dirty gas nozzles, so according to the limits for surface and joint geometry imperfections in ISO 6520-1, they are accepted, and there are internal imperfections in the form of porosities with an area of less than 3%, and the largest size of the porosity is only 1.96 mm or less than 3 mm, if you refer to the limits for internal imperfections in ISO 6520-1, they are accepted.
