The Experimental Analysis and Behaviour of Locally Corroded Metakaolin-Blended Reinforced Concrete Beams Under Flexural Loading

Abstract

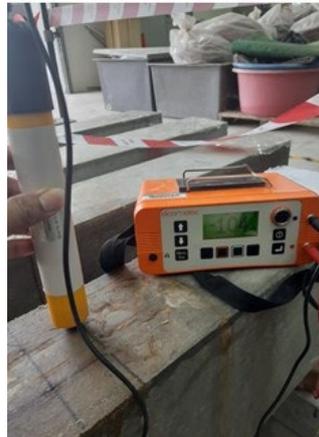
Fig. 4 HCP data collection

Data for Half-Cell Potential (HCP) were collected at 22 points in the area of 500 mm x 150 mm, specifically on the installed tensile reinforcement, for CB1 and CB2. Fig. 4 shows the data collection process for each beam and the test results are discussed in the subsequent section.

According to the calculation of time for 10% corrosion in Table 2, after reaching 1121.76 hours, data collection for HCP was continued as illustrated in Fig. 4.

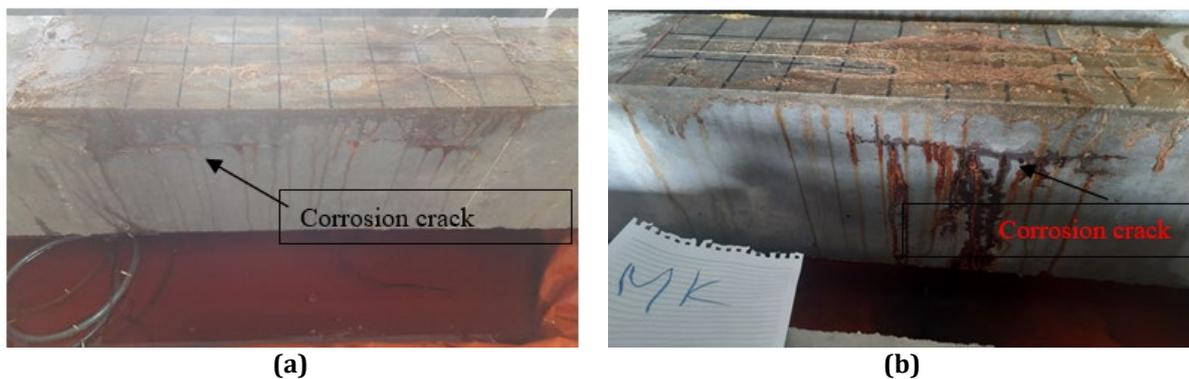
Fig. 7 Corrosion crack (a) CB1 horizontal crack; (b) CB2 horizontal crack

As previously explained, the corrosion process was conducted by placing the tension side of the beam in an upper position. Fig. 7 showed that after reaching 1121.76 hours of the corrosion process, horizontal cracks occurred on the side of the beam. However, there was no significant difference observed, as both test specimens were targeted to corrode by 10%.
