# Implementation of Digital Twin for Investigation of Delayed Building Construction

The object of this research is the office building of one of the government agencies in Bandung, West Java. It was constructed in early 2019 and experienced a construction delay of 3 years (Fig 1). This building was situated on 2,513 m<sup>2</sup> of land, with 3 floors, a basement, and a rooftop.

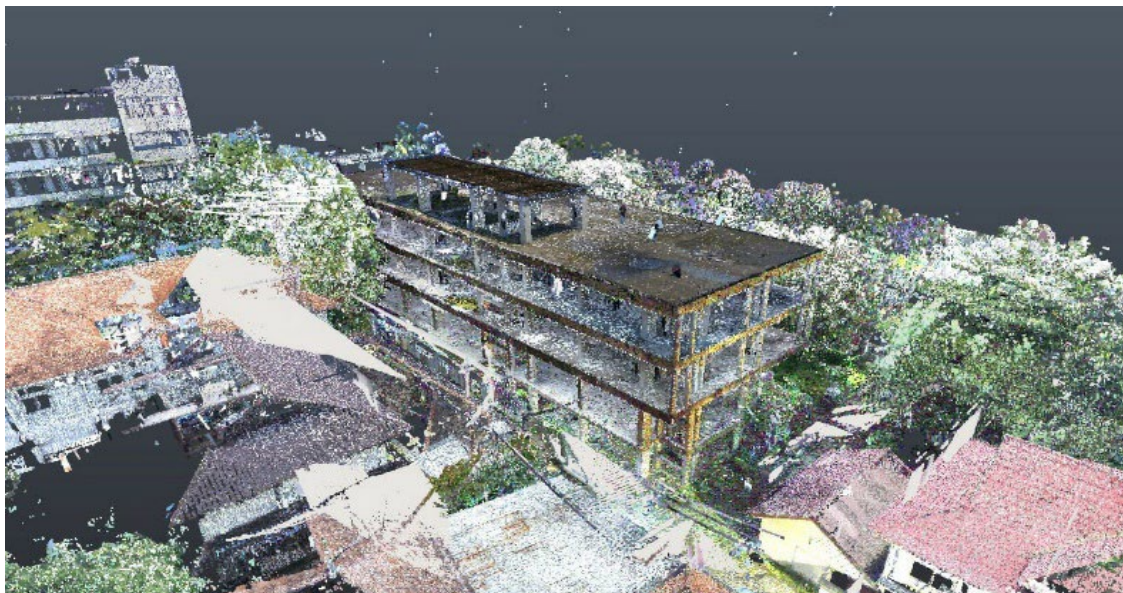
**Fig. 5** The 3D model before the filtering process (a); and after the filtering process (b)

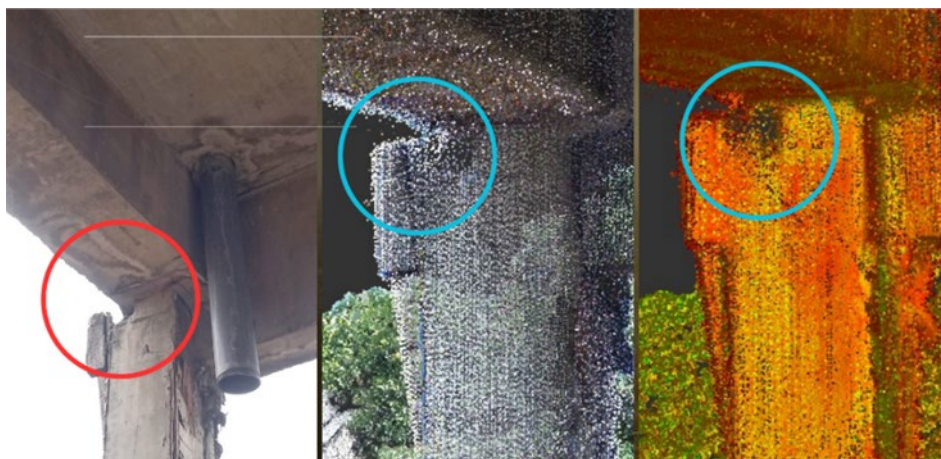
**Fig. 10** Comparison of damage visualization on field object and 3D model

Fig. 10 shows a comparison of damage visualization in the field and the 3D model in two views. In the 3D model (real colour), no damage is visible on the column element. The use of false colour can reveal the presence of damage, but it is difficult to identify the type of damage [32]. This condition is influenced by at least two main factors:

1. The location of damage on the column is too far from the radius of the instrument's standing location, especially for damage located at the outer end of the building. To improve the results, it is necessary to acquire excess data while ensuring that the overlap between the radius of the instrument's standing locations is above 60% [33]. Overlap aims to increase the number of points with a higher density of points.

- The conversion process from point clouds to solid 3D models significantly affects the visual quality of building damage. It requires the use of more powerful software applications or more appropriate methods. The voxelization method based on points automatically transforms point cloud data into solid models using computational modelling [34].

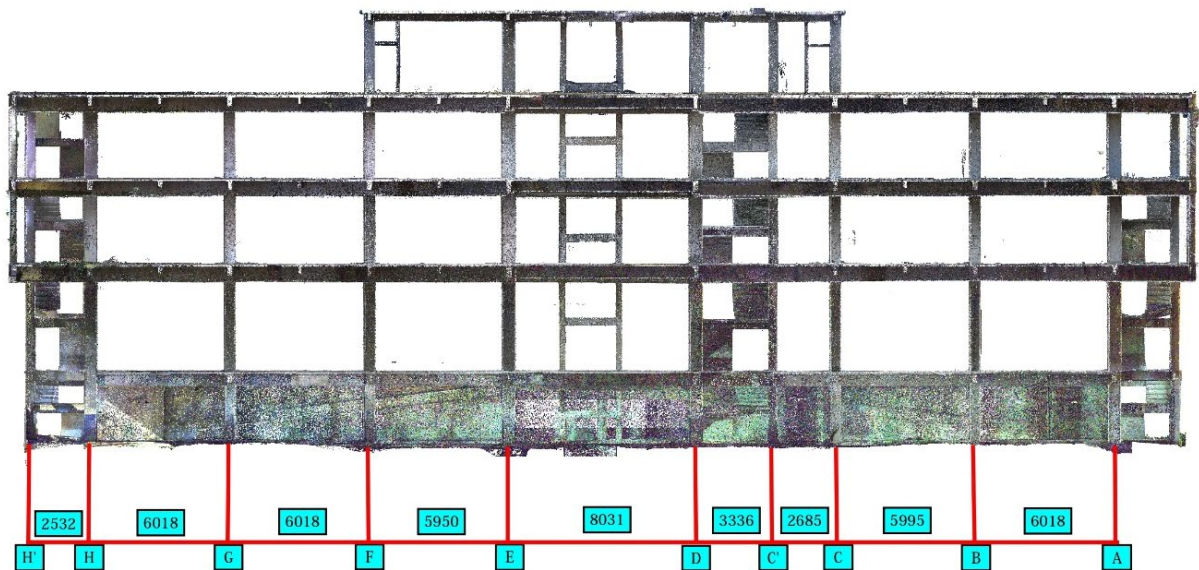
**Fig. 13** Location of axis to axis

Table 3 shows that the as-to-as distance measured using TLS tend to be larger than the other two comparison values. Although there is variation in the distance values among the comparison objects, these differences are not significant [35]. The largest difference in as-to-as distance recorded is 60 mm.
