# Mitigating Slope and Embankment Erosion in Malaysia: Case Studies and Integrated Approaches

## Abstract

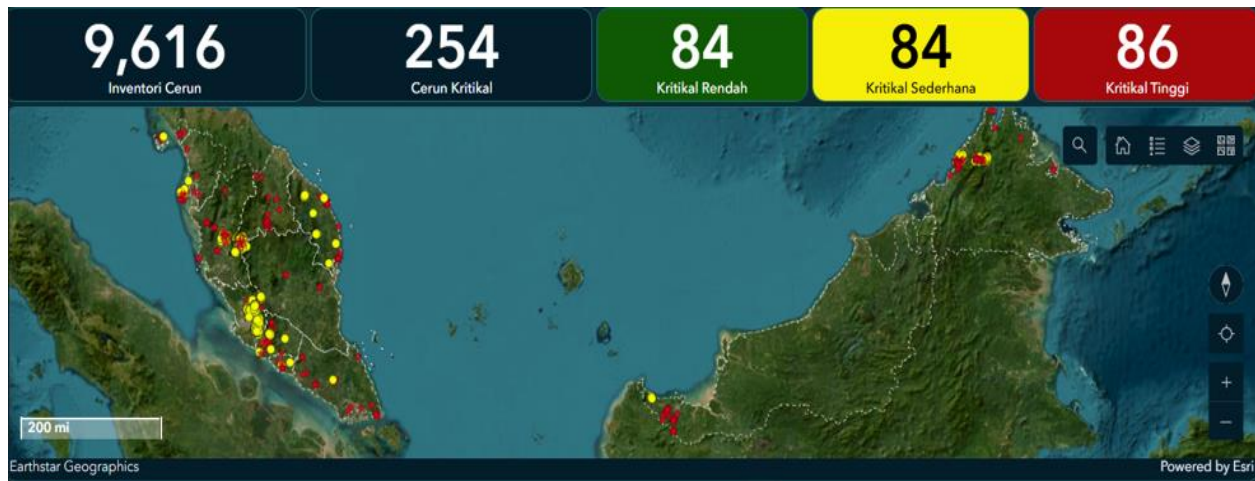
**Fig. 1** Inventory of current slope in Malaysia in the year 2025 [6]

Referring to Fig. 1, NaTSIS JMG [6] categorised the high critical slope as showing the immediate and comprehensive remediation, often involving robust engineering solutions. In contrast, medium and low critical slopes might benefit from less intensive but equally important measures, such as enhanced monitoring, the deployment of early warning systems, and targeted stabilisation efforts. Effective mitigation, as underscored by the data, requires an integrated, multidisciplinary approach. This approach extends beyond conventional engineering solutions such as slope stabilisation, improved drainage systems, and the construction of reinforced structures, to encompass broader strategies.

The analysis of the NATSIS JMG data for 2025 provides a crucial overview of Malaysia's slope stability landscape. Geographically, states such as Sabah, Johor, Kelantan, Pahang, Perak, and Terengganu exhibit the highest concentrations of critical slopes, highlighting regional vulnerabilities. While mitigation works have been completed for a small percentage of critical slopes (approximately 14.6%), the majority remain under monitoring or are awaiting active intervention, underscoring the considerable scale of the ongoing challenge.

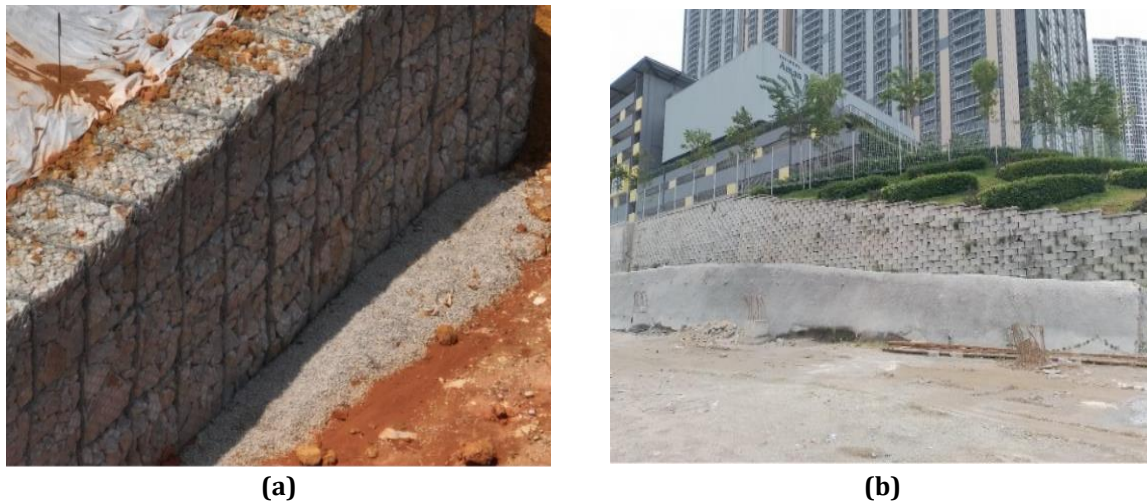
**Fig. 3** (a) Gabion wall; and (b) Interlocking blocks known as Omega bricks

Fig. 3 shows typical structural techniques for mitigating slope erosion and serving as retaining walls. There are various typical retaining wall systems used in Malaysia, such as gabion walls (gravity retaining walls), soil nailing, and guniting (shotcrete). This type of mitigation can be considered because of economic reasons. But it still has disadvantages, such as lateral pressure from backfill and soil movement. A gabion wall can topple if improper design and construction, i.e., inadequate wire connections or improper backfilling, contribute to instability and the risk of toppling. To mitigate the risk, a gabion wall or an omega wall can be integrated with geosynthetics (geogrids) to improve stability when encountering taller walls or challenging soil conditions.

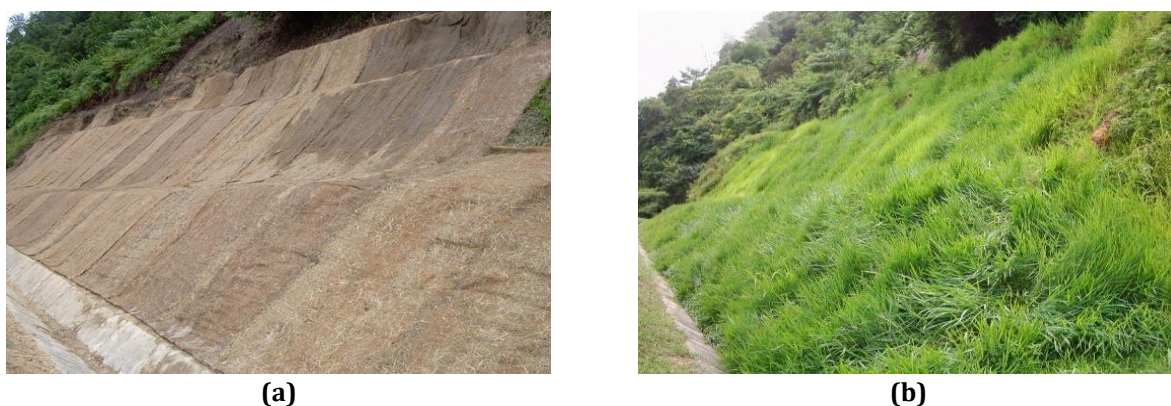
**Fig. 4** Vegetation slope (a) Erosion control blanket; and (b) Vegetation of signal grass on slope [20]

This indicates that reforestation, appropriate selection of deep-rooted plant species, and bioengineering solutions are not just "green" initiatives but essential, cost-effective engineering practices for long-term slope stabilisation and erosion control. Fig. 4 shows the hydroseeding and erosion-control blanket techniques (using paddy, palm, or coconut fibre) on the slope. The environmental impact of erosion control techniques is critical, particularly in ecologically sensitive areas. Sustainable techniques, such as vegetation cover and biodegradable erosion control blankets, are preferred for their ability to support biodiversity and integrate seamlessly into the natural environment.
