Findings of the safety inspections found on the TEN-T road network in the Czech Republic

Abstract: In 2015 the Czech Technical University in Prague carried out a safety inspection on the TEN-T road network in the Czech Republic and on the selected 1st class roads (in the future they are intended to replace the planned TEN-T network). This article is designed to provide a basic overview of the most common problems in terms of both the frequency with which these risks occur and their significance. This article will also present a newly developed web application, CEBASS, which gives road operators an effective and systematic tool to manage the process of solving these problems. The aim of this article is to describe the classification created and used during the safety inspection course, which is better for road operators than the existing methods for safety inspections.

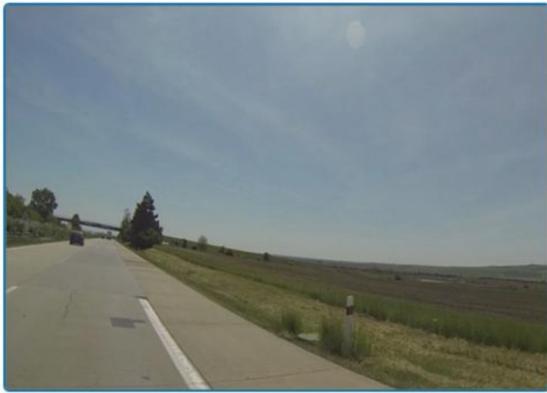
Fig. 1 Form with additional information about every road safety problem.

ROAD SAFETY PROBLEM
Link (section) between junctions

CATEGORY OF PROBLEM
Absence and worn down of road marking
Notice: Absence of road marking in length of 180 m

SEVERITY OF RISK LOW

LOCATION
GPS: N: 48° 53'37.17"
E: 16° 48' 01.47"
Stationing (chaining): km 33 - 34
Location: Road in rural area
Responsible administrator (Organization): SSÚD 7 Provodín
Speed limit: 130 km/h

Implemented measure: Correction of road marking
Notice: Realization of rod marking type V2a and v4
Difficulty of realization: SIMPLE

Current phase ➔ Removed

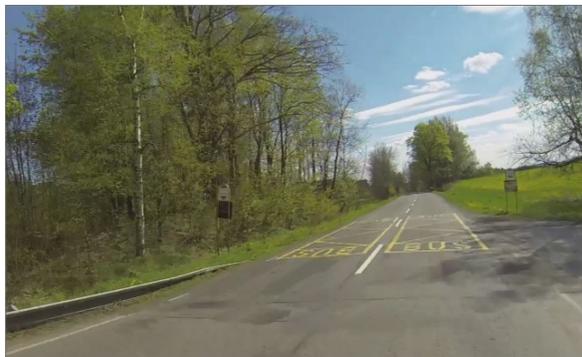
Fig. 6 Bus stop (1st class road I/16, km 189 – 188).

Four basic problems were found at bus stops:

- missing traffic signs;
- missing / worn down road markings;
- unsuitable arrangement of stops and types of stops;
- poor conditions for pedestrians, i. e. poor access to the bus stop.

The last two subcategories are essentially the most risky. The following figures show the standard bus stop designed on rural roads in the primary road network of the Czech Republic. Figure 6 shows example of bus stop.

The safety inspection reveals the main development issues among bus stops on rural roads. The authors therefore suggest the following:

- develop bus stops that encourage people to use public transport, improve comfort and increase road safety;
- avoid upgrading bus stops on the traffic lane and use this solution as a special option in justifiable cases only;
- carry out a detailed assessment of the location of bus stops on rural roads from the point of view of routing; compare this with the routes for road users not driving motor vehicles who could be injured.
