Compressive Behavior of Jacketed Specimens and Flexural Behavior of Concrete Beam Strengthened using Sodium Silicate Mortar

DOI: <https://doi.org/10.30880/ijie.2019.11.09.028>

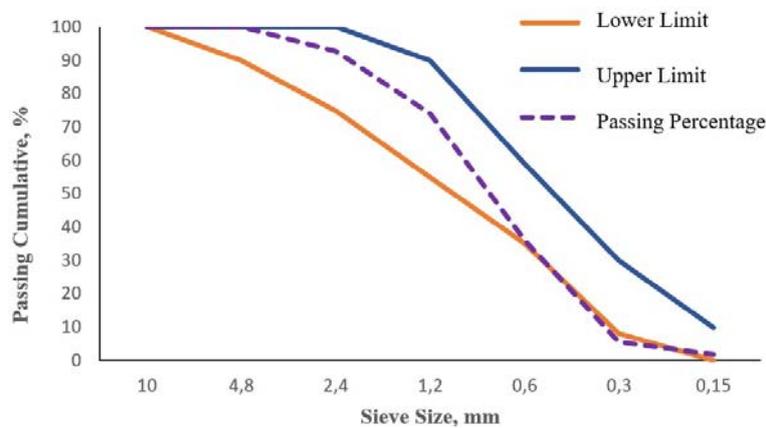
Fig. 1 - Fine aggregate distribution size

Distribution size of the fine aggregate was checked to know whether it could be used or not as concrete mix. The Indonesian Standard (SNI) was referred to as guidance for the test, which in this case was based on SNI 8321:2016. The result of the distribution size is illustrated on Fig. 1. The fine aggregate passing cumulative used was slightly under the lower limit than the allowed especially on small sieve size, however this material was still acceptable for mix concrete.

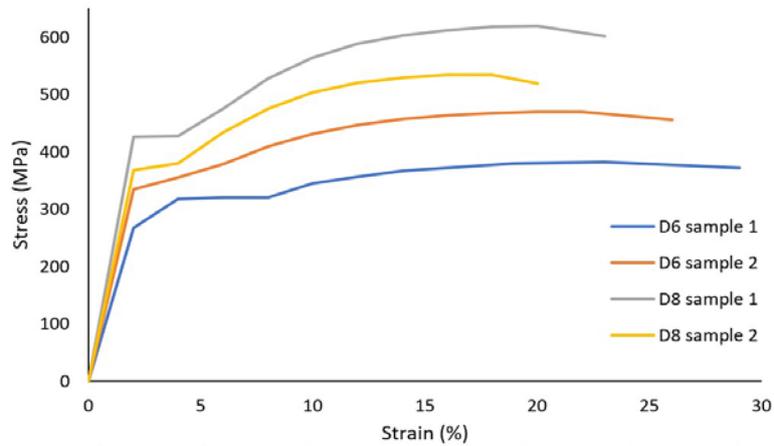
Fig. 2 - Stress-strain interaction of reinforcing bar used

Beam specimen cannot withstand itself without reinforcing bars. There are two possibilities of failure in the beam, namely flexural and shear failure. It is expected to fail from bending test, so that the shear strength must be stronger than its flexural. Two varieties of reinforcing bars were installed in the concrete, one had 6 mm of diameter and the other had 8 mm. These two bars were tested under the tensile test on universal testing machine (UTM). The 6 mm bar had yield stress (f_y) about 250MPa to 350 MPa and the 8 mm bar had about 350MPa to 420 MPa. Fig. 2 presents the complete result of the bar testing.

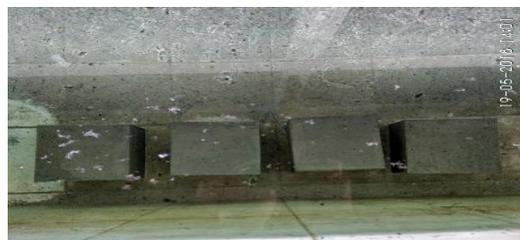
Fig. 4 - Cube specimens inside the water for curing

calibration to normal compressive strength (f'_c) with a multiplier of 0.83. Below in Fig. 3 and Fig. 4 are displayed the concrete cube moulds and the implementation of curing of concrete samples.

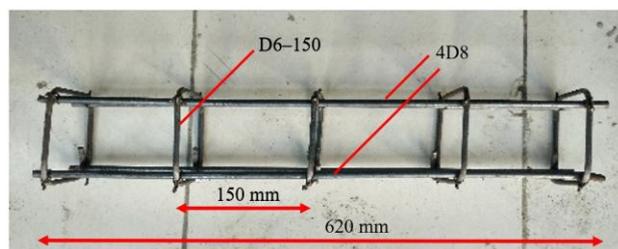
Fig. 5 - Reinforcing bars for beam specimens.

Four reinforced concrete beam samples were used with 1 control beam which was not repaired. Three other samples were distinguished based on sodium silicate to cement ratio which was for grouting applied. The beam had a rectangular section of 15 cm x 15 cm with a total span of 62 cm. Moreover, the support was pinned-rolled support with a span length of 60 cm. The beam had the reinforcement configuration as depicted in Fig. 5 with the illustrated cast in Fig. 6. After cast, the concrete was cured by covering it using a wet gunny sack for 28 days, as pictured in Fig. 7.

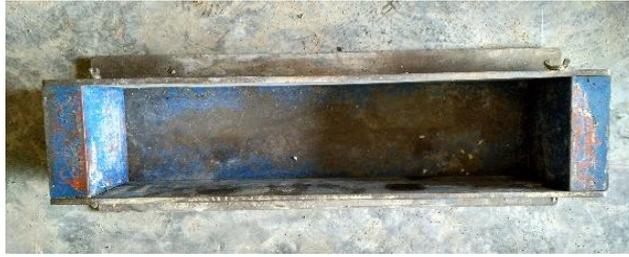
Fig. 6 - Concrete beam metal cast

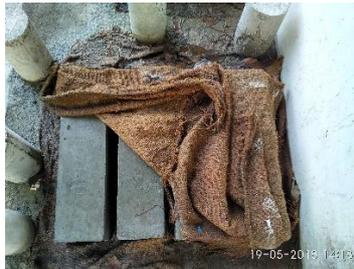
Fig. 7 - Beam samples curing process

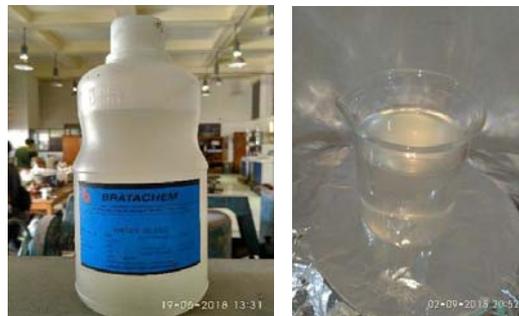
Fig. 8 - Sodium silicate

Sodium silicate, or usually called as water glass, is the name for chemical compound of Na_2SiO_3 . This chemical was obtained from Bratachem, Indonesia. Its form is liquid so that it can directly be mixed with cement. This compound can be seen in Fig. 8. The cement used for this research was Portland Pozzolan Cement with “Semen Gresik” brand and the mixing between Sodium silicate with the cement to create Sodium silicate mortar is illustrated in Fig. 9.

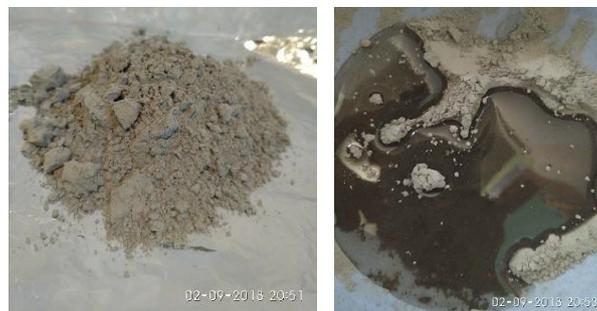
Fig. 9 - Cement (left) and Sodium silicate mortar (right)

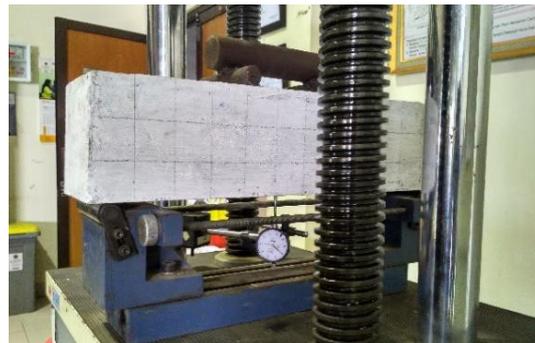
Fig. 11 - Testing set up for beam sample

bending tests for the beam specimens were performed by Universal Testing Machine (UTM) in this laboratory as seen in Fig. 10. For the bending test, the UTM was modified with some additional supporting steels to conduct three-point loading as suggested in ASTM C78. The configuration of the support system with modified steel can be seen in Fig. 11.

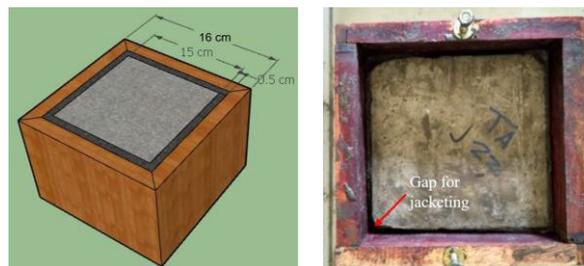
Fig. 12 - Concrete cube jacketing treatment

The jacketing method for the cubical concrete samples was by using an additional casting from multiplex wood, which is presented in Fig. 12. This casting had a dimension of 16 x 16 cm² so that it left small gaps around the cube to be filled with sodium silicate cement. Different with the compressive test samples, the beam was repaired by making the first crack and the load for the first crack was predicted by manual calculation before the real test. After the first crack appeared, then the beam was prepared to be injected by sodium silicate mortar along its crack, then the bending test was continued on the next 28 days for its final age. This treatment is shown in Fig. 13.

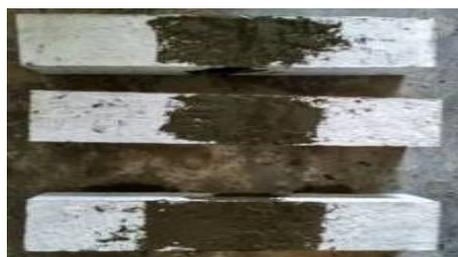
Fig. 13 - Concrete beam grouting treatment

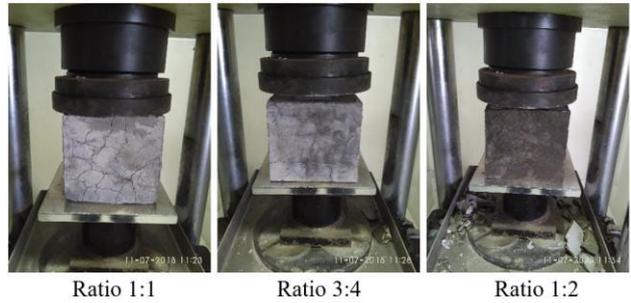
Fig. 16 - Failure at the compressive test for strengthened cubical specimens

The first compressive test indicated that all the three ratios had the compressive strength more than 30 MPa as designed in the beginning. After the jacketing, these three ratios were tested again due to axial load and still had good average ultimate strength at least 72% from the initial strength for ratio 1:1 and 92% for ratio 3:4. This shows that the sodium silicate mortar really helped the cubical concrete to retain all the axial forces that occurred during the test, even though the repaired concrete could not go back to its full strength. The detail of the compressive test result for both conditions is presented in Table 3 while the damage during the test is depicted in Fig. 16.

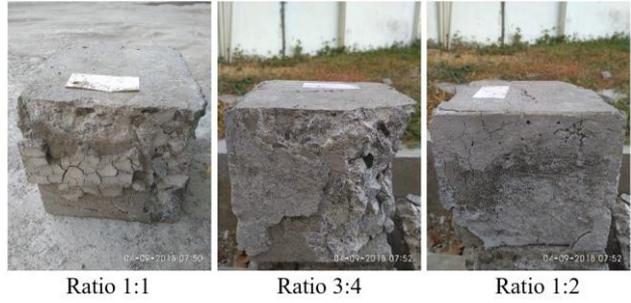
Fig. 17 - Detailed failure occurred in jacketed concrete cubes

After the test, these three ratios were observed closely to see the types of the damages. From Fig. 17, it can be known that ratio 1:1 and 1:2 were mostly damaged on the outer part, which is the sodium silicate mortar, while the ratio 3:4 had all the damages on its body.

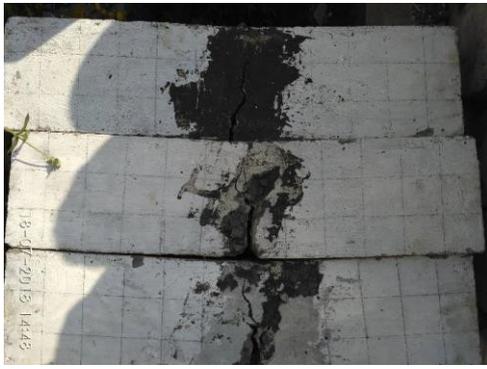
Fig. 19 - Bending failure for three grouted beams

The next experiment was bending test for beam specimens. The first crack that occurred in the beam was placed in the middle of the beam as illustrated in Fig. 18. This means that the beam had been damaged from the flexural failure. After retrieving the first crack, the injection of sodium silicate mortar grouting was done especially in the part of openings, then bending re-test was performed until the ultimate strength was obtained. The final failure on the three beams is depicted in Fig. 19.

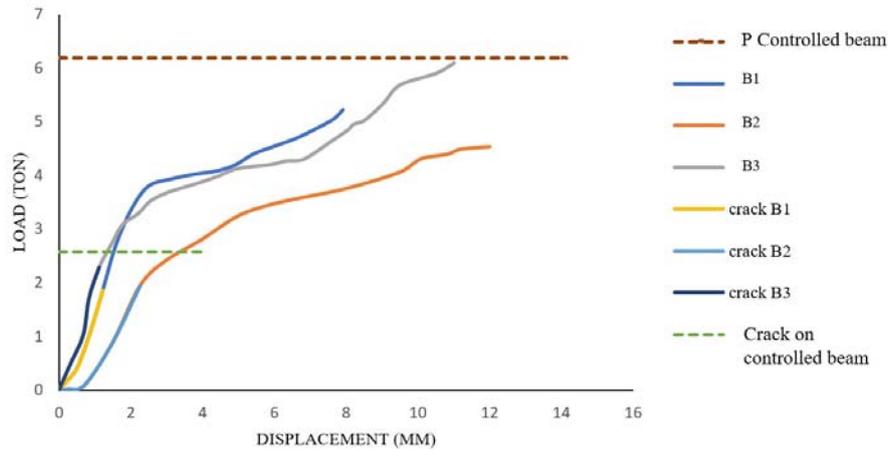
Fig. 20 - Bending test result of beam specimens.

The control beam was also tested as comparison especially on the first crack load and the ultimate load. The full result of the bending test is portrayed in Fig. 20 and Table 4.

There were three beam specimens involved in this test, with different Sodium silicate-cement ratios (SSCR). Beam 1 (B1), Beam 2 (B2) and Beam 3 (B3) had the SSCR of 1:1, 3:4, and 1:2 respectively. The load and displacement were observed to know the detail of P-delta curves. The first crack was also monitored, and all the first cracks were shown in Fig. 20 with different colors. After the crack, the beam was repaired then the loading was continued until all the specimens failed. The dashed lines illustrate the crack point and ultimate point of the control specimen results. These are drawn in Fig. 20 to compare all the results.

From the test outcome, it can be learned that the load to make the first crack of the repaired beam was not as high as the control beam which is possibly because the sodium silicate was not fully covered and did not have enough grip to maintain the beam concrete especially on the gap. Similar with the ultimate strength, the load to make the control beam reach the ultimate condition was still higher than the load for all the three beams.

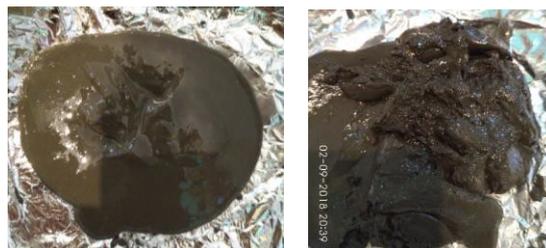
Fig. 21 - Setting time in 1 minute (left) and 7 minutes (right).

In addition to the test result, it is noticed that the sodium silicate mortar had a short setting time, so the strengthening had to be done quickly before the mortar hardened. Fig. 21 shows the mixing condition of this mortar. In only 7 minutes, the mortar had already set so that it was hard to fill the crack gap. In 10 minutes, the mixture had partly hardened and created some clogs as illustrated in Fig. 22. This quick setting time might also be the reason of the lower bending test result for repaired specimen compared to controlled beam.

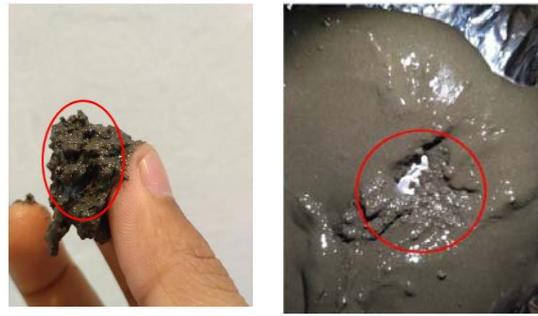
Fig. 22 - Clogging that happened in sodium silicate mortar after 10 minutes.
