Forensic Study on Federal Road Pavement Failures at Rengit and Semerah, Batu Pahat

Abstract: Forensic investigations in engineering term may be conducted to identify the causes of failure to facilitate the design of proper repairs, or to improve the performance or lifespan of a component, assembly, or structure. This paper presents the combination of geotechnical investigation and geophysical survey method as a forensic tool to predict the causes of pavement failure occurred along the coastal area of federal road FT005. The number and type of field testing are varying on each selected study area at Rengit and Semerah, Batu Pahat as this location constructed on soft soil area. Non-destructive testing (NDT) method using electrical resistivity tomography (ERT) were chosen to be applied at the worst severity of the road failure. Three number of resistivity lines of 100m and 200m were laid out using ABEM Terrameter LS2 with gradient method of electrode arrays covering up to 40-meters depth. Then, further testing of destructive testing (DT) method using borehole drilling conducted near the ERT lines to obtain soil profile with SPT N-value measurement. The disturbed and undisturbed sampl

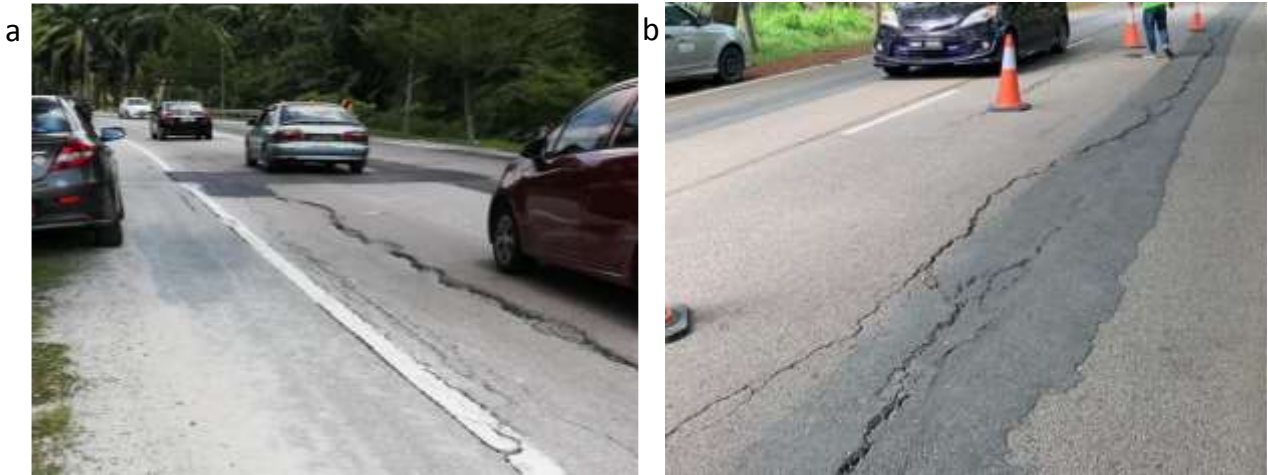
Fig. 1 - Longitudinal cracking found along FT005 (a) Rengit and (b) Semerah

The large number of defects where longitudinal cracking were seen along the federal route as it was constructed on soft soil area at the west coastal region in Johor. In areas with soft soil, settlement is one of the most common difficulties experienced on the road and it frequently results in severe damage to the pavement structure's overlying layers [6-7]. These defects caused mainly by the differential settlement between the new and the old roads Besides, the increased of permanent loading from the resurfacing from extensive seal coatings and thin overlays, correspondingly causes the rapid settlement. These temporarily surface treatment led to severe pavement failure as the increasing of traffic loading also one of the factors resulting in surface cracking and further settlement [8-12]. Despite periodic surface treatments, the overall pavement condition continues to deteriorate.

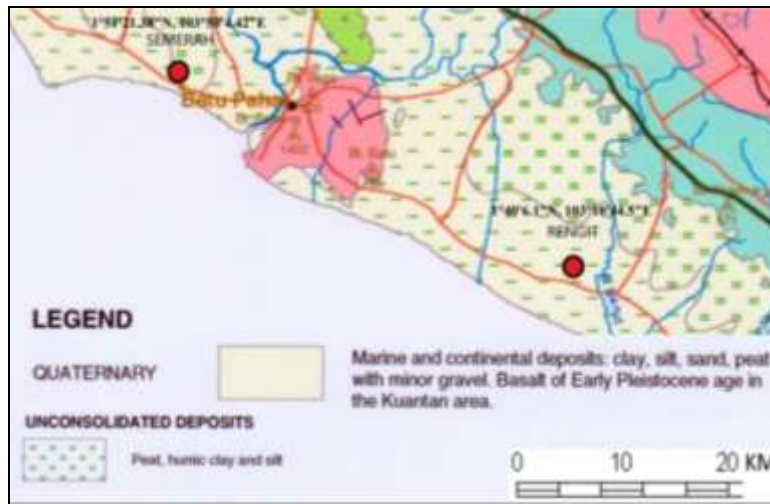
The geology at Rengit and Semerah, Batu Pahat, Johor belongs to Quaternary unconsolidated marine clay. It consists of a deposit of clay, silt, sand, and peat with minor gravel as shown in Fig. 2. The characteristics of Quaternary deposit are soft, unconsolidated and high groundwater table. Malaysia's soft soil is often classified as quaternary sediments made up of marine clay deposits and organic or peat soils [21].

Fig. 2 - Geology map of FT005, Rengit and Semerah, Batu Pahat, Johor [21]

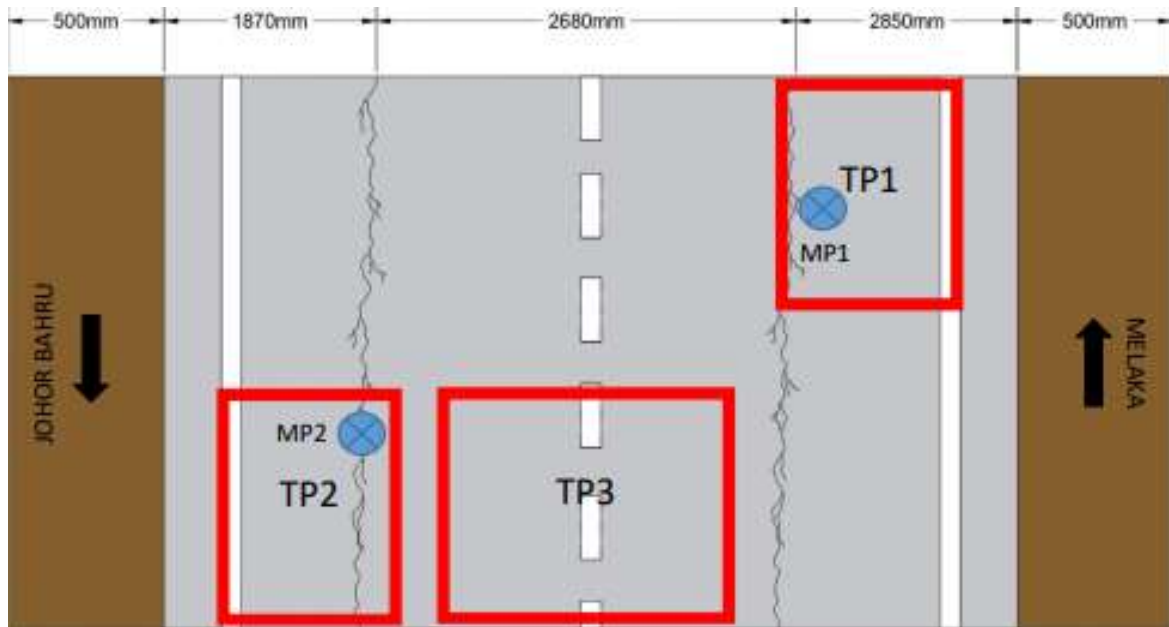
The pavement distress shows longitudinal cracking, indicating highly deteriorated areas along the roadways at the center of both lanes. In this case, TP1 was dug 5 m away from TP2. TP2 and TP3 points were excavated together side-by-side, as shown in Fig. 5. The concrete slab is underlain by reinforcing fabric of steel (BRC reinforcement), which was found at TP2 and TP3 in a depth of 600 mm and a width of 2.3 m. The gap between the concrete slab is 1-inch (24.5 mm) at the centerline of the roadways. The concrete slab layer was constructed between both centers of the road lane. During the widening road project, the different methods from the existing construction were adopted geotextile between the crusher run layer and the treated subgrade (500mm – 600mm) material.

Fig. 5 - Trial Pit and Mackintosh Probe location Section 90 – Rengit

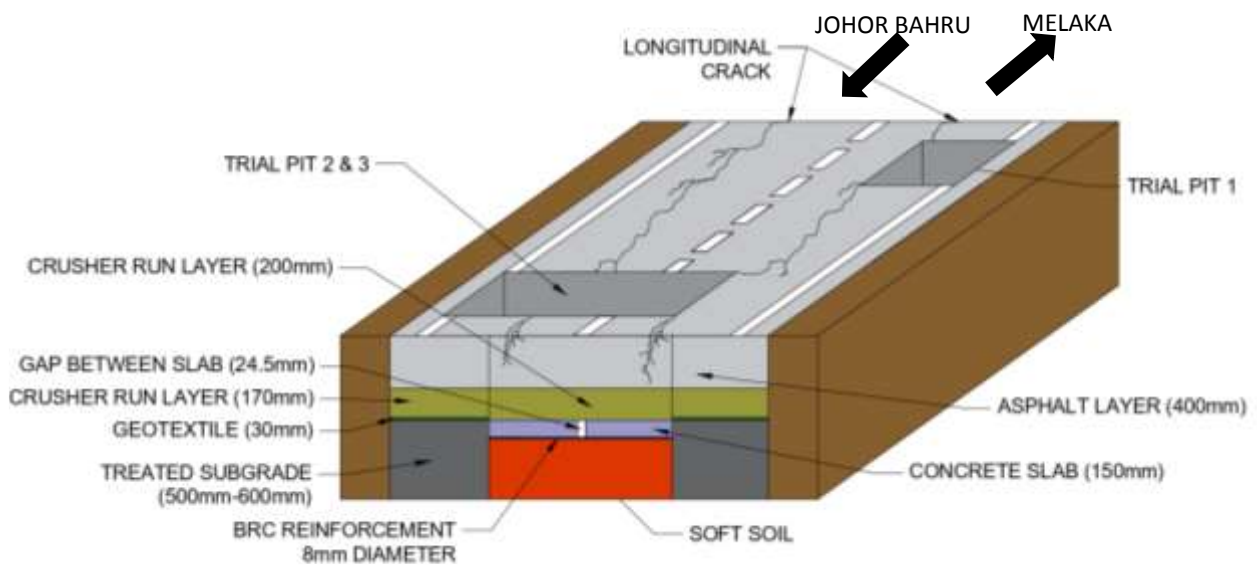
Illustration in **Fig. 6** show that the longitudinal cracking seen from the center of the side lane dispersed downward to the asphaltic layer only. A longitudinal cracking dispersed on the pavement surface caused by differential settlement at the edge of the concrete slab was due to the different layers of material for road widening construction. The material used for road widening are geotextile layers and are treated as subgrade material. Meanwhile, the existing road was constructed using concrete slabs with BRC reinforcement underneath, followed by soft soil. Another longitudinal cracking dispersed only on the pavement surface caused by differential settlement at the center of road was due to the 1-inch gap between the reinforced concrete slabs. However, with a very high groundwater table of 1.0-meter, lateral (horizontal) force also tends to occur. Visual inspection indicates that the pavement is structured at TP1 & TP3 to have 4 layers; E1 Asphaltic Layer (400mm-thick), E2 Crusher Run (170mm), E3 Geotextile (30mm-thick) and E4 Treated subgrade (500mm – 600mm). The pavement at TP2 is structured to have 5 layers; E1 Asphaltic Layer (400mm-thick), E2 Crusher Run (200mm), E3 Concrete Slab (150mm- thick), E4 BRC Reinforcement and E5 Soft Soil.

Fig. 6 - Cross section of the Trial Pit hole excavated at Section 90.0 (Rengit)

Based on the investigation, the soil subsurface profiling at Rengit and Semerah shows a very soft to stiff clay soils. The soil profiling from borehole and resistivity values displays an identical consistent result. This is also supported by the geological map that the research area is considered as Quaternary unconsolidated sediment consisting of marine clay. Therefore, the settlement is likely to be factor of the road failure as the federal road were built on top of soft soils area. From the trial pit excavation, it was found the differential settlement along the cross section of the road due to different construction method. Furthermore, there were a ruptured slab found along the longitudinal cracking on the surface. Ensuring the comfortability and safety of road users, damaged areas have been repaired over the years by a concession company using resurfacing method. This has caused the thickness of the pavement to increase up to 0.4 m from the road surface. Thus, the increased of the static load on the road due to resurfacing has triggered other problems related to the weak condition of subgrade. In conclusion, improper construction practices using varies material had contributed to the failure of the road. Generally, several road improvement attempt can be considered on soft soil construction which include strengthened the soil and stabilized the soil.

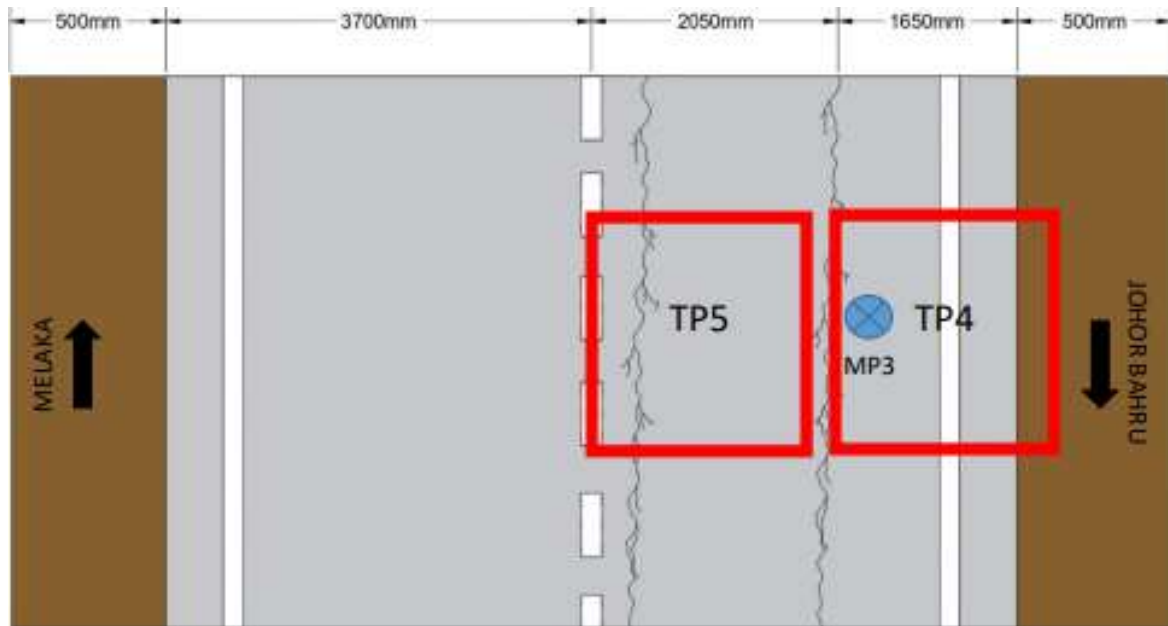
The pavement distress shows longitudinal cracking, indicating highly deteriorated areas along the roadways at one lane. In this case, TP 4 and TP 5 points were dug together side-by-side, as shown in Fig. 7.

Fig. 7 - Trial Pit and Mackintosh Probe location Section 90 – Rengit

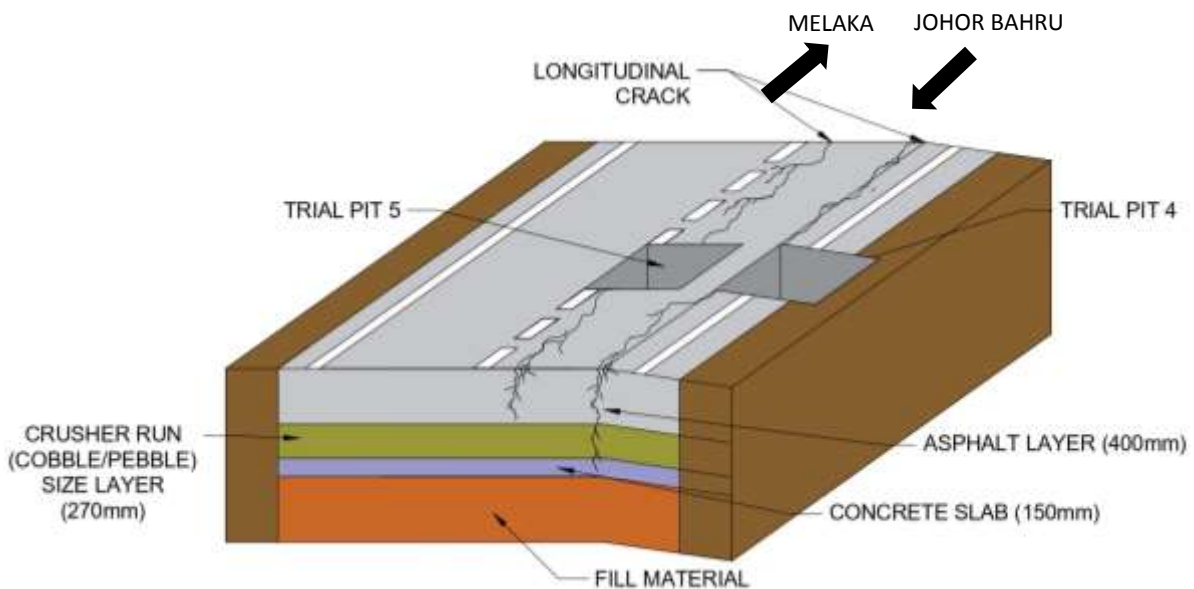
Illustration in Fig. 8 shows that the concrete slab layer was found from the road shoulders to the centerline of roadways, below the crusher run layer on both sideways without a gap. The concrete slab layer in Semerah was found along the road without BRC reinforcement underneath it. A longitudinal cracking dispersed from the surface of the road is due to the failure of a concrete slab, which was made by solid concrete material without any reinforcement. Therefore, any increment of loading can cause concrete composite material to have less strength under tensile strength. In addition, the pumping effect due to traffic load, traffic high speed, traffic volume, and increase of surcharge loading (resurface pavement) can deflect the concrete slabs and rupture near the edge of the concrete slab. Moreover, heavy loading of crusher run layer of material using larger gravel, such as cobble and pebble, might also be possible causes of excessive loading. Furthermore, the road was constructed on a high embankment of the road. Therefore, slope stability failure might occur and lead to soil tension crack. This tension crack may cause the whole structure of pavement to fail. In the analysis, the pavements at TP 4 & TP5 were structured to have 4 layers; E1 Asphaltic Layer, E2 Crusher Run layer, E3 Concrete Slab and E4 Soft Soil.

Fig. 8 - Cross Section of Trial Pit 4 & 5 in Section 154.0 (Semerah)
