Wear Characteristics of 22MnB5 Boron Steel under Friction Micro Pin-On-Disks Test

Abstract: 22MnB5 Boron Steel can be considered as emerged material for high strength and low weight application. This material potentially used in abrasive condition such as cutting tool or brake pad where high friction resistance applies. In this study, the wear characteristics of 22MnB5 was investigated under the frictional tests via micro pin-on-disk. 22MnB5 Boron Steel was prepared the form of round shape within the size of 2.6 mm thickness and 12 mm diameter by using laser cutting. 4 different samples were tested namely blank (sample A), self-hardening heat treatment (sample B), 60 HRC hot stamped (sample C) and 70 HRC hot stamped (sample D). The results show that Coefficient of Friction (COF) increased as the hardness of 22MnB5 decreased. Low COF of 0.2114 recorded for sample D with 70 HRC hardness. The COF increased to 0.24, 0.29 and 0.3 when sample C (60 HRC), sample B (52 HRC) and sample A (45.5 HRC) applied respectively. For pin-on disc test, worn area decreased as the hardness increased. 22MnB5 that prepared with the highest hardness of 70 HRC presented smallest wear area of 700 μm x 2400

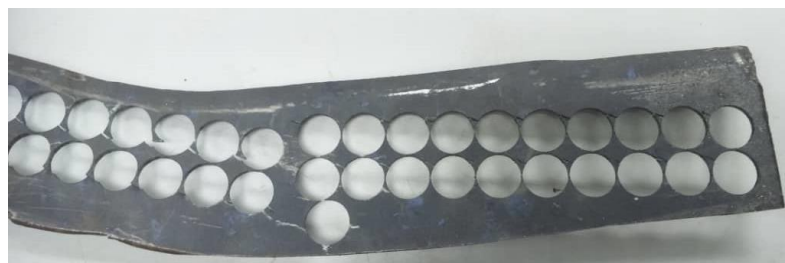
Fig. 1 – Raw 22MnB5 in the form of grinded steel

22MnB5 Boron Steel was prepared in the form of metals stamped product as shown in Fig.1. The raw material being parted by hand grinder before cut separately part by part using the laser cutting machine as shown in Fig. 2. Table 1 shows the parameters used to cut 22MnB5. The thickness of material was set at 2.6 mm with the diameter of 12 mm. Fig. 3 shows the inserts that have been produced by laser cutting process.

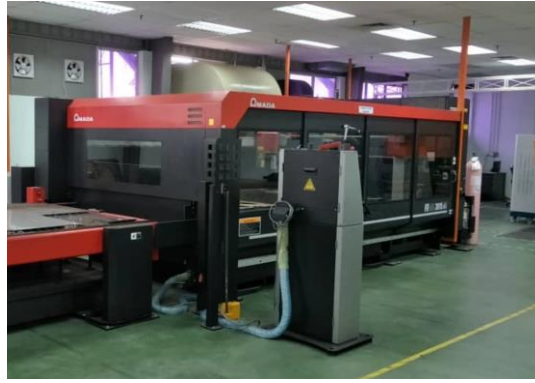
Fig. 2 – Laser cutting machine

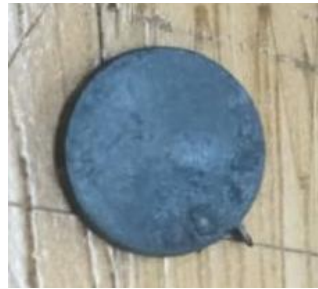
Fig. 3 – 22MnB5 after cut by laser cutting machine

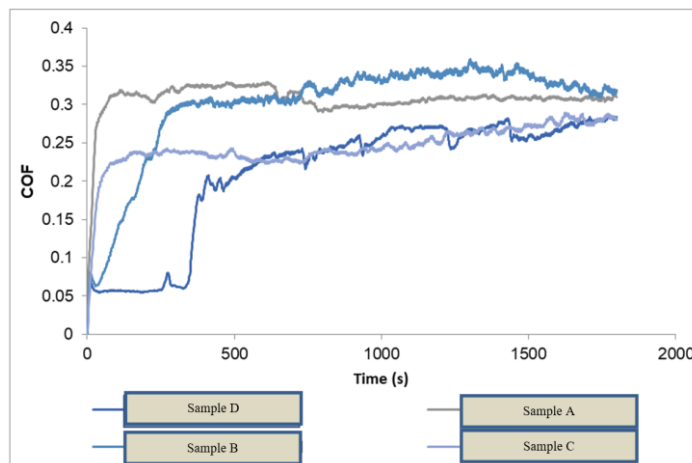
Fig. 5 shows the COF graph comparison versus time during pin on disk tests for 1800 s. Fig. 4 shows average COF value for each sample. For sample A, the initial friction is very high then followed by flat curve. Similar characteristics for Sample B where the friction is high at initial stage and tend to decline slightly as the friction progressed. The oscillations of around the average value are noticeable. This behavior has been attributed to the presence of local roughness variations on the materials surface due to the occurrence of pull-outs fragments because of soft condition of the product [10-11]. Whereas for C, the initial friction is almost half of its value during the initial stage and progress steadily at constant value. In case of 70 HRC, the initial friction started lower and friction increased as the tests progressed. Overall, lowest friction of 0.211 recorded for sample D, whilst higher friction recorded for blank sample A at 0.3.

Fig. 5 – Comparison of friction profiles of each sample during pin on disk tests for 1800 s
