Wear Characteristics of 22MnB5 Boron Steel under Friction Micro Pin-on-Disks Test

Abstract: 22MnB5 Boron Steel can be considered as emerged material for high strength and low weight application. This material potentially used in abrasive condition such as cutting tool or brake pad where high friction resistance applies. In this study, the wear characteristics of 22MnB5 was investigated under the frictional tests via micro pin-on-disk. 22MnB5 Boron Steel was prepared the form of round shape within the size of 2.6 mm thickness and 12 mm diameter by using laser cutting. 4 different samples were tested namely blank (sample A), self-hardening heat treatment (sample B), 60 HRC hot stamped (sample C) and 70 HRC hot stamped (sample D). The results show that Coefficient of Friction (COF) increased as the hardness of 22MnB5 decreased. Low COF of 0.2114 recorded for sample D with 70 HRC hardness. The COF increased to 0.24, 0.29 and 0.3 when sample C (60 HRC), sample B (52 HRC) and sample A (45.5 HRC) applied respectively. For pin-on disc test, worn area decreased as the hardness increased. 22MnB5 that prepared with the highest hardness of 70 HRC presented smallest wear area of 700 μm x 2400

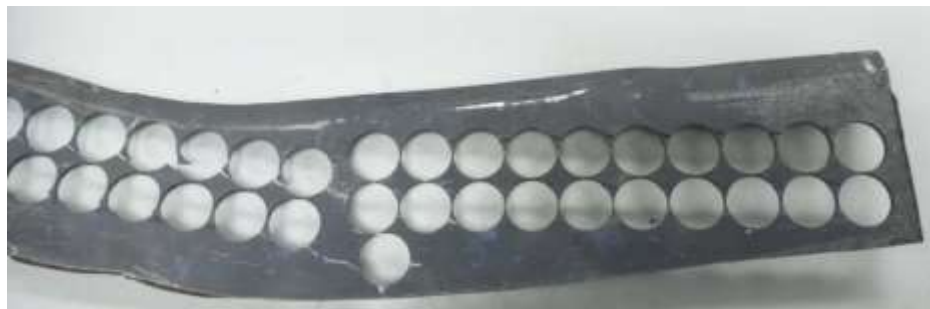
Fig. 1 - Raw 22MnB5 in the form of grinded steel

22MnB5 Boron Steel was prepared in the form of metals stamped product as shown in Fig.1. The raw material being parted by hand grinder before cut separately part by part using the laser cutting machine as shown in Fig. 2. Table 1 shows the parameters used to cut 22MnB5. The thickness of material was set at 2.6 mm with the diameter of 12 mm. Fig. 3 shows the inserts that have been produced by laser cutting process.

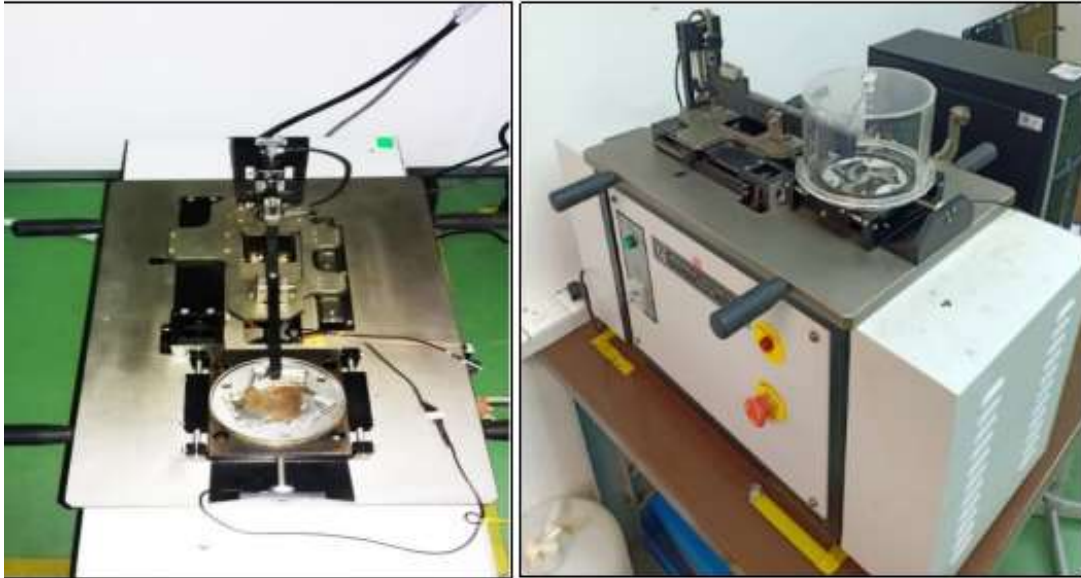
Fig. 4 - Micro pin on disk tribotester

Evaluation of Coefficient of Friction (COF) being held by using micro pin on disk tribotester machines, model CM-9109. In pin-on-disc test procedure, a pin is loaded in the form of stainless-steel ball against a flat rotating disc specimen. The movement path of the pin was prescribed by the machine. The parameters selected was 10N load, 1800-s or 30-minutes time interval, 3 mm distance and 5 mm/s friction velocity. Fig. 4 shows an illustration of the movement of stainless-steel pin friction on the tested 22MnB5 cutting tool.

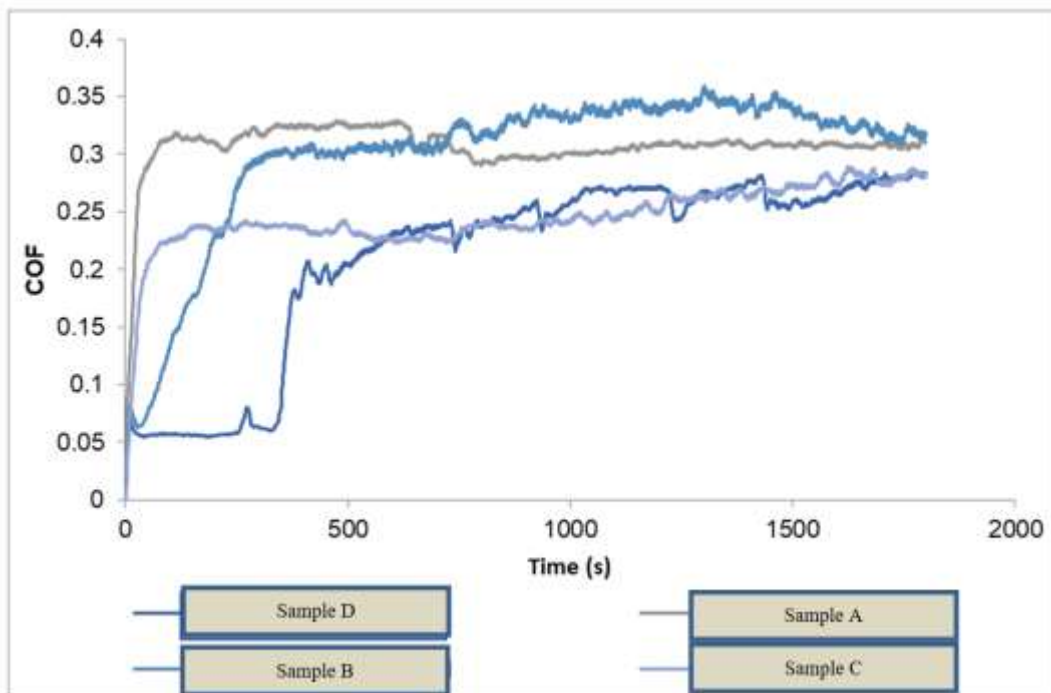
Fig. 5 - Compariosn of friction profiles of each sample during pin on disk tests for 1800 s

Fig. 5 shows the COF graph comparison versus time during pin on disk tests for 1800 s. Figure 4.12 shows average COF value for each sample. For sample A, the initial friction is very high then followed by flat curve. Similar characteristics for Sample B where the friction is high at initial stage and tend to decline slightly as the friction progressed. The oscillations of around the average value are noticeable. This behavior has been attributed to the presence of local roughness variations on the materials surface due to the occurrence of pull-outs fragments because of soft condition of the product [10-11]. Whereas for C, the initial friction is almost half of its value during the initial stage and progress steadily at constant value. In case of 70 Hrc, the initial friction started lower and friction increased as the tests progressed. Overall, lowest friction of 0.211 recorded for sample D, whilst higher friction recorded for blank sampel A at 0.3.

- i. Coefficient of Friction decreased as the hardness of 22MnB5 Boron Steel increased. Minimum COF of 0.21 recorded for sample D at the hardness of 70 HRC. Maximum COF recorded at 0.3 for sample A at the hardness of 45.4 HRC.
- ii. Worn area decreased as the hardness of 22MnB5 Boron Steel increased.
- iii. Wear mechanism on the worn area dominated by the material delamination in the form of fragmented flaking of 22MnB5 debris.

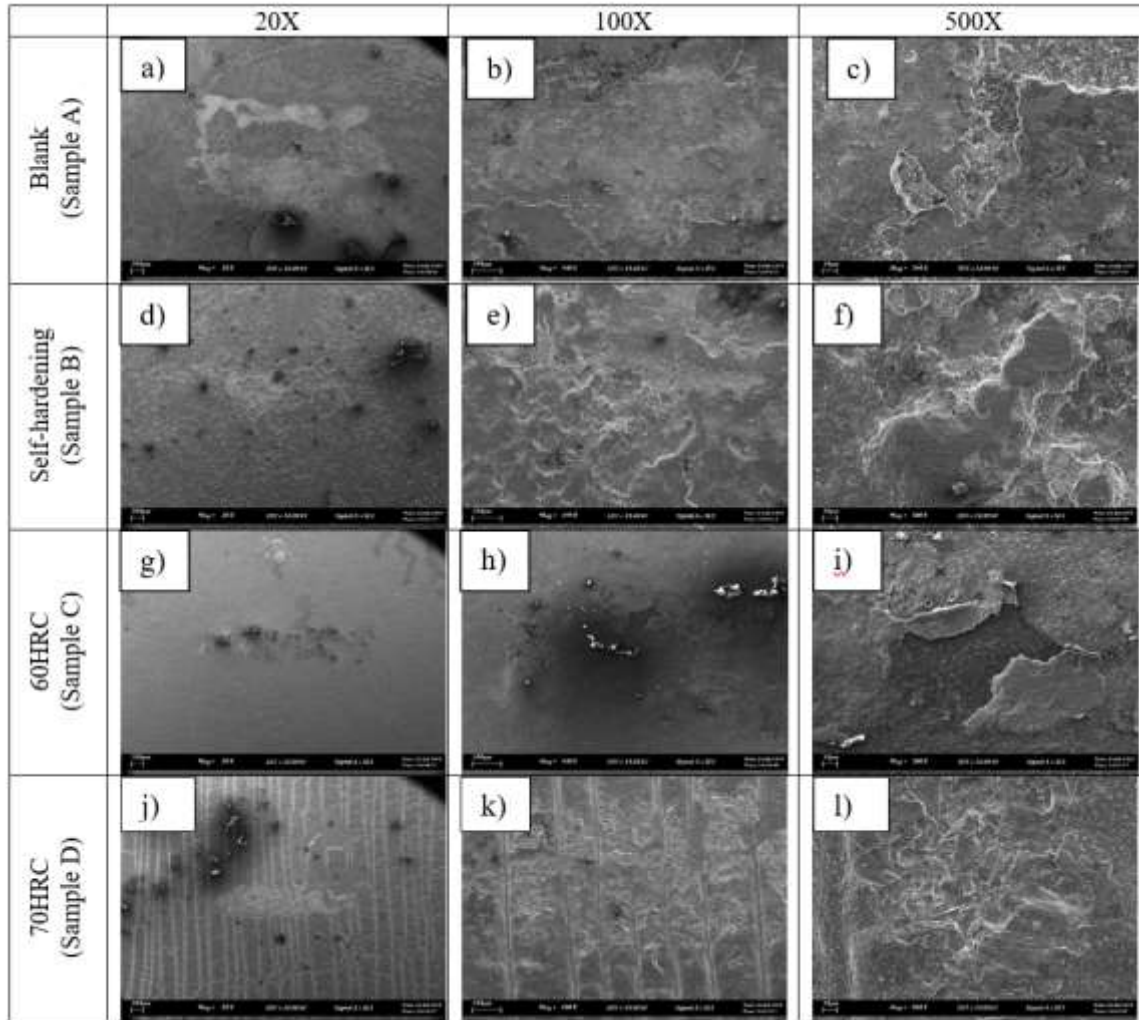
Fig. 7 - SEM images for scratched surface after pin-on-disk tests

Fig. 7 shows SEM images for scratched surface after pin-on-disk test at 20X, 100X and 500X magnification. The figure demonstrates the sliding direction which is length 3mm. It is observed that the width of wear track on boron steel. For sample A, the surface delamination occurred on top of the sample. The size of scratch 1, within the range of $1600\ \mu\text{m} \times 2800\ \mu\text{m}$ (length x height). The scratch mark appeared in white colour and it covers the whole scratched area. For sample of B, the scratch area presented smaller region at $1000\ \mu\text{m} \times 2400\ \mu\text{m}$ (length x height). The white scratch area only concentrated at the specific region. The hardened sample shows resistance to pin on this load. In contrast, for sample C, no white scratch mark observed on the worn region. The scratch area presented smaller region at wide round $800\ \mu\text{m} \times 2400\ \mu\text{m}$ (length x height). The sample with maximum hardness (sample D) demonstrated ability to resist shear deformation from the pin on disk. The scratch area presented slightly smaller region at $700\ \mu\text{m} \times 2400\ \mu\text{m}$ (length x height).

The analysis of the worn surface for all samples reveals micro cutting which is a friction mechanism characterized by large mass removal by surface delamination, dominated the wear region. This indicate that the surface of 22MnB5 possess brittle properties where debris lost from the scratched surface in front of the worn area. In practice of machining, such debris could detach out from machining zone to result material lost. Some portion of particles debris could entrap at the cutting zone to further abrade contacted surfaces. For sample A, a lot of scratched flaking and irregular surface appeared due to fragmented deformation imposed by the pin on disc. Similar results presented in Sample B, Figure 4.12(f) where signs of surface delamination, detachment of flaking materials and micro cutting with visible material deformation caused by the pin scratches. For the sample C, the main micro mechanism of surface delamination and material flaking with less area in comparison to the sample A and B. The scratches were less visible consequence from more resistance for deformation because of better hardness on the scratched surface. In Figure 4.12(l), the results presented for the sample D steel indicate micro cutting as the main mechanism but practically limited signs of surface deformation due to the elevated hardness of the material. This suggests lower material removal rates with slightly smaller scratches area [12-13].
