A Study of Weld Seams on Low Carbon Steel ABS Grade a Marine Plates Using SMAW Process

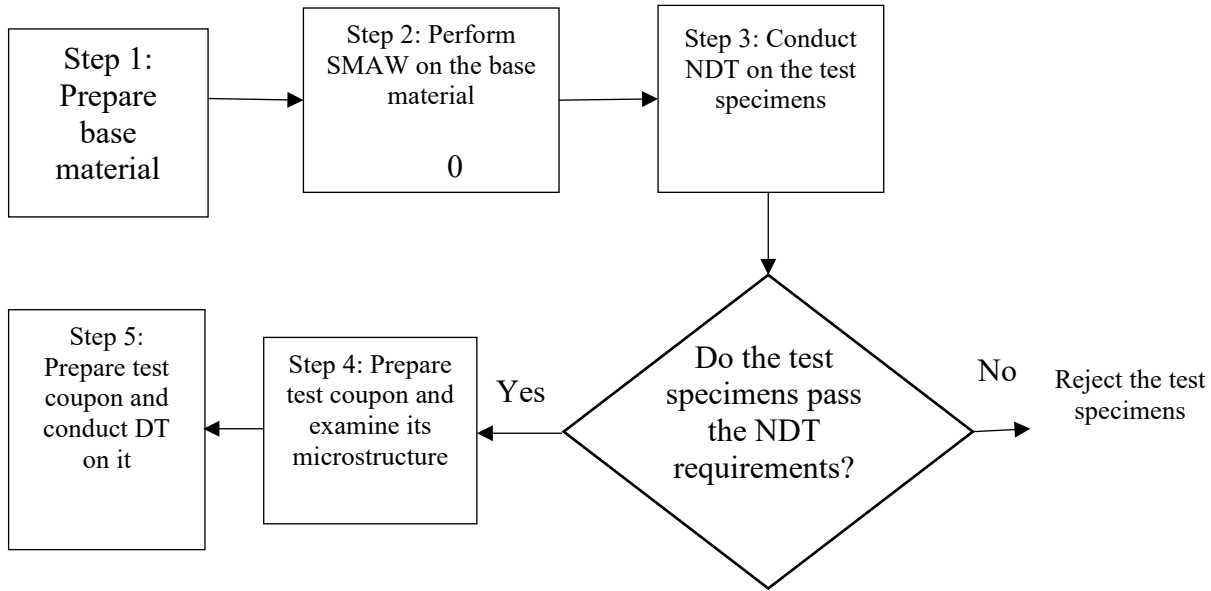
Fig. 1 - Flow chart of methodology

The process flow chart of the research methodology is presented in Figure 1. In Step 1, the base materials were prepared by oxy-cutting, beveling to the required bevel angle, grinding, and cleaning. Eight low carbon steel ABS Grade A marine plate were sectioned, each with dimensions of 200 mm × 140 mm × 12.7 mm, using an oxyacetylene cutter. The chemical composition and mechanical properties of the ABS Grade A plate were obtained from the mill certificate, as shown in Table 1. Preheating was not carried out in this experiment since low carbon steels with thickness less than 1 inch do not require preheat. A 30° bevel angle of a single V groove with a root opening of ±3 mm and root face thickness of ±2.0 mm was machined at the edge of the steel plates. After beveling, grinding, and cleaning, two tack welds, each 20 – 25 mm long, were made to align the two steel plates in the proper location before welding commenced.

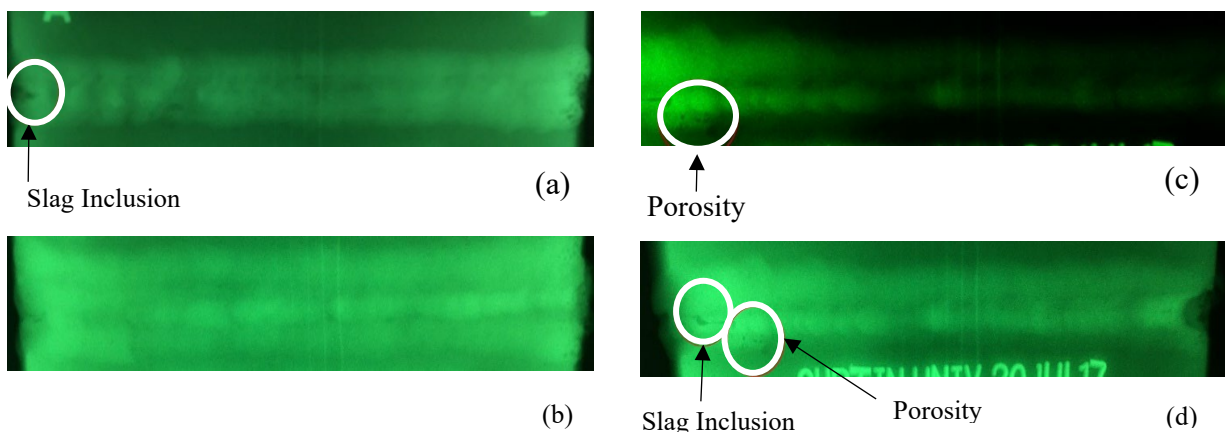
Fig. 5 - X-Ray Films for specimens welded with (a) 65A; (b) 70 A; (c) 80 A and; (d) 90 A

X-ray films of the specimens obtained from the radiographic test are presented in Figures 5(a)-(d). Darker shadows on the films indicate the presence of defects and hidden flaws, as more radiation passes through. Based on the X-ray films, the specimens produced with 65 A and 90 A (Figure 5(a) and (d), respectively) were rejected due to the presence of a slag line and both slag line and cluster porosity, respectively, at the sub-surface of the weld seam. On the other hand, the specimens produced with 70 A and 80 A (Figures 5(b) and (c)) were accepted. The specimen produced with 70 A exhibited no defects, while the specimen produced with 80 A was accepted despite having cluster porosity in a 1 cm.

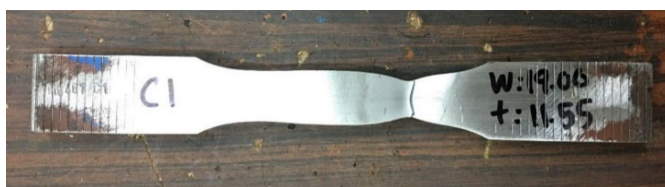
Fig. 9 - Test coupon (a) after tensile test; (b) cross section view of test coupon after tensile test

The test coupon, as seen in Figure 9(a) after the tensile test, fractured at the base metal. Based on Figure 9(b) and the stress-strain curve in Figure 10, the test coupon undergoes moderate ductile fracture with plastic deformation after exceeding the yield point. This fracture location is acceptable as it confirms the higher tensile strength of the weld metal compared to the base metal.

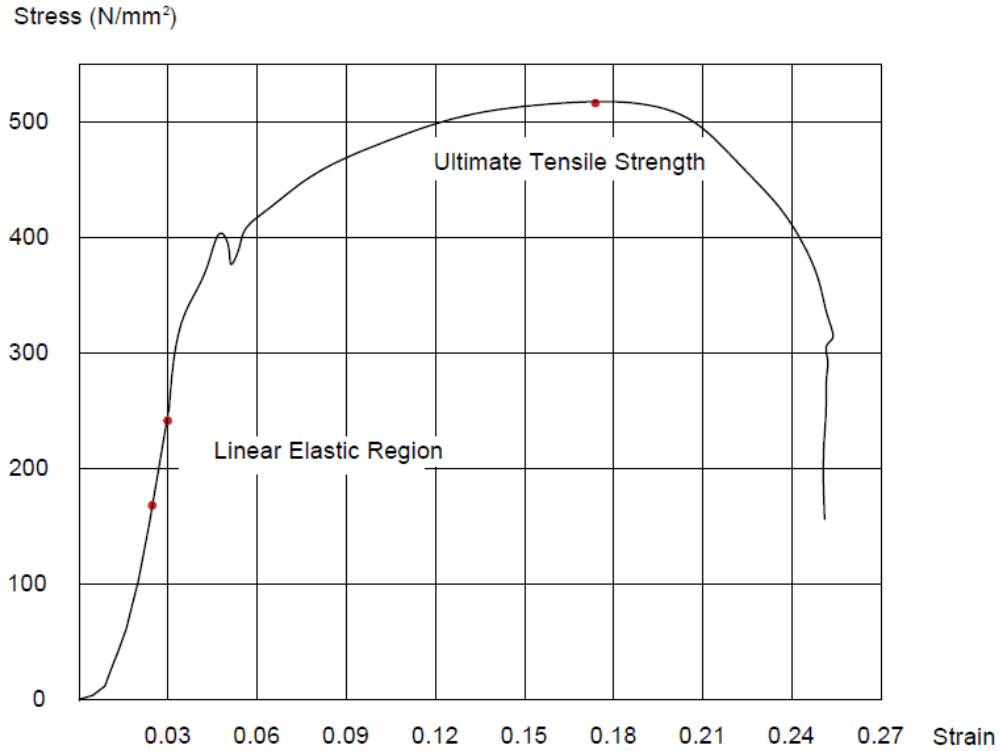
Fig. 10 - Stress-strain curve

To meet the requirements of ASME Section IX [20], the weld metal's tensile strength should be higher than the base metal's minimum tensile strength. According to Table 1, the base metal's minimum tensile strength is 491 MPa, while the weld metal's tensile strength, calculated from the stress-strain curve in Figure 10, is 522 MPa. As the test coupon's ultimate tensile strength is greater than the base metal's minimum specified value, it meets the ASME Section IX requirements [20]. The yield strength, which exceeds the minimum requirement for carbon steel yield strength in ASME Section IX [20], is 289.08 MPa, as shown in Figure 10.

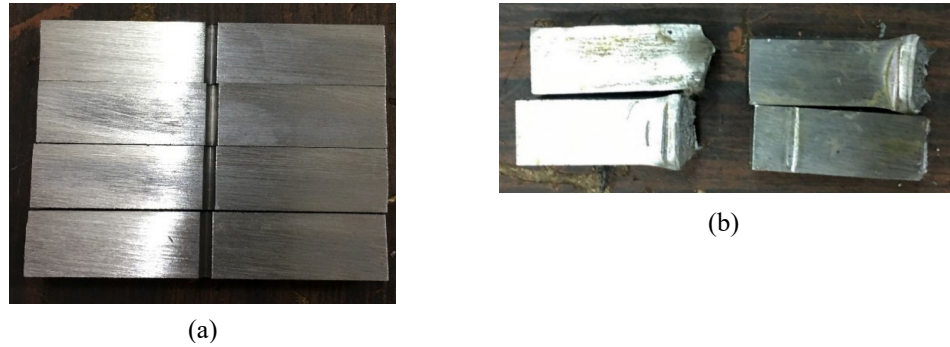
Fig. 12 - Test coupon (a) before and; (b) after Charpy Impact Test

Table 3 displays the average impact energy obtained from the Charpy V-notch impact test. The average impact energy is calculated from the average value of two test coupons for each test temperature. These values meet the minimum requirements specified in ASME Section IX [18]. Figure 12(a) and Figure 12(b) depict the test coupons before and after the Charpy impact test, respectively. As observed in Figure 12(b), all the test coupons were completely broken into two halves after the test. The dull breaking surfaces indicate the occurrence of ductile fracture, and fibrous pullouts are observed at the breaking surface, showing deformation before fracture. These observations support the results of the tensile test. The impact energy decreases as the test temperature decreases, as shown in Table 3. This is due to the presence of ferrite in the body-centered cubic (BCC) metals, indicating brittleness during low temperatures.

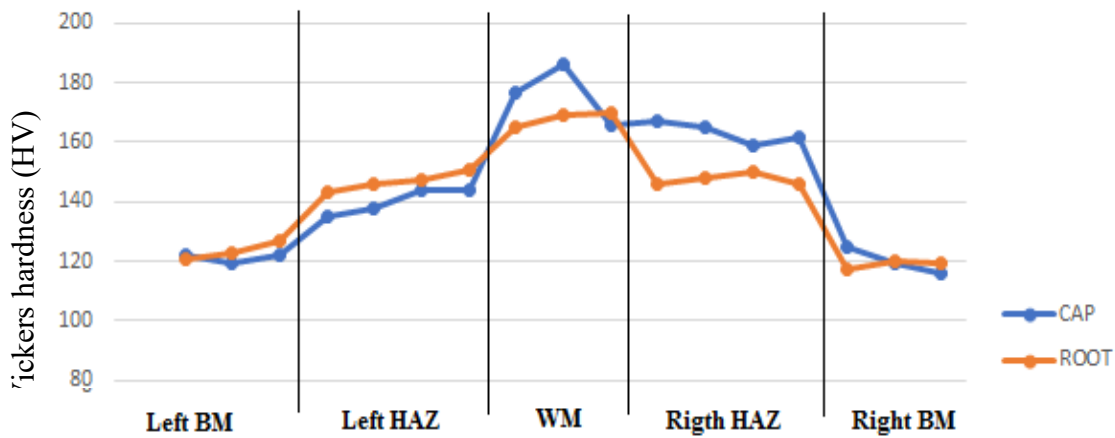
Fig. 2 - Hardness distribution curve in welded joint

Figure 13 displays the Vicker hardness (Hv) values obtained at 17 points in the welding cap and root, which are grouped into five regions (left base metal, left HAZ, weld metal, right HAZ, and right base metal) as indicated in Figure 2. The hardness of the weld metal is the highest among all the five regions for both cap and root, as shown in the figure. As the distance of each region from the weld metal increases, the hardness decreases. This distribution of hardness indicates acceptable weld quality since the weld metal is harder than the other regions. The microstructure examination

also supports this finding, and the highest hardness of the weld metal is attributed to its finest grain size. These results align with the tensile test results, where the test coupon broke at the base metal instead of other regions of the weld.
