## Non-Destructive Test for IC Package With 8D Report

**Keywords:** Non-Destructive Test, 8D Report, IC Failure

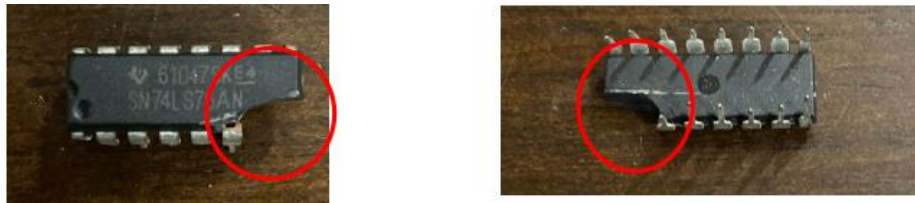
**Figure 4: Crack/broken for IC SN74LS76AN**

The results were show 8D Report for SN74LS76AN. All the NDT Test such as Visual Inspection, Functionality Test and Electrical Test were run to identify the failure that occur in the IC. All the data and analysis will show in the 8D Report. The IC were detected broken failure at the multiple pins. The analysis of failure in this IC is miss part/open circuit and Electrical Overstress (EOS). Figure 4 shows the broken failure were occur in the IC.

Investigation of the IC SN74LS76 showed that the IC have broken failure. Crack and broken form when these forces exceed the fracture strength of the molding compound. When these pressures exceed the molding compound's fracture strength, cracks develop. Normal molding pressure is 20-100bar. The open circuit failure cause from the broken wire. While short circuit cause from the wire error connection. Visual Inspection were carried out to identify the physical damage in the IC SN74LS76. The result of the inspection was crack and broken failure at the IC SN74LS76. Functionality Test were carried out to identify the pin at the IC were function or not and to identify the IC have short circuit failure or open circuit failure were occur in the IC. The result of the Functionality Test was all the pin of IC were in good condition except at pin 7 and 8 because it was broken. Table 1 shows the result of Functionality Test for SN74LS76AN.

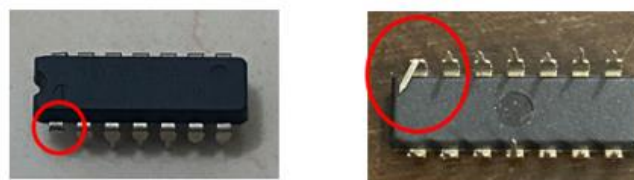
**Figure 5: IC pin 1 broken for SN74LS04**

The results were show 8D Report for SN74LS04. All the NDT Test such as Visual Inspection, Functionality Test and Electrical Test were run to identify the failure that occur in the IC. All the data and analysis will show in the 8D Report. The IC were detected broken failure at the multiple pins. The analysis of failure in this IC is short circuit, open circuit and Electrical Overstress (EOS). Figure 5 shows the broken failure were occur in the IC.

Investigation of the IC SN74LS04 showed that the IC pin 1 have broken failure. The broken pin of IC can make the IC short circuit failure. The open circuit failure cause from the broken wire. While short circuit cause from the wire error connection. Visual Inspection were carried out to identify the physical damage in the IC SN74LS04. The result of the inspection was IC pin 1 broken at the IC SN74LS04. Functionality Test were carried out to identify the pin at the IC were function or not and to identify the IC have short circuit failure or open circuit failure were occur in the IC. The result of the Functionality Test was all the pin of IC were in good condition. Table 3 shows the result of Functionality Test for SN74LS04.
