Investigation of Pavement Condition at Jalan Kampung Jawa, Pagoh, Johor

Department of Civil Engineering, Centre for Diploma Studies

Universiti Tun Hussein Onn Malaysia, Pagoh Higher Education Hub, 84600, Pagoh, Johor, Malaysia

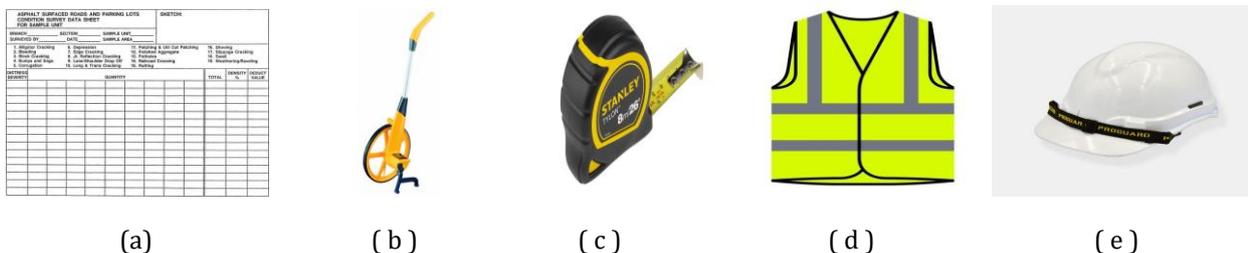
Prior to the test, materials were acquired and used in this investigation. First, the main component is the PCI table form, which is utilized to record every kind of deflection on the pavement. There are supporting materials such as odometer, measuring tape, safety jacket and helmet. Fig. 1 shows the materials that were conducted for the test.

Fig. 1 The materials for PCI preparation (a) PCI table form; (b) odometer; (c) measuring tape; (d) safety jacket; (e) safety helmet

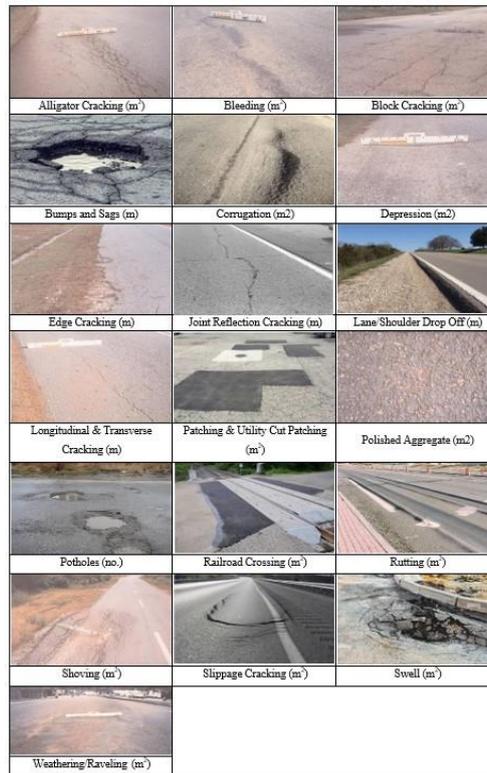
older pavement that had already oxidized [10]. Bleeding occurred when the bituminous mixed contained too much asphalt cement relative to the aggregates. In this case, the asphalt cement tended to bleed through the surface, hence, reduced the skid-resistance of a pavement thereby made the pavement very slippery when wet, created hazard to the road users. Polished was a failure mode of the pavement surface consisting of rough exposed aggregates which was caused by excess repeated traffic on an ageing pavement system. It could result in a dangerous low friction surface with a decreased skid-resistance. Fig. 3 illustrates the types of defects used in determining the PCI.

Fig. 3 Types of Defects used in Determining the PCI

One of the main damages of the road was cracking. It could have described as damaged occurred in the surface layer of the road, divided into 9 (nine) typed of cracked such as hair cracking, alligator cracks, edge cracks, edge joint cracks, lane joint cracks, widening cracks, reflection cracks, shrinkage cracks and slippage cracks [6]. Cracking could cause because the soil road base was less stable, the drainage system is not good, the job execution procedure is not good and there is not good paving material which exceeds the loaded capacity of the road traffic. The cause of the higher than cracking square measured as aging of binder or initial over heated ended up in break ableness of binder [7].

Other than that, surface deformation was also one of road damages. Pavement deformation was the result of weakness in one or more layers of the pavement that had experienced movement after construction. Cracking might have accompanied the deformation. Surface distortions could have been a traffic hazard [8]. The basic type of surface deformation rutted, corrugations, shoved, depressions and swelled.

Otherwise, disintegration can also cause road damaged. The progressive broke up of the pavement into small, loose pieces called disintegration. The two most common types of disintegration were potholes and patches. Potholes were bowl-shaped holes of various sizes in the surface layer or extended into the base course. These are caused by localized disintegration of material and usually appeared at watered logged placed or after rained [9]. Patches was defined as a portion of the pavement that had been removed and replaced. Patches were usually used to repair defects in the pavement or to cover a utility trench.

Next, surface defects related to problems in the surface layer. The most common type of surface defects is raveled, bleeding and polished. Raveling was the loss of material from the pavement surface because of insufficient adhesion between the asphalt, cement, and the aggregate. Raveling typically tended to occur on an

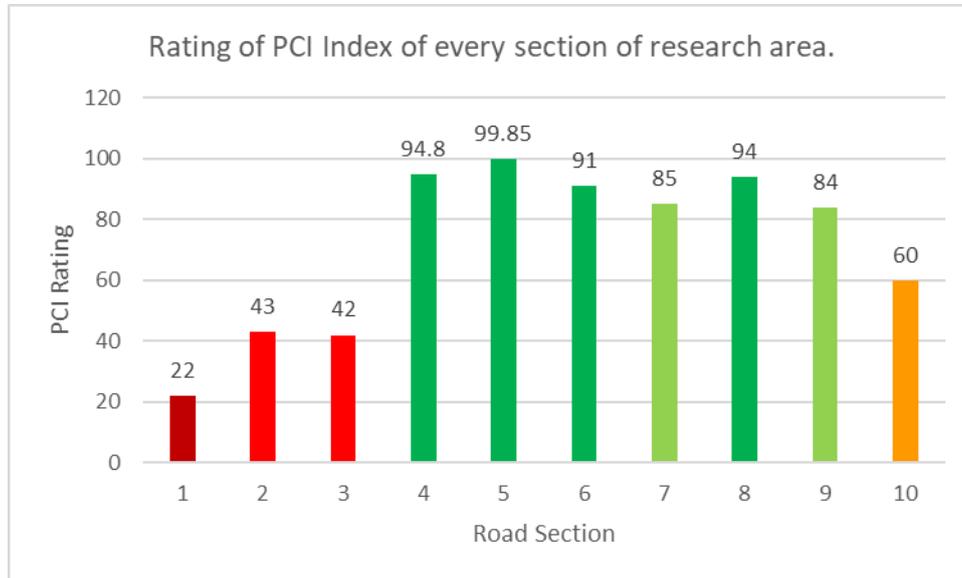
Fig. 4 shows rating of PCI Index of every section of research area. The graph shows that section 1 of Jalan Kampung Jawa, Pagoh have amount of 22 of PCI rating. This is the lowest PCI rating of every section on Jalan Kampung Jawa, Pagoh. Meanwhile section 5 has 99.85 amount of PCI rating which is the highest PCI rating on every section of Jalan Kampung Jawa, Pagoh. High amount PCI rating indicates that the condition of the road is good. The data from the table can be displayed in a visual form, with each part coloured in accordance with its PCI rating categories.

Fig. 4 Rating of PCI Index of every section of research area.

The investigation of the pavement condition across the designated sections has provided a comprehensive assessment of the current state of the infrastructure. The analysis revealed varying degrees of distress, with certain areas exhibiting severe degradation requiring immediate attention. Based on the results, major distress in Jalan Kampung Jawa, Pagoh is longitudinal cracking. This type of distress caused by reflections from shrinkage cracks, poor bituminous layer construction, joint displacement on road widening, differential deposits between cut and embankment areas and connection reflection on the site. Next, minor distresses in Jalan Kampung Jawa, Pagoh is potholes. Potholes were caused by loss of surface on the road, moisture entry into the base layer through cracks in the pavement surface and separation of the site due to impact of the load. Other than that, 20% of pavement conditions of Jalan Kampung Jawa was defined as satisfactory, 40% as good, 10% as poor, 20% as very poor and 10% as serious. These results can be classified as 60% of Jalan Kampung Jawa were still in a good condition and does not affect the user’s life. Whether 40% of pavement were in bad condition and can caused an accident or damage to vehicles. Lastly, the types of maintenance required for the road is rebuild the road, replace the bitumen layer, strengthen the site or subsite and reinforce the overlay.
