Analysis On Seepage Through Senggarang Coastal Embankment in Johor, Malaysia.

DOI: <https://doi.org/10.30880/peat.2023.04.01.084>

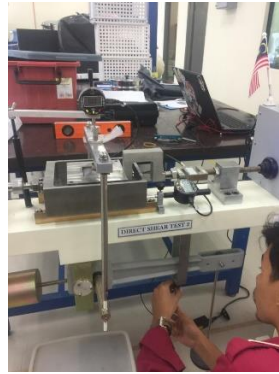
Figure 4: Direct Shear Test for SCE

Soil and rock samples were collected and preserved with care in the field for accurate results. The majority of testing procedures were conducted according to the international standards. The stability of the slope is related to the water, load, slope and soil parameters, and the soil parameter determines the engineering properties of the slope itself [9]. To determine the cohesiveness, which is related to the issue of seepage, a direct shear test will be conducted (Figure 4). For better evaluation of engineering properties of soil, it is important to analyze the changes in soil microstructure [6].

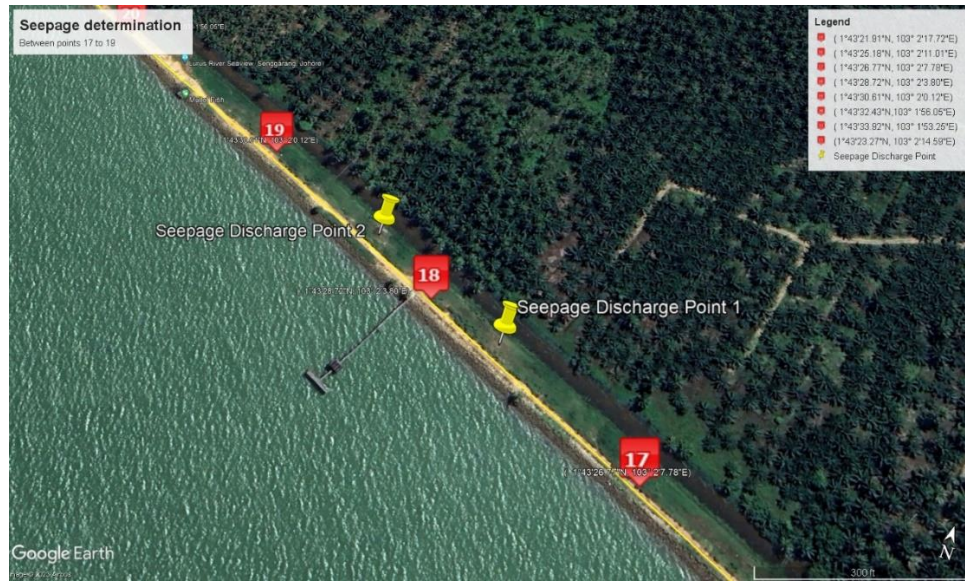
Figure 5: 2 Points are selected based on the severity of seepage

Seepage, in soil engineering, is the movement of water in soils, often a critical problem in building foundations [3]. It is possible for water to infiltrate into the body of the embankment as a result of an increase in excess pore pressure caused by rising water levels and saturated material. At SCE, a test will be conducted to determine the quantity of seepage flow at the highest monthly tidal level on November 11 and 12, 2022. A few critical spots being assess using piezometer alike method. The output of water flow is collected during the test. To determine the seepage rate, two points (Figure 5) are picked between point 17 to 19 based on the severity of seepage and the accessibility at SCE. These 2 points are about

150m apart from each other.

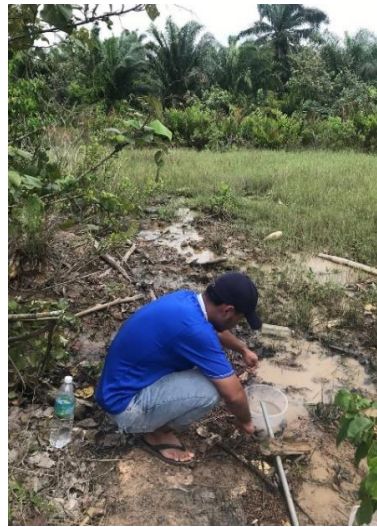
Figure 6: Setup for seepage analysis

These two points are subsequently fitted with half-inch PVC pipe (Figure 6), at which point the leak becomes visible to the naked eye. The time interval is 20 minutes, which means that water is collected and recorded every 20 minutes.

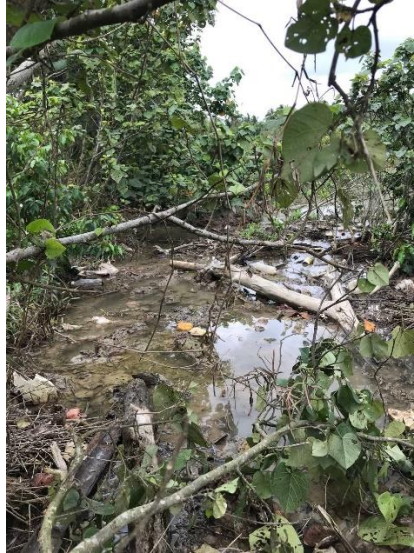
Figure 7: Severe seepage point causing flood inland area

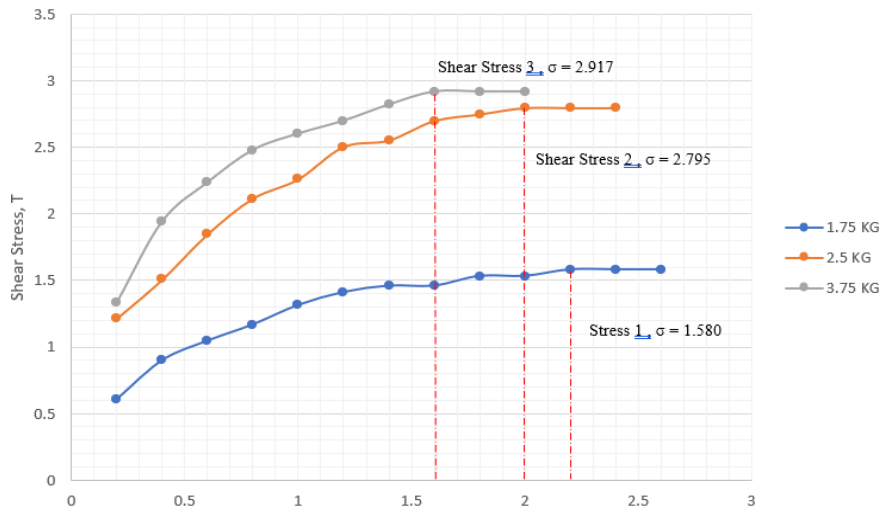
Figure 8: Shear Stress VS Displacement

Roads, dams, embankments, and other important engineering constructions and infrastructure all use soil as a fundamental component [12]. Cohesion of the soils is one of the most essential factors by which a soil's suitability for building foundations, or in this case the embankment, is evaluated. In reality, the safety of slope depends on the shear strength of the soil [13]. The figure of shear stress vs. horizontal displacement (Figure 8) gives the maximum shear stress for a vertical confining tension. For each test, the maximum shear stresses vs. normal vertical confining stresses were plotted. The graphic gives a straight-line approximation of the Mohr-Coulomb failure envelope curve, f , and shear strength for cohesionless soils. From data below (Table 2), a graph has been drawn (Figure 9) to produce the cohesion value of the sample soil taken from SCE. The data shown that the value of cohesion is 0.4 kPa which it is classified as low. Depending on the kind of slope and other soil factors, an increase in cohesiveness will reduce slope stress, strain, and displacement.

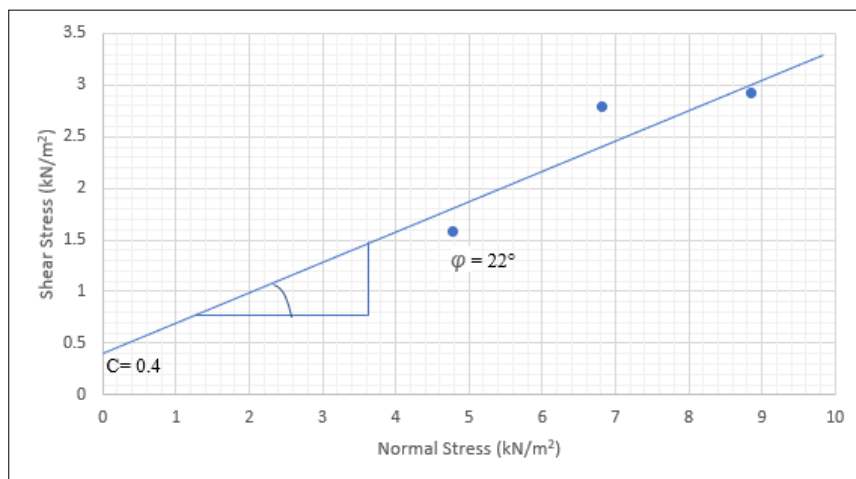
Figure 9: Normal Stress VS Shear Stress

Loading (kg)	Normal Stress (kN/m ²)	Shear Stress τ (kN/m ²)
1.75	4.77	1.58
2.5	6.81	2.795
3.75	8.86	2.917

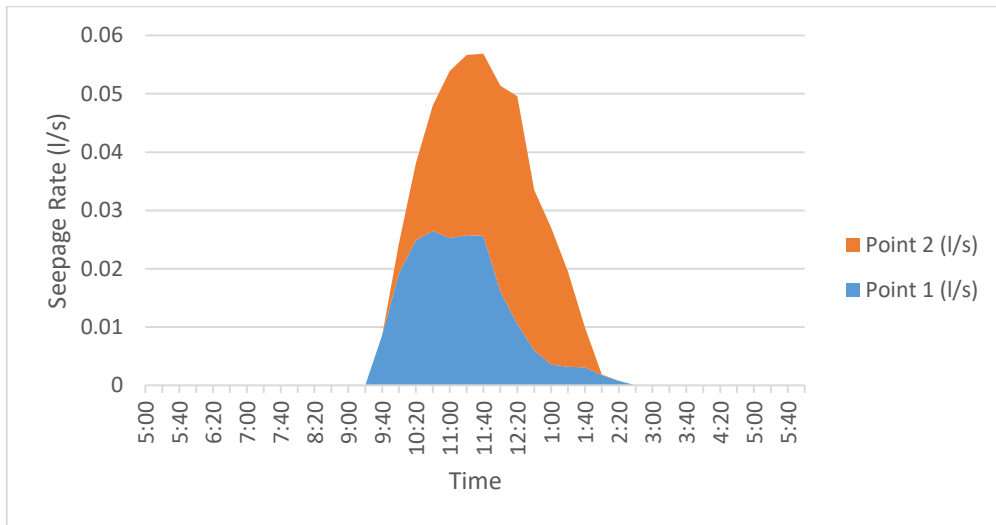
Figure 11: Graph of seepage rate for point 1 and point 2

From the seepage rate and volume table, the rate of tidal height increase at SCE is 0.652 cm/min, and seepage begins once the height reaches 2.1 meters. It takes approximately 6 hours for the tide to rise from 0.6m to 3m, or from 5:37 AM to 11:45 AM. Seepage begins at 9:40 a.m. and 10:00 a.m. at both points, which have nearly the same tidal height of approximately at 2.1 meters. Same goes with the seepage to stop at between 2.1m. However, the amount of reduction in tidal height varies. It takes around seven and a half hours for seepage to cease at a rate of 0.564cm per minute. The tide height decreases from 11:45 a.m. at 3 meters to 6:50 p.m. at 0.6 meters.

From the graph obtained, it is proven that the highest reading of volume and seepage rate occurs while the tide height at its peak. According to Bakari [15], by raising pressures within the soil pores or by flooding the slope, seepage may cause the slope to collapse. This seepage rate is quite concerning as it produces huge amount of discharged which lead to failure of embankment.

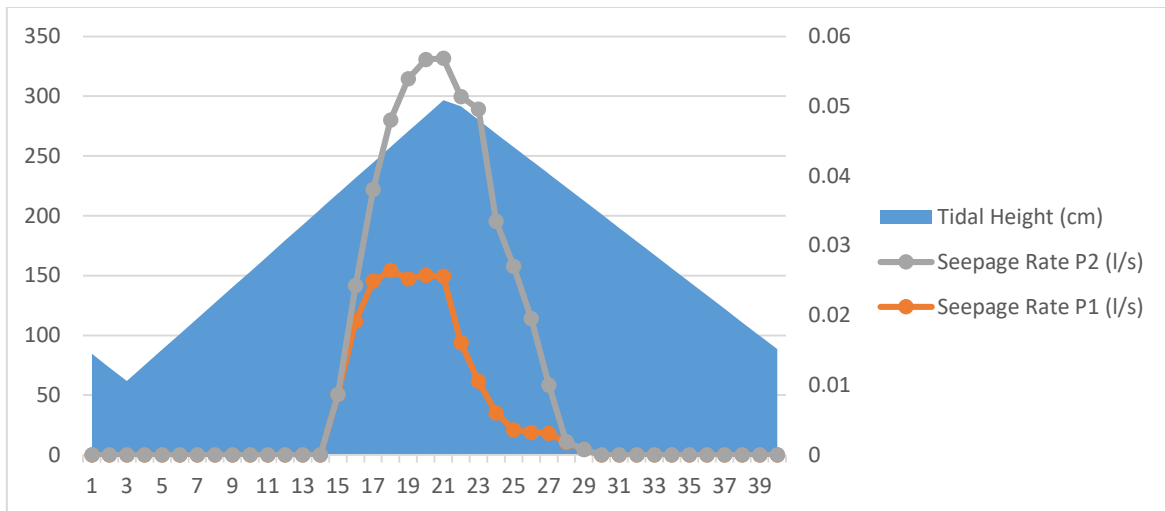
Figure 12: Graph for relationship between tidal height and seepage rate for point 1 and 2
