# Deformation Pattern of Expanded Polystyrene (EPS) and Palm Oil Fuel Ash (POFA) Concrete Subjected to Experimental Pullout Test

Su Kah Won<sup>1</sup>, Mohamad Hairi Osman<sup>1\*</sup>

<sup>1</sup> Faculty of Engineering Technology

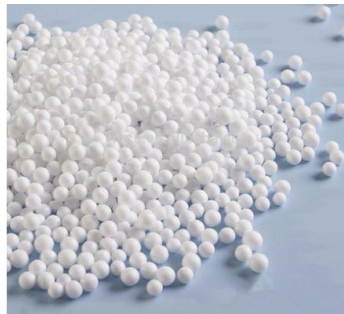
**Fig. 1** Expanded Polystyrene (EPS)

Expanded Polystyrene (EPS) has a significant history in civil construction, notably in lightweight aggregate concrete, and the concept of a circular economy has driven the use of waste EPS as a filler in lightweight concrete, aligning with sustainability goals [5]. While EPS is commonly used in structural applications, its utilization in non-structural polystyrene concrete, particularly from waste EPS, remains an underexplored area in research [5]. This form of concrete offers promises for non-structural elements like walls and slabs, providing lightweight, cost-effective construction with improved insulation and sustainability benefits [6]. EPS properties, stemming from its closed-cell structure, include low density, thermal insulation, hydrophobicity, and resistance to various chemical agents, making it a desirable material in construction [7]. Recognized initially for packaging, EPS has evolved into a crucial construction material, contributing to green building designs by enhancing energy efficiency, indoor environmental quality, and structural durability [6].

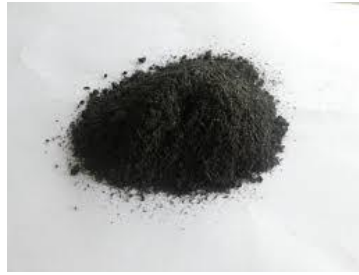
Fig. 2 Palm Oil Fuel Ash (POFA)

The burgeoning demand for concrete has fueled interest in sustainable alternatives to mitigate its environmental impact. Palm Oil Fuel Ash (POFA), an abundant agricultural byproduct from palm oil production, is gaining attention as a Supplementary Cementitious Material (SCM) for concrete. POFA, with an annual global production of 12 million tonnes, offers potential to reduce CO<sub>2</sub> emissions linked to conventional cement production. Studies highlight its ability to enhance concrete sustainability by improving strength, durability, and reducing shrinkage. Despite potential drawbacks like increased water absorption and delayed hydration, treated POFA particles exhibit improved concrete properties due to their high silicon dioxide (SiO<sub>2</sub>) content, triggering pozzolanic reactions [8]. The particle fineness of POFA significantly impacts its performance, influencing concrete strength through enhanced interaction with cement [9]. Chemically, POFA is rich in amorphous silica (SiO<sub>2</sub>) and trace elements, contributing to its cementitious characteristics and long-term strength [10]. Treatment methods to remove residual carbon particles from POFA optimize its compatibility with superplasticizers, ensuring improved performance in concrete production [11].

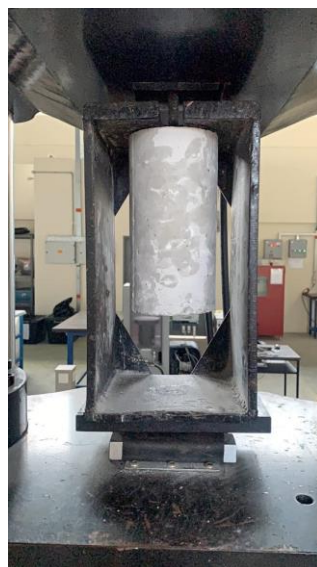
**Fig. 10 Pullout Test**

The pullout test stands out as a significant method for assessing concrete strength, involving the extraction of a small concrete cone embedded with an anchor to measure the force required for removal, distinguishing it from indirect techniques like the rebound hammer. It's highly regarded in non-destructive testing due to its accuracy in estimating in-situ concrete compressive strength, especially in field scenarios where potential strength might not be pertinent, as outlined in British Standards BS 1881: Part 207 [21]. While it's considered one of the most reliable NDT procedures for concrete strength assessment, it comes with drawbacks, causing surface damage and requiring expensive measuring tools. Construction engineers and inspectors primarily aim to use NDT methods like the pullout test to ascertain whether structural concrete components meet or exceed the specified target strength [22].

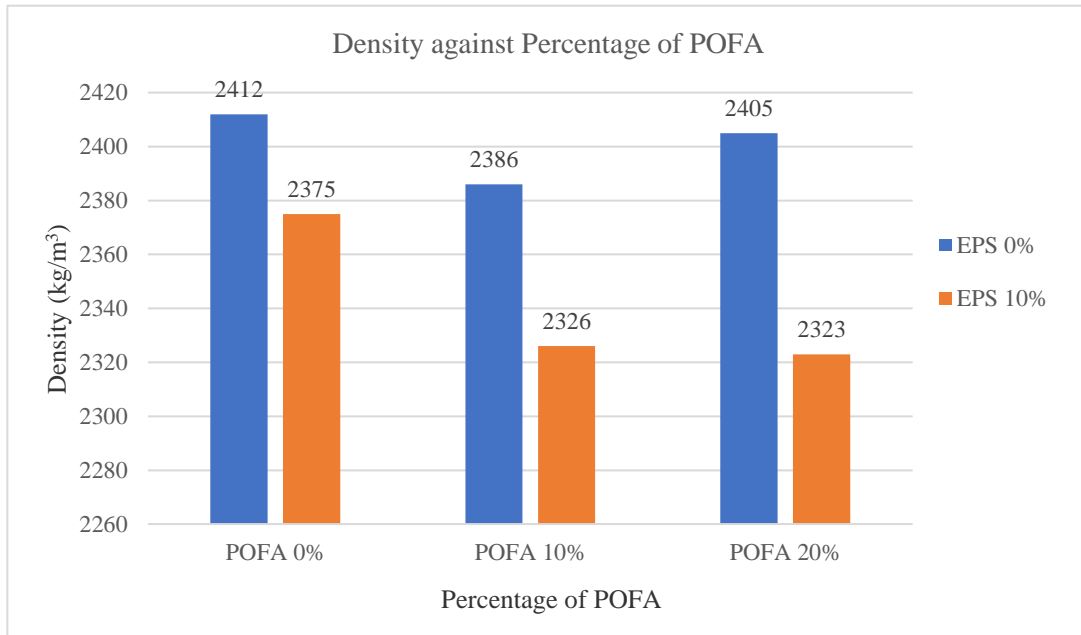
**Fig. 12** Bar Chart of Density against Percentage of POFA

The bar chart illustrates a noticeable decrease in concrete density as the percentage of EPS and POFA increases, reaching a minimum of 2323 kg/m<sup>3</sup> compared to the control ratio of 2412 kg/m<sup>3</sup>. This decrease of 89 kg/m<sup>3</sup>, approximately 3.7% less than normal concrete, is primarily attributed to the lightweight properties of EPS. Substituting fine aggregate with EPS reduces the overall weight of the concrete while maintaining adequate strength. This density reduction directly lessens the dead load of the concrete structure, offering advantages in construction by optimizing load distribution and enhancing structural integrity. Consequently, incorporating EPS and POFA in concrete formulations leads to lower density compositions, thereby reducing the dead load and improving overall structural efficiency [1].

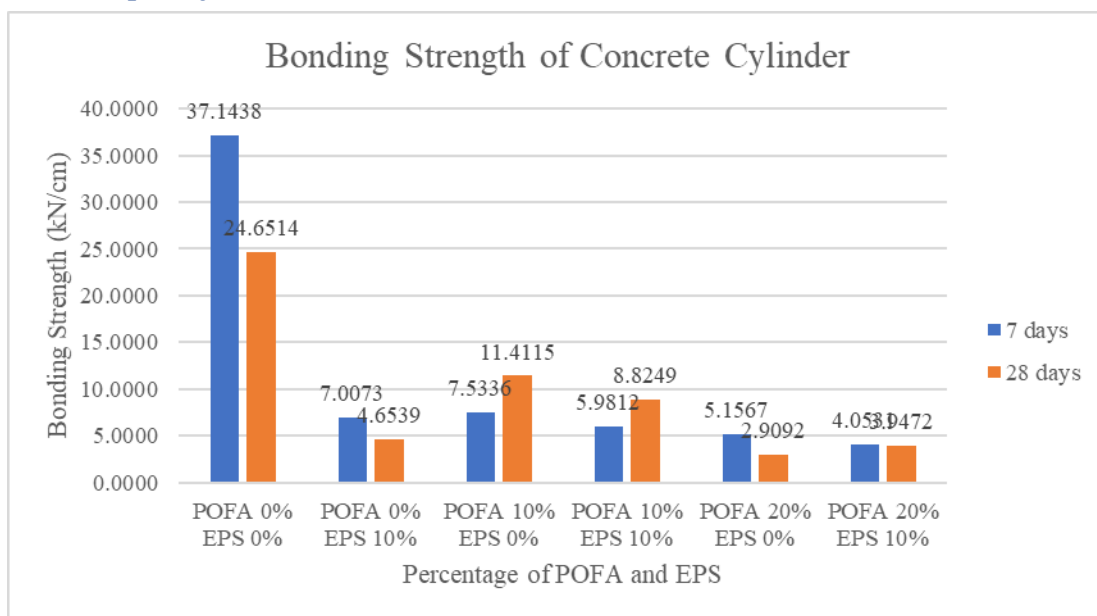
**Fig. 13** Bar Chart of Bonding Strength of Concrete Sample

The graph displays the bonding strength of concrete subjected to pullout tests. Concrete with POFA replacements shows higher bonding strength compared to other replacement ratio of concrete mixture, except for the control specimen. The control mixture (0% EPS, 0% POFA) demonstrates the highest bonding strength, reaching 37.14 kN/cm at 7 days and 24.65 kN/cm at 28 days. Whereas 10% POFA-containing mixes, exhibit second highest bonding strength at 7.53 kN/cm at 7 days and 11.41 kN/cm at 28 days. The trend that concrete mixtures that containing POFA, especially at 10%, showing the highest bonding strength among other replacement ratio suggests that POFA enhances bonding between concrete and reinforcement bars. This improvement is credited to POFA's pozzolanic properties, as it reacts with calcium hydroxide during cement hydration, forming additional C-S-H gel. The amorphous silica in POFA aids this reaction, leading to denser and better-connected interfaces between the concrete and reinforcement. This densification strengthens the bond, reduces micro-cracks, and improves load transfer, ultimately enhancing the concrete's ability to withstand pullout forces [24].

The disparity in bonding strength between the control specimen and the concrete with POFA and EPS is linked to a crucial aspect of the experimental methodology. The use of untreated POFA in this study indirectly affected its bonding capacity due to residual impurities and unprocessed particles. These elements hindered the formation of a robust bond between the concrete matrix and the embedded reinforcement, potentially reducing bonding strength [25]. Recognizing the untreated nature of the POFA used is vital, as it significantly influenced the observed results. Future studies could benefit from using treated or processed POFA to address this issue and ensure a more accurate assessment of the bonding capabilities in concrete mixtures.
