Building Condition Assessment In School Using JKR Standard

Keywords: Building Condition Assessment, School Building, Defects Building

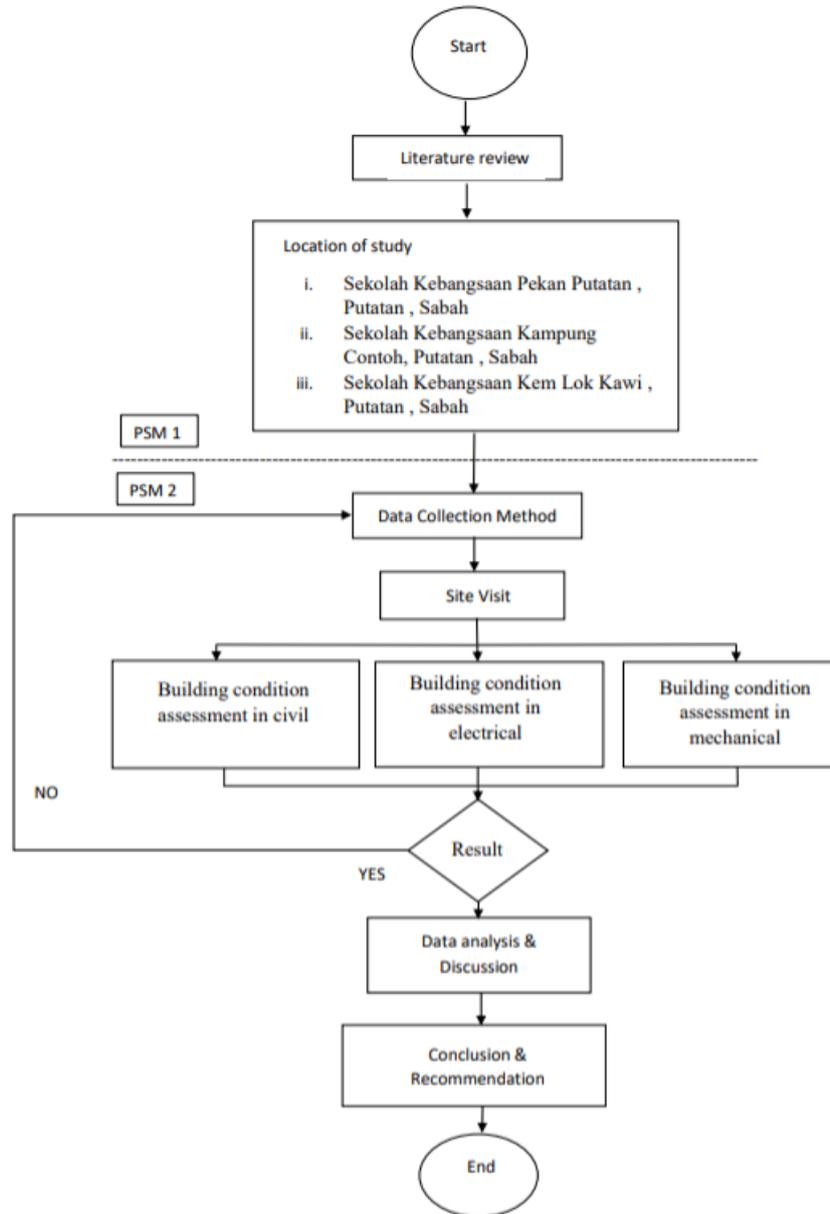
Figure 1: Flowchart Research Methodology

The BCA checklist was used with reference to the standard for registering the information of the building, identification, characterization, defects in functional element, evaluation of condition of defect, and maintenance action and the information in terms of the defects' condition and priority were assessed [6]. Data were sorted using Building Condition Assessment Rating System and then analyzed with frequency distributions. The score of building condition rating was obtained by deriving the total mark of defects with total number of defects found in the building. Afterward, the defect data were analyzed and summarized to identify the major defective element in civil, mechanical and electrical as in objective number two.

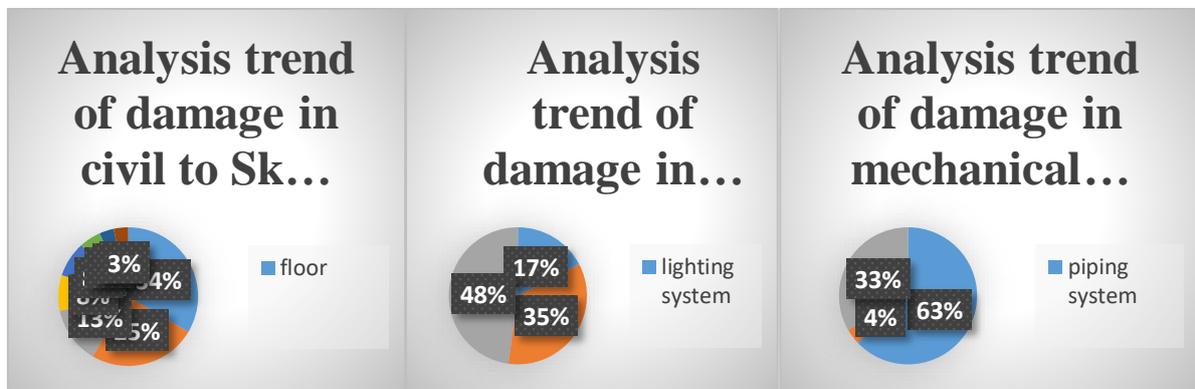
Figure 1: The trend of damage in Civil, Electrical and Mechanical to Sk Pekan Putatan

The trend of damage in civil to SK Pekan Putatan are mostly covered by floor damage at 34.0 %. This mostly by broken floor slab. This followed by pillar structure at 25.0 %. Pillar structure were badly in shape caused by old rusty reinforced iron inside the pillar. Also at 13.0 % are the broken external wall caused by wear and tear throughout the year this school operating. At 8.0 % are the roof and internal construction material that were worn out.

The trend of damage in electrical to SK Pekan Putatan are mostly by low voltage system at 48.0%. This school always faced electrical problem due to old wire system that worn out. The electrical system has not yet upgraded since the school operating in 1994. Followed by communication system is this school covered 35.0 %. Following by lighting system at 17.0 %.

The trend of damage in mechanical to SK Pekan Putatan as mostly by piping system. The piping system were broken at one or two part throughout the whole school. This caused by poor maintenance by the contractor who responsible for all maintenance for this school. Also followed at 33.0 % , this school poorly at having proper firefighting system. The design of this school were old fashion and it's not included proper firefighting system at that time. Minorly at 4.0 % are ventilation system this school has. Adequately ventilation system all over the school.

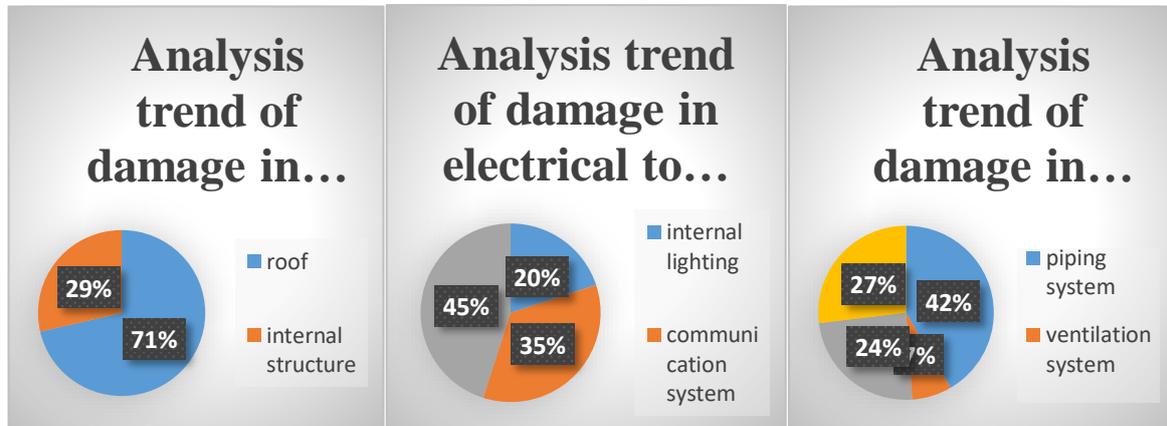
Figure 2: The trend of damage in Civil, Electrical and Mechanical to Sk Kg Contoh

The trend of damage in civil to SK Kg. Contoh are mostly by roof at 71.0 %. The roof of this school faced broken due to bad weather striking over years. Minor broken happen first and major problem comes later. It can be seen a hole at this school roof. Followed by 29.0 % of internal construction. Pest attack all the wood material at this school. The doors and windows are majorly broken by pest attack

The trend of damage in electrical to SK Kg. Contoh are mostly by low voltage current. This happen due to the main switch for electrical once were in fire. All the electrical system yet still under construction. Also at 35.0 % the communication appliances affected by this fire. Along with internal lighting at 20.0 %.

The trend of damage in mechanical to SK Kg. Contoh are mostly by piping system at 42.0 %. The piping system were minor maintenance by the contractor while the overflow from the main pipe are not controlled properly. At 27.0 % is firefighting system this school have. The firefighting system were not maintained. This cause the system is not working properly. At 24.0 %, power distribution faced problem from electrical system that were once on fire. This yet still in constructions.

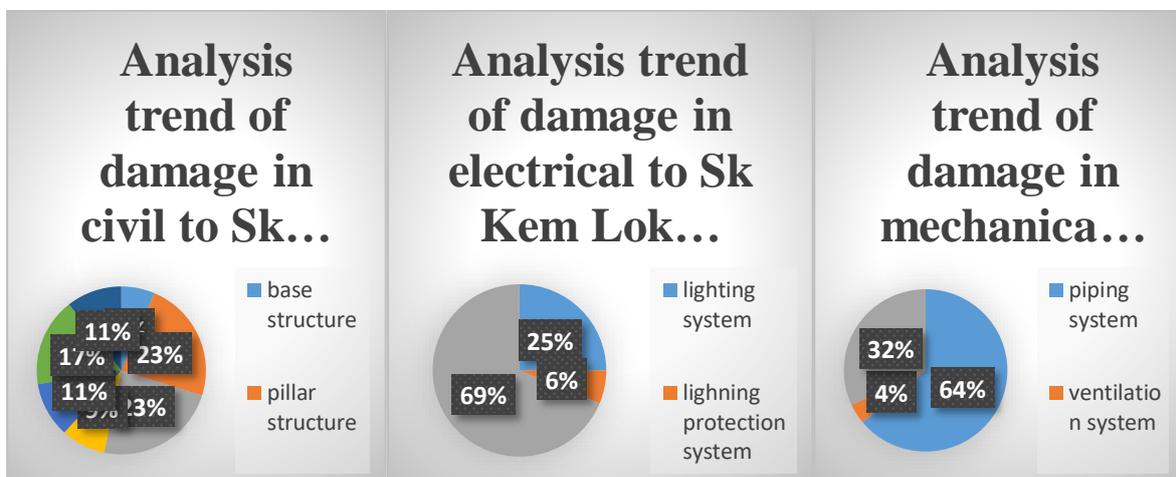
Figure 3: The trend of damage in Civil, Electrical and Mechanical to SK Kem Lok Kawi

The trend of damage in civil to SK Kem Lok Kawi mostly by base slab and pillar structure at 23.0 %. This majorly caused by poor maintenance performed by contractor. Followed by stair at 17.0 %. The handrail of the stair already rusty and worn out by everyday use. The roof also mostly in bad shape due to bad weather and poor maintenance.

The trend of damage in electrical to SK Kem Lok Kawi mostly by power distribution system at 69.0 %. The school has been used the old wiring system since it was built. Also at 25.0 % the lighting system also faced the same problem. Adequately in lightning system in the school.

The trend of damage in mechanical to Sk Kem Lok Kawi mostly by piping system in the school at 64.0 %. The poor maintenance by contractor with old piping system has been a major problem faced by this school. Also at 32.0 % this school did not have proper firefighting system. It was designed old way where firefighting system still not introduce to the most school. At 4.0 % this school has minor ventilation system.
