## **Study on Building Defect by Using Non-Destructive Test at Masjid Jamek Panchor, Muar, Johor**

**Abstract:** An existing concrete building will be deteriorating with time due to various factors and bring impact on concrete durability and structural safety. Masjid Jamek Panchor Muar Johor is one of the earliest built in this area. This building is located at Panchor, Muar, Johor. According to En. Ghazali, among the old inhabitants that usually visited the mosque, the Masjid Jamek Panchor had already been constructed by the time the year 1929. Therefore, assessing the current concrete strength of the existing building is necessary for ensuring safety. Hence, the objectives of this study are to identify the types of building defects that occur at Masjid Jamek Panchor, Muar, Johor to measure the defect by using the Non-Destructive Test method and to recommend the solution to conserve the building. Therefore, visual inspection including defect mapping and condition-based assessment using Condition Survey Protocol 1 Matrix was conducted at the beginning to achieve the first objective. Next, to fulfill the second objective, two type of selected Non-Destructive test were carried out.

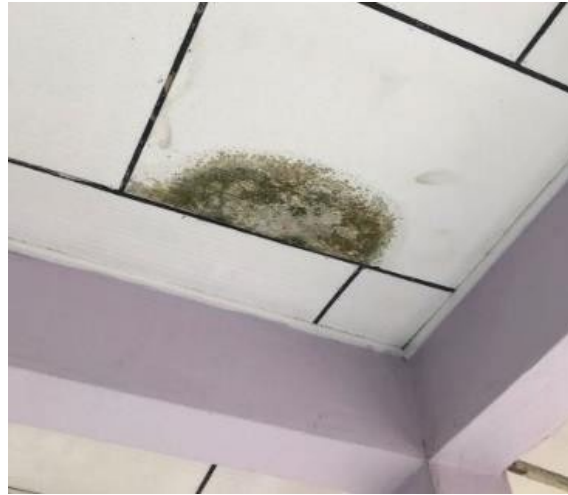
**Figure 1: Mould Growth**

It is important and required to analyse the impact of new buildings on existing buildings. Masjid Jamek Panchor is one of the area's oldest. This building is at Muar, Panchor, Johor. According to En. Ghazali, the Masjid Jamek Panchor had been built by 1929 among the old residents who frequented the mosque. The building is 797.80 m<sup>2</sup>. Locals and Pagoh Education Hub students regularly occupy this mosque. The structure appears to have various flaws. Concrete cracking, spalling, and moulding are structural problems. Observation photos are underneath. (Figure 1 and 2)

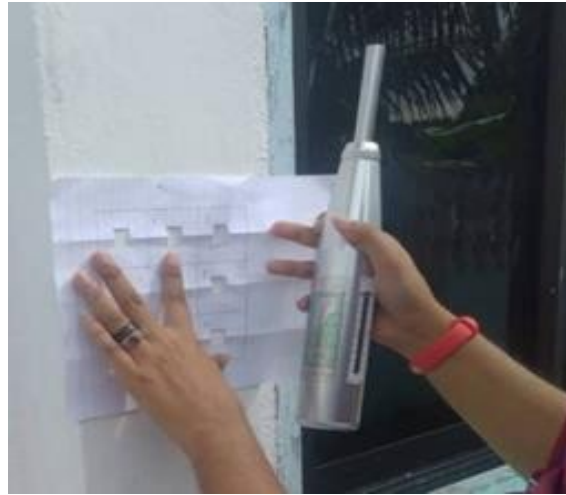
**Figure 4: Rebound Hammer**

This test is also known as the impact hammer or accelerometer test, and the test is based on the principle that the rebound of an elastic mass depends upon the hardness [8]. If it is to be utilized to determine strength, a correlation between the rebound hammer reading and the strength of the concrete under inquiry must be established. The rebound principle, on the other hand, is more widely accepted. Below is the image of equipment that been used in conducting Rebound Hammer Test;

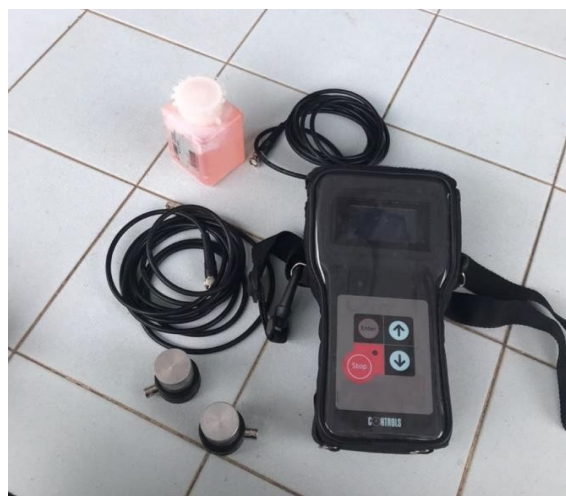
**Figure 5: Ultrasonic Pulse Velocity**

This test is done to assess the quality of concrete by ultrasonic pulse velocity method as per IS: 13311 (Part 1) – 1992.

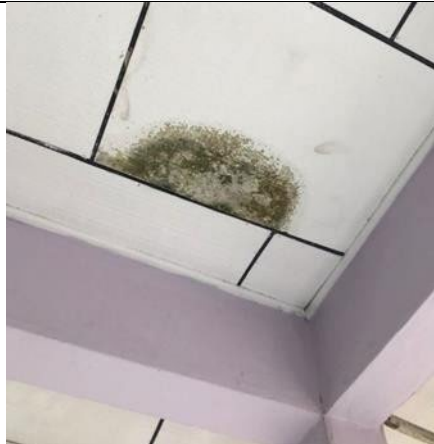
<b>Location</b>	R1	<b>Element/Component</b>	Ceiling		
		<b>CSP 1</b>			
		<b>Condition</b>	<b>Priority</b>	<b>Matrix</b>	<b>Colour</b>
		2	2	4

<b>Description of defect:</b> Mould growth			
		<b>Recommendation:</b> Minor Defects / damages, need for monitoring, repairs, replaced to prevent serious defect / damages			
<b>Location</b>	R2	<b>Element/Component</b>	Ceiling

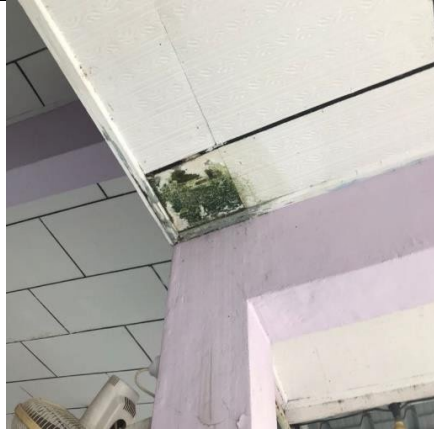
<b>CSP 1</b>			
		<b>Condition</b>	<b>Priority</b>	<b>Matrix</b>	<b>Colour</b>
		2	2	4	
		<b>Description of defect:</b> Mould growth			
		<b>Recommendation:</b> Minor Defects / damages, need for monitoring, repairs, replaced to prevent serious defect / damages

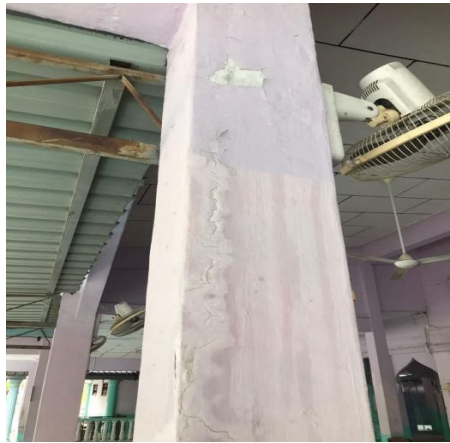
<b>Location</b>	T1	<b>Element/Component</b>	Column

<b>CSP 1</b>			
	<b>Condition</b>	<b>Priority</b>	<b>Matrix</b>	<b>Colour</b>
	2	2	4	
	<b>Description of defect:</b> Peeling paint			
	<b>Recommendation:</b> Minor Defects / damages, need for monitoring, repairs, replaced to prevent serious defect / damages			
<b>Location</b>	T2	<b>Element/Component</b>	Column/wall

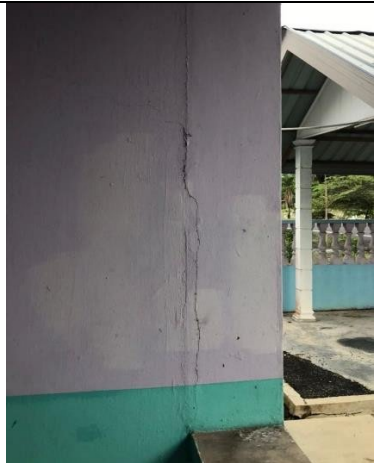
<b>CSP 1</b>			
	<b>Condition</b>	<b>Priority</b>	<b>Matrix</b>	<b>Colour</b>
	2	2	4	
	<b>Description of defect:</b> Wall crack			
	<b>Recommendation:</b> Minor Defects / damages, need for monitoring, repairs, replaced to prevent serious defect / damages			
<b>Location</b>	T3	<b>Element/Component</b>	Column

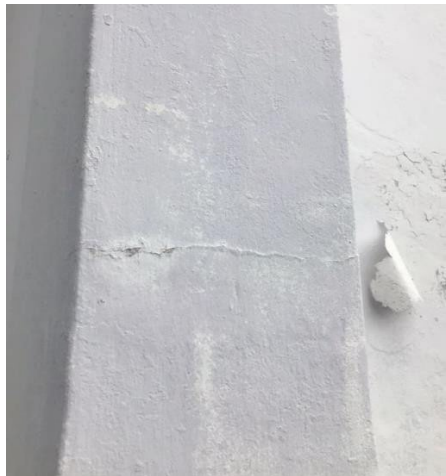
<b>Recommendation:</b> Minor Defects / damages, need for monitoring, repairs, replaced to prevent serious defect / damages			
<b>Location</b>	T4	<b>Element/Component</b>	Column

<b>CSP 1</b>			
		<b>Condition</b>	<b>Priority</b>	<b>Matrix</b>	<b>Colour</b>
		2	2	4	
		<b>Description of defect:</b> Cracking		<b>Recommendation:</b> Minor Defects / damages, need for monitoring, repairs, replaced to prevent serious defect / damages	
<b>Location</b>	B1	<b>Element/Component</b>	Beam

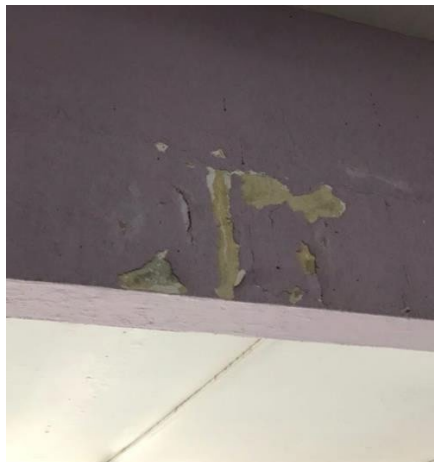
<b>CSP 1</b>			
		<b>Condition</b>	<b>Priority</b>	<b>Matrix</b>	<b>Colour</b>
		3	2	6	
		<b>Description of defect:</b> Concrete spalling		<b>Recommendation:</b> Minor Defects / damages, need for monitoring, repairs, replaced to prevent serious defect / damages	
<b>Location</b>	W1	<b>Element/Component</b>	Wall		
		<b>CSP 1</b>

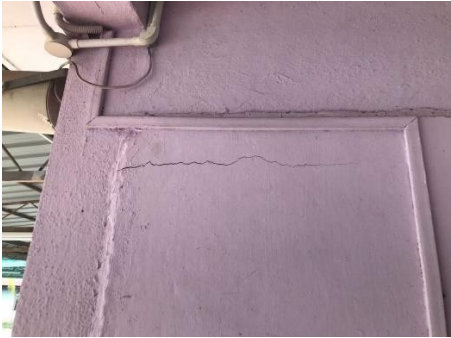
<table border="1"> <thead> <tr> <th>Condition</th> <th>Priority</th> <th>Matrix</th> <th>Colour</th> </tr> </thead> <tbody> <tr> <td>2</td> <td>2</td> <td>4</td> <td style="background-color: #008000;"></td> </tr> </tbody> </table>	Condition	Priority	Matrix	Colour	2	2	4	
	Condition	Priority	Matrix	Colour					
	2	2	4						
<p><b>Description of defect:</b> Wall crack</p> <p><b>Recommendation:</b> Minor Defects / damages, need for monitoring, repairs, replaced to prevent serious defect / damages</p>									
<table border="1"> <tr> <td><b>Location</b></td> <td>W2</td> <td><b>Element/Component</b></td> <td>Wall</td> </tr> </table>	<b>Location</b>	W2	<b>Element/Component</b>	Wall					
<b>Location</b>	W2	<b>Element/Component</b>	Wall

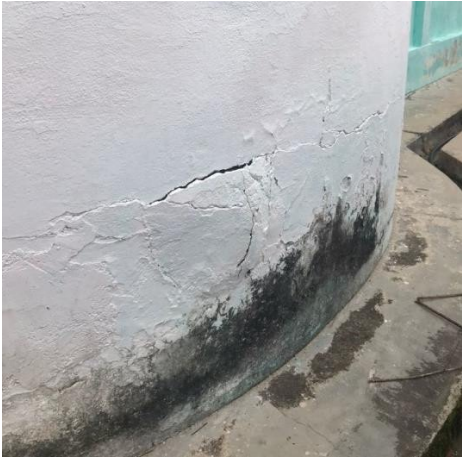
<b>CSP 1</b>								
	<table border="1"> <thead> <tr> <th>Condition</th> <th>Priority</th> <th>Matrix</th> <th>Colour</th> </tr> </thead> <tbody> <tr> <td>4</td> <td>3</td> <td>12</td> <td style="background-color: #808080;"></td> </tr> </tbody> </table>	Condition	Priority	Matrix	Colour	4	3	12

Condition	Priority	Matrix	Colour					
	4	3	12						
<p><b>Description of defect:</b> Wall crack</p> <p><b>Recommendation:</b> Minor Defects / damages, need for monitoring, repairs, replaced to prevent serious defect / damages</p>									
<table border="1"> <tr> <td><b>Location</b></td> <td></td> <td><b>Element/Component</b></td> <td></td> </tr> </table>	<b>Location</b>		<b>Element/Component</b>						
<b>Location</b>		<b>Element/Component</b>

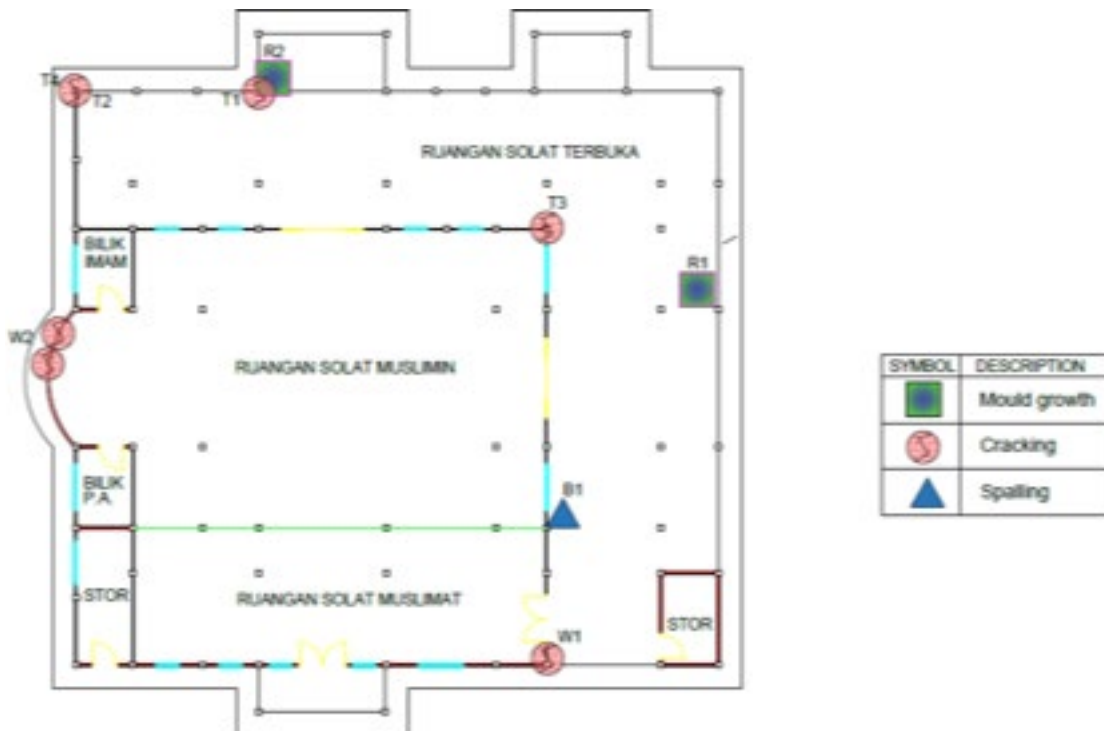
**Appendix B (Defect mapping)**

Defect mapping is used to point the location of defects or problem. It used to mark or check off the locations of defects for the purpose of collecting frequency data of the various defects observed. A defect maps displays the location of defects and simplifies the process of data collection repair. Defect's

locations are marked so that workers will know where to look. The drawing of defect mapping is at the Appendix B.
