## The Defect Monitoring of Micro Steel Fiber (MSF) Concrete Using Acoustic Emission Technique

**Abstract:** Concrete is an essential building material for construction industry. The strength and the performance of the concrete will be deteriorate as the age of the concrete due to extreme weathers and cracking. The main goal of this study is to monitoring the concrete conditions using Acoustic Emission (AE) technique. Therefore, a series of concrete prisms with size of 100 mm × 100 mm × 300 mm with specified percentage (0, 0.5, 0.75, 1.00,1.25) of micro steel fiber (MSF) were produced to conduct AE test. The results obtained from AE test were dicussed in term of real crack observation, b-value, and RA value. Apart from that, a series of concrete cube with the size of 100 mm × 100 mm × 100 mm were batched to conduct compression test. As a result, a highest reading of 74.50 kN was obtained at the 28<sup>th</sup> day of curing for the specimen contained 1.25% MSF. Meanwhile, there is an occurence of a macro-crack in the middle of the specimens. Also, as the load increases the macro-crack further developed until the specimen fracture. Besides, a highest value of 95 dB to 100 dB amplit

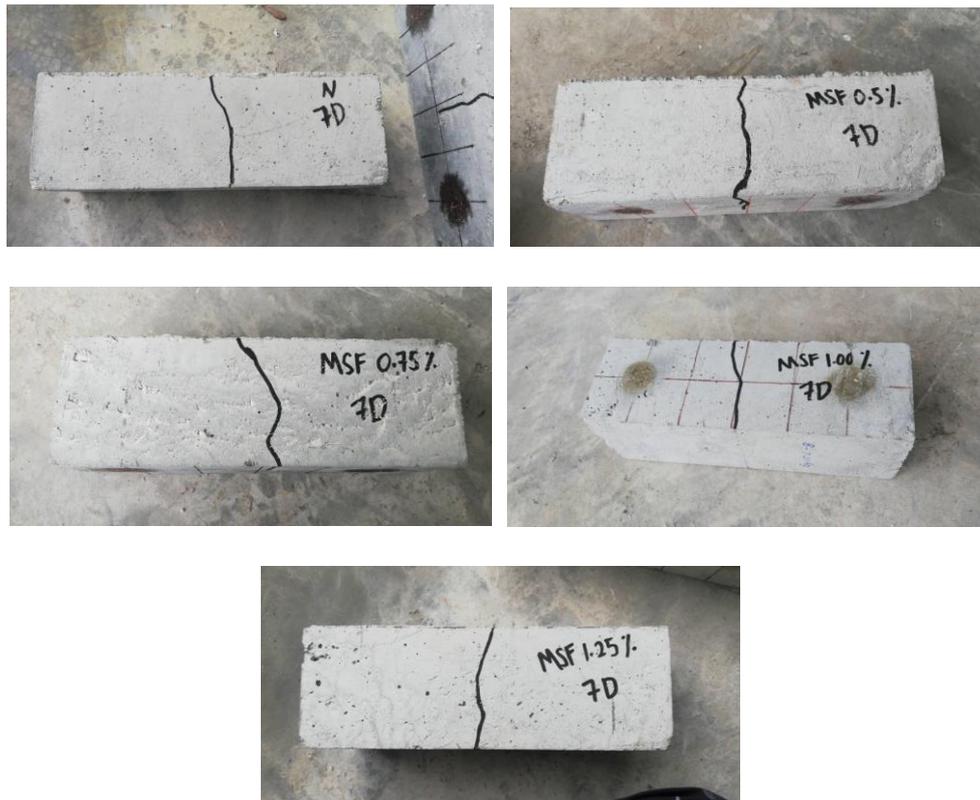
**Figure 5: 0%, 0.5%, 0.75%, 1.00%, and 1.25% of MSF concrete**

This contains the development of the cracking and breaking process of the beams during the test. All the beams usually have the same pattern of cracks. The micro-crack can be seen during the initial stage of the test at the middle part of the beam. This crack type called a flexural cracking. At the same moment, steel having the tension for exerted from the load of the test.

Even so, the loading increased constant with the normal concrete sample. The flexural type cracks remain to propagate and simultaneously several diagonal cracks were founded between support and loading point. At the same time, the link took shear load and influence the stiffness of the beam. The type of cracks is called as mixed mode cracking that means the combination of tensile and shear. The sample failed when load reached 13.4kN.

The loading remains same but the sample change to 0.5% of MSF. The flexural cracks develop rapidly between point loading to produce a major crack and spread it to the compression area. Besides, the shear cracks started to occur nearly both supports. The sampled failed at 19.82kN load.

Next, the sample was change to 0.75% of MSF with the same loading. The sample of 0.75% took a bit longer to failed, while the flexure cracks remain the same as the loads before. It is called diagonal cracks development for this period. When load reached 20.86kN the sample was failed.

After that the 1.0% of MSF was tested. There was a macro-crack in the middle of the specimen. At the same time, there were 3 to 4 visible cracks found near the support. Both combination of tensile and shear occurs at the sample. For the sample 1.25% it takes the longest time to failed and showed some minor and major crack at the middle. Both samples failed when loading reached 22.18kN and 25.24kN.
