Unmanned Aerial Vehicle (UAV) Technology Use in Visual Road Inspection at Ft005, Johor Bahru-Melaka (Pengkalan Raja, Pontian)

Abstract: Visual road inspection is one of the key phases of road maintenance, whose function is to examine and describe the condition of road infrastructure. Local authority still uses conventional road inspection method. However, this method has its drawbacks. In this study, Unmanned Aerial Vehicle (UAV) was used to help in the road infrastructure information search and determining the severity level of road in visual road inspection. The objectives of this study are; to capture road images at study locations using UAV technology, to produce a data for pavement distress using UAV photogrammetry method, and to analysis level of pavement distress using the Pavement Condition Index (PCI) method. Results from this study showed that UAVs are suitable for aerial mapping with condition that it is operated by a professional operator during data acquisition and the use of UAVs as a verification medium is clearly more efficient than the conventional method because it measures every end and vertex of the road using a digitising method, whereas the conventional metho

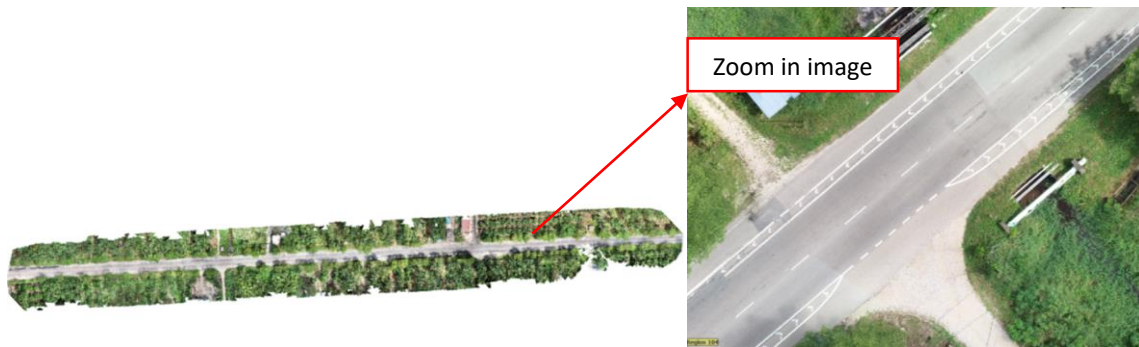
As a result of these three processes, an orthomosaic image, as shown in Figure 3, is produced. The zoom in image is a UAV image that can be seen clearly by using the orthomosaic image.

Figure 3: Orthomosaic Images Produced using Pix4DMapper

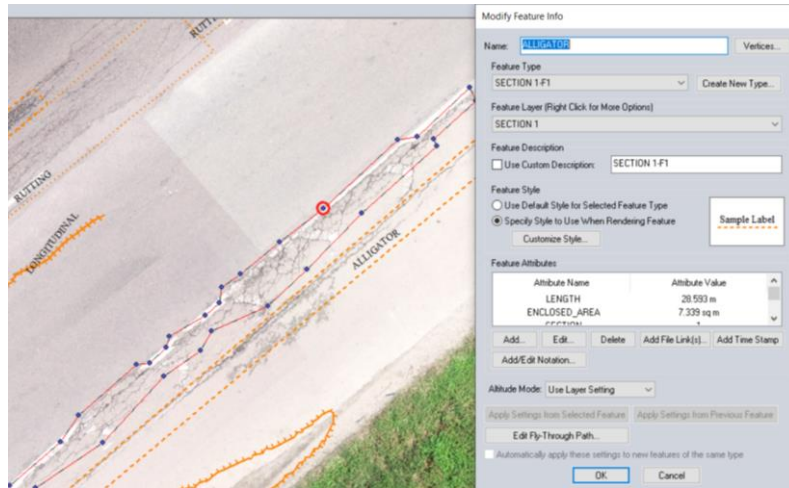
The following information is required to determine pavement distress: width, length, area, depth, location, severity level and types of pavement distress based on orthomosaic and DSM image. For all sections, the same method was used to determine the distress pavement. Figure 4 shown information to determine the pavement distress.

Figure 4: Determine the Pavement Distress Data

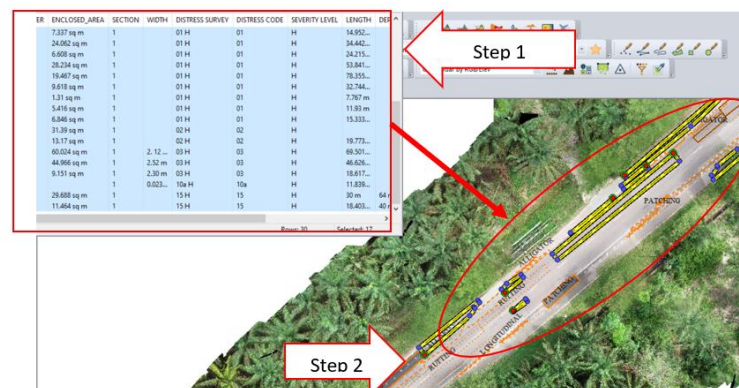
Figure 5 shown example of query to determine the location of the high severity level pavement distress in section 1. The severity level of pavement distress is divided into three categories: low (L), medium (M), and high (H). Section 1 will provide an example of a high severity level for this query. An example of query is:

Figure 5: Steps to Determine the Location of Pavement Distresses

The data obtained from figure 5 represents the location of all types of pavement distresses that are at a high level of severity in section one.

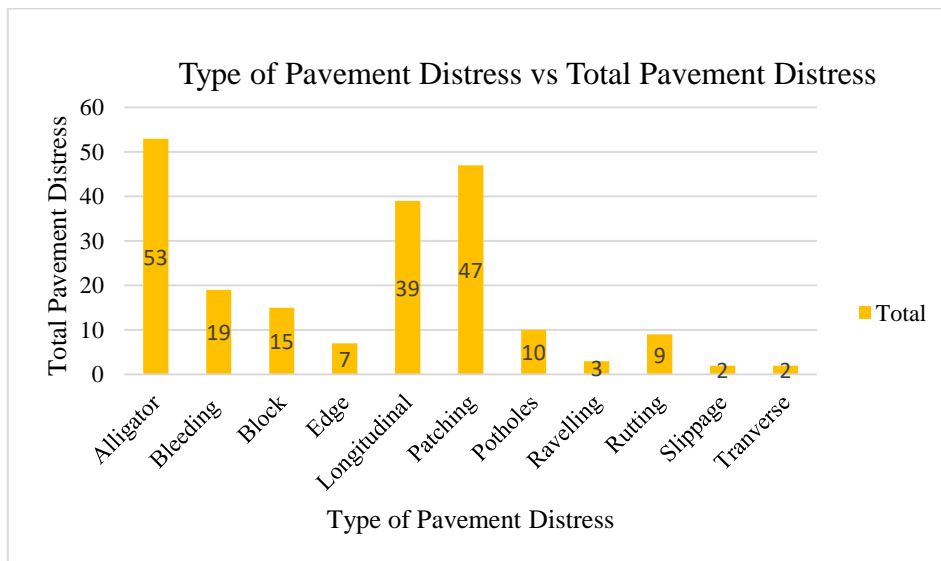
Figure 7: Graph for All Section

Figure 7 shown the total distress survey for all section. The data shows that 11 of the 19 distress types encountered on the subject road. The quantities of distress areas are listed according to the type of distress and also indicate the total pavement distress. Among all the distresses, alligator cracking and patching contribute the highest number of occurrences, which are 53 and 47 respectively. This is due to the road is the main federal road connecting the people of Pontian and nearby areas to Johor Bahru and Singapore. The area has long been a hot topic of discussion in newspapers and on social media, due to the cracking problem at this road [4]. According to the Figure 7, cracking is the highest cause for this road. This is due to the fact that cracking is the most common and serious type of distress that affects all asphalt pavements [9].

This road constructed on soft soil. Various types of maintenance, such as regulate, resurfacing,

CIPR, and others, are performed on that road each year. However, it did not solve the problem. This is because, the maintenance performed are only temporary, as they are only performed on the road's pavement surface. Those maintenance also result in additional loads on the road base surface. The crack will become wider as the load increases. Furthermore, during peak hours, this road sees a significant increase in traffic, which is one of the causes of cracking [4]. Therefore, The PCI method is used to determine the level of pavement distresses in this study area, which is then followed by appropriate maintenance recommendations based on the road's level of service.
