## Crack Detection Using Unmanned Aerial Vehicle (UAV) Applications

The objectives of this study are to identify the crack present at exterior structure by using Unmanned Aerial Vehicle (UAV) and also explore the ability of UAV in the inspection field. The study has proposed on the utilization of UAV in crack detection systems. UAV is capable to cover more than 1000 m height which engages the significant advantage in the crack detection system. Moreover, it reduces the life risks of associated individuals with crack detecting operations. The study area was selected at Kuaters Kediaman Institute of Land and Survey (INSTUN), Tanjong Malim, Perak which is a 4-storey building.

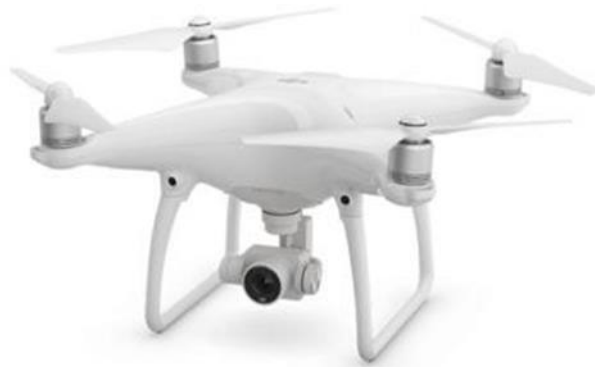
Unmanned Aerial Vehicles (UAV) can be depicted as an aircraft that can be guided by using a remote control as well as automation systems. It consists of various sensors like RGB, lidar in order to carry out an inspection on unreachable places like tall structures [8]. The UAV used in this study is model DJI PHANTOM 4 as shown in Figure 2 which is an entry level professional drone. DJI PHANTOM4 includes a 20-megapixel sensor which has 12 dynamic range stops which allows for more

detailed shots even in intense light. Besides, the 4K video at 60 fps capabilities increase the quality overall giving users better results [3].

**Figure 2: UAV model DJI PHANTOM 4**

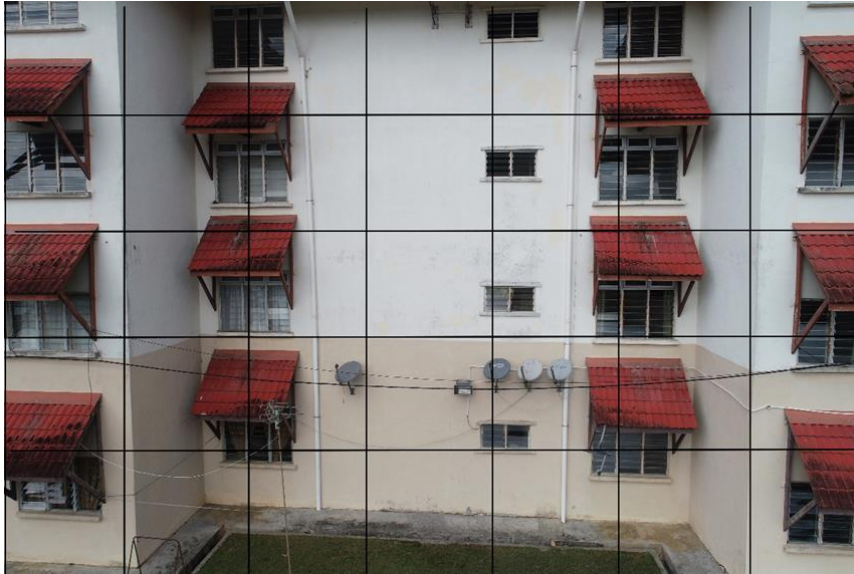
To conduct this study, at least two people must be present while the UAV is being flown. One of them operates the UAVs remote control, while the other keeps an eye on the smartphone and directs the controller. The capturing of pictures starts from the bottom, then the UAV continues upward until it reached the top of the structure, then to the right and slowly descends till it reaches the ground. This process is repeated until the end. Figure 4 shows the grid as a reference of image position and flight direction. Then, the images processed by using Adobe Photoshop and analysis of images is carried out manually to find out if the cracks occur.

**Figure 4: Grid as a reference of image position and flight direction**

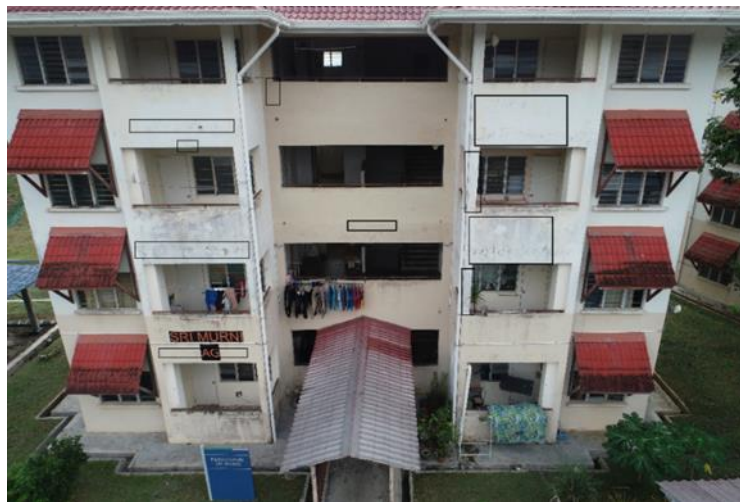
Table 1 shows the total number of detected cracks in this study. There are total 33 cracks had identified out. Figure 7, 8 and 9 shows the front, rear and left elevation of the structure which pointed out the position of cracks.

Elevation	Cracks	Number of crack identified out
Front	Diagonal	1
	Hairline	4
	Horizontal	2
	Shrinkage	4
	Vertical	1
Rear	Diagonal	1
	Hairline	1
	Horizontal	1
	Settlement	4
	Shrinkage	1
Left	Diagonal	2
	Hairline	1
	Horizontal	2
	Settlement	4
	Shrinkage	1
Total	Vertical	3
		33

**Figure 7: Front elevation of Kuaters Kediaman INSTUN**

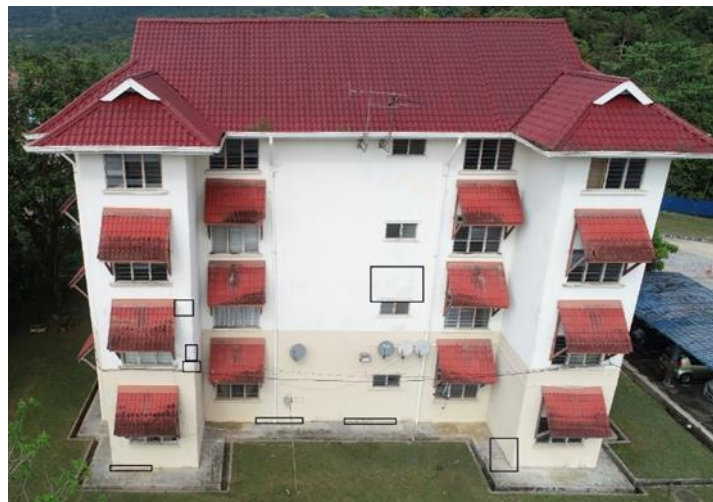
**Figure 8: Rear elevation of Kuaters Kediaman INSTUN**

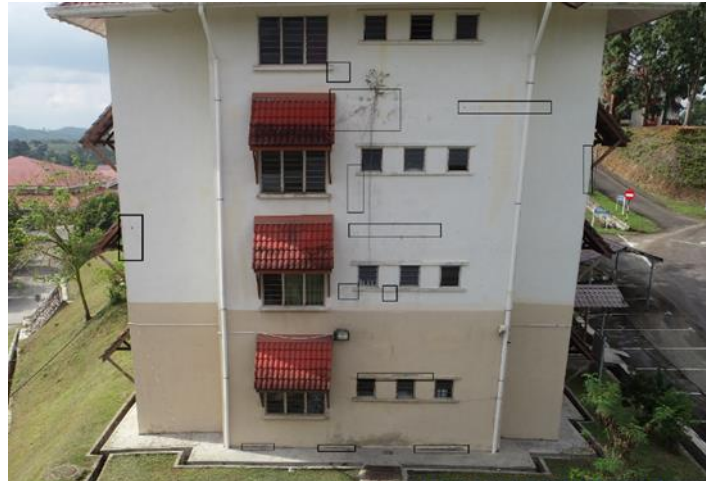
**Figure 9: Left elevation of Kuaters Kediaman INSTUN**
