# Implementation of CSP1 Matrix Application for Roof Defects Inspection: Case Study in F2 Examination Hall UTHM

Inspections were carried out on the roofs of F2 examination hall Universiti Tun Hussein Onn Malaysia. Researchers need to find defects on each roof surface structure. Following the discovery of defects, the researcher will use the CSP1 Matrix approach to determine the defect type and suggestion for improvements.

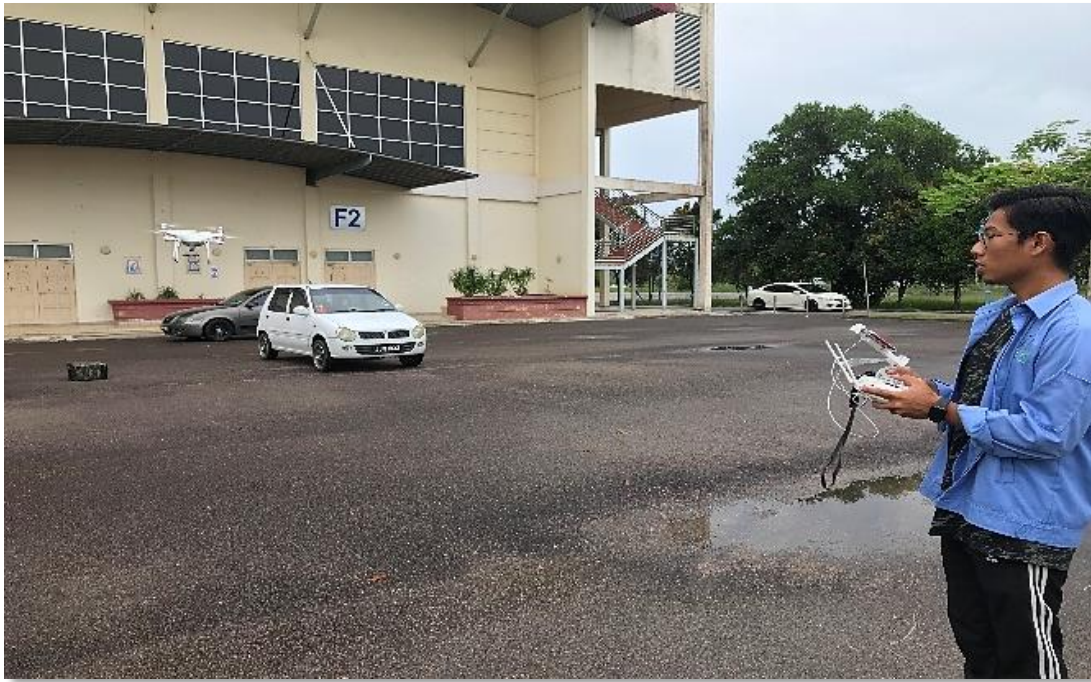
Figure 1: Researcher fly the UAV DJI Phantom 4 Pro

The first step in data acquisition was visual inspection which required flight person to setting up and fly the UAV and the use of Pix4DCapture software to plan the UAV route, as seen in Figure 1 and Figure 2 respectively. It is critical to prepare thoroughly and precisely before start the data collecting procedure. The goal of this part was to use Pix4DCapture for DJI devices to build a UAV route, project scale, overlapped, height, speed, and sensor coordination system. Overlapped will be set at 60%, in order to create a good quality images for this project. This part must prevent any UAV issues throughout the flight. The operator must calibrate the remote controller and the UAV internal GPS observation signal to ensure it is ready to fly with the coordinates pre-set in flight planning.

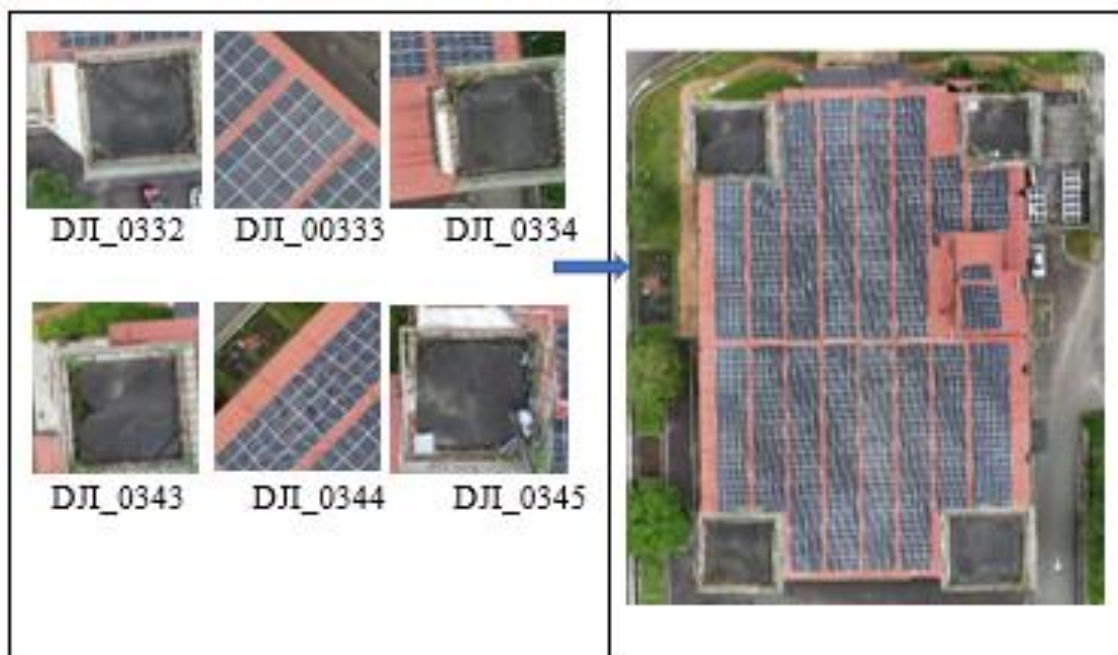
**Figure 4: Steps of image processing F2 examination hall UTHM**

The entire area of the roofs of examination hall at block F2 UTHM was image processed to generate an orthophoto with Pix4d Mapper to display the full area and high quality images of F2 examination hall UTHM (Figure 4). The stages in this method are to upload a photo to Pix4D Mapper, order it in one photo, and then open it in Adobe Photoshop to labelled picture flaws. The image produced must fulfil the criteria which is must be clear, not blurry and bright, the images overlapped more than equal 60%.

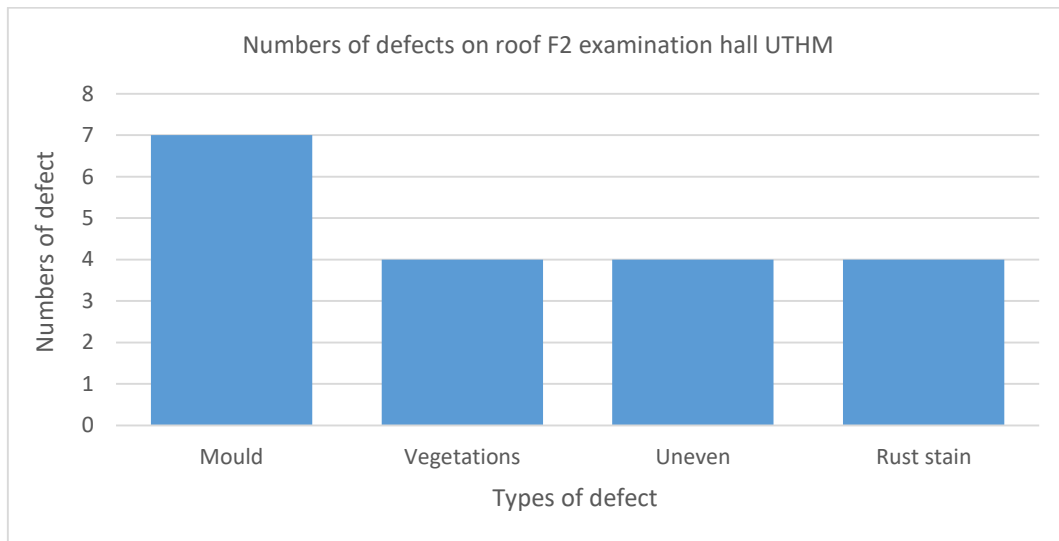
**Figure 7: Numbers of Numbers of defects on roof F2 examination hall UTHM**

Total = 46 Total mark, d = 46 Defects numbers, e = 19

Total score,  $d/e = \frac{46}{19} = 2.4$

Assessment overall building = good

Maintenance Plan = Planned maintenance
