Shoreline Profile and Changes Monitoring Via Unmanned Aerial Vehicle (UAV) Photogrammetry

Abstract: This research focuses on the identification of shoreline profile and its changes. As for this study, the shoreline of Pantai Punggur is selected as the study area. This study was driven by a climate change factors that resulted to a sea level rise and violent behavior of sea waves. This factor relates to coastal erosion and coastal changes along the west coast of Malaysia. Malaysia's coastline vulnerability on coastal changes is something that is important to be addressed as the location of this country is surrounded by water and the coastal area plays a big role in the socio-economic activity. In order to understand coastal erosion, it is important to understand about the physical properties of the sediment as well as the knowledge on how it is transported. There are three objectives of this study which are to analyze the condition of shoreline at Pantai Punggur using visual inspection method, identify the shoreline beach profile using Pix4D Mapper and Global Mapper software and to identify relationship between beach profile with shoreline changes. Based on the output of this study

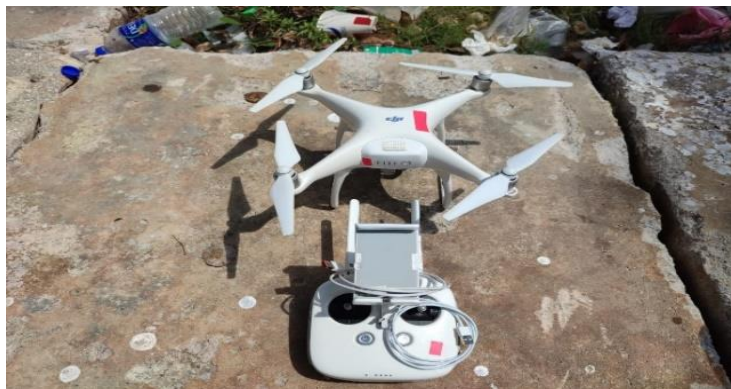
Figure 1: Unmanned aerial vehicle (Drone)

An unmanned aerial vehicle (UAV) is an aircraft that does not have a human pilot on board. The unmanned aerial vehicle is controlled either autonomously by the system that uses a microprocessor or telemetrically by the operator who can control it on the ground. UAV can be programmed to carry out observation or detection missions automatically or remotely. They are mostly utilized in mapping applications, environmental change monitoring, disaster preventative response, resource exploration, and other similar applications. When acquiring aerial images, UAVs offer two benefits over other flying vehicles and satellite remote sensing technology: low cost and great mobility. However, they have many environmental restrictions on their use due to low flight stability. As a result, how to deploy UAVs in various settings so that geographic data for qualitative and quantitative analysis may be consistently processed and created is a critical problem influencing their implementation [8]. Figure 1 shows one of unmanned aerial vehicle (Drone).

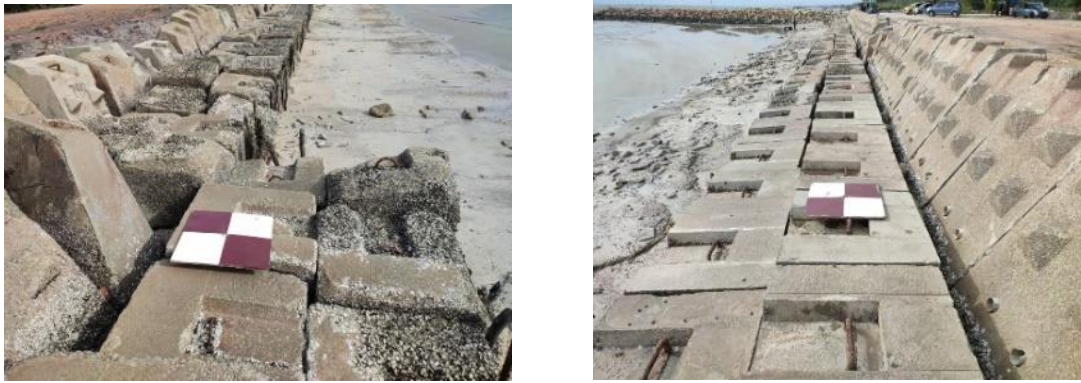
Figure 2: The ground check point

Preliminary surveys at Pantai Punggur was conducted by observing coastal conditions. Apart from site visits by observing the location of the coast above ground, aerial photographs of the survey will help to get a complete picture of the changes in the coastline in the study area. An aerial photograph with a drone to record an image of the survey area at a determined location distance provides unlimited information on the details of the Earth's surface. Before starting the survey, a field visit to the survey area should be conducted to determine the condition of the survey area and the appropriate time to carry out the flight plan. Weather conditions also play a role in this study as to determine the suitable time to fly the drone. The ground check point (GCP) will used for making the temporary benchmark at the location that have been marking. The main function of GCP is to mark the GPS point when flying drone. GCP is used during the data retrieval process to facilitate aerial retrieval of data. Figure 2 shows the GCP. The implementation of Pix4D Mapper and Global Mapper software were used as a medium to quantify the shoreline changes. UAV (Unmanned Aerial Vehicle) is used as a tool to capture aerial image of Pantai Punggur with high resolution images to be processed by the software. This research implements physical and visual approach to correlate the shoreline changes and beach profile. Figure 3 shows the orthomosaic profile in Global Mapper software.

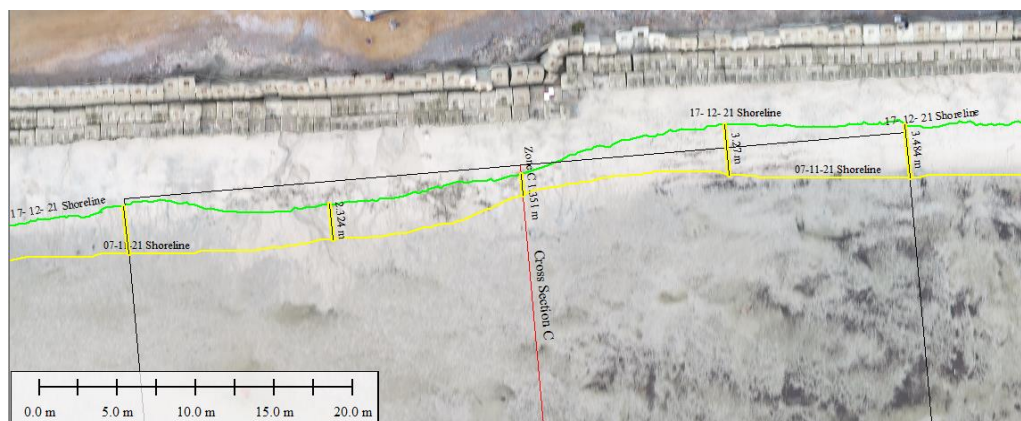
Figure 7: Shoreline changes at zone C

Zone C, as shown in Figure 7, is also located in the middle revetment. The revetment area, or in another definition, the Labuan block, covers all of the areas in the middle of this study scope area to prevent and control the shoreline changes from becoming worse in the future, threatening public economic activity in the coastal area. The shoreline changes at zone November to December 2021 is 1.698 m. The changes that occur between zone B and C are seen as intangible. Among the shoreline changes that occur between the two zones are 0.3 m.

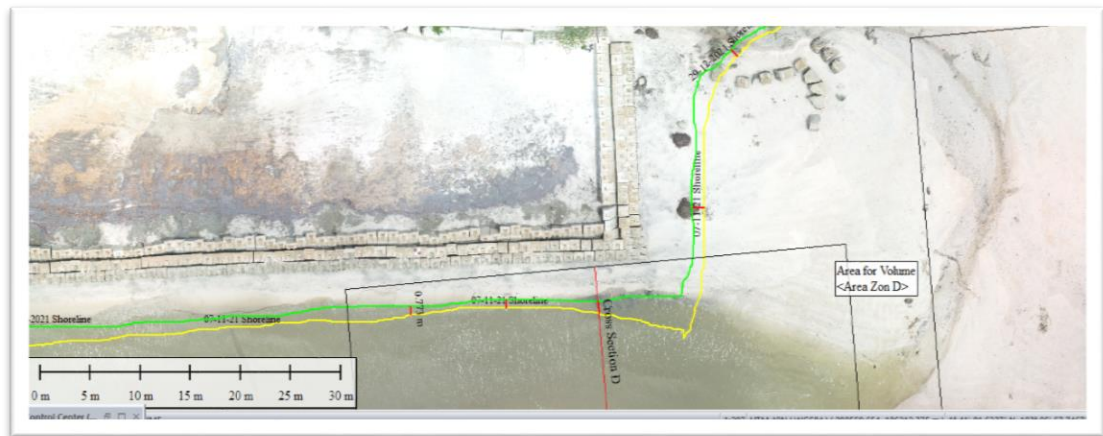
Figure 8: Shoreline changes at zone D

Location D is selected near the left side of the study area which is not surrounded by the revetment thus that location is not protected against coastal erosion. There were abrupt changes that happened in that location from November to December 2021. The shoreline change is 0.956 m. In zone D from the observation, the occurrence of sand accretion is shown in this image. As a result, little movement in the shoreline occurs.

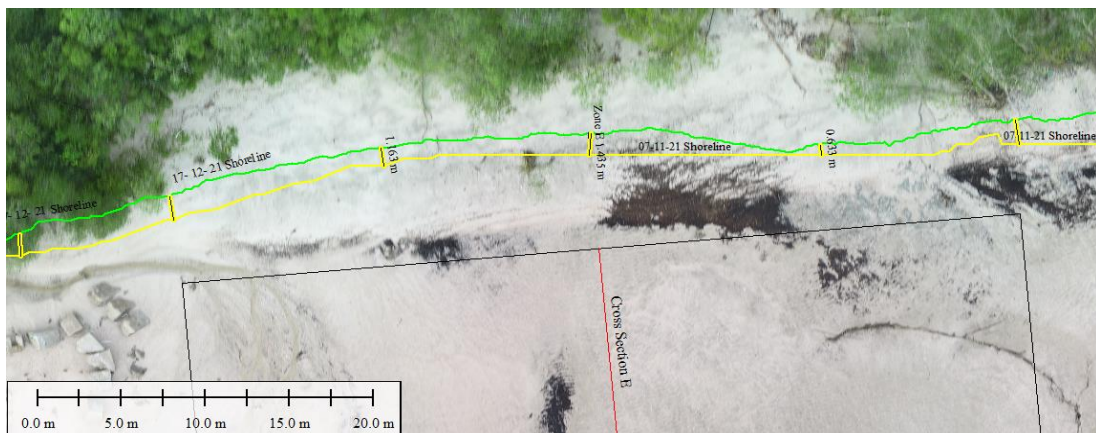
Figure 9: Shoreline changes at zone E

Location E is selected near the left side or the last location for the shoreline changes zone. Area zone E is surrounded by the mangrove forest and sand accretion is shown in this image. From the observation, the shoreline changes is 0.812 m. Zone E shows a little shoreline change compared to another zone.

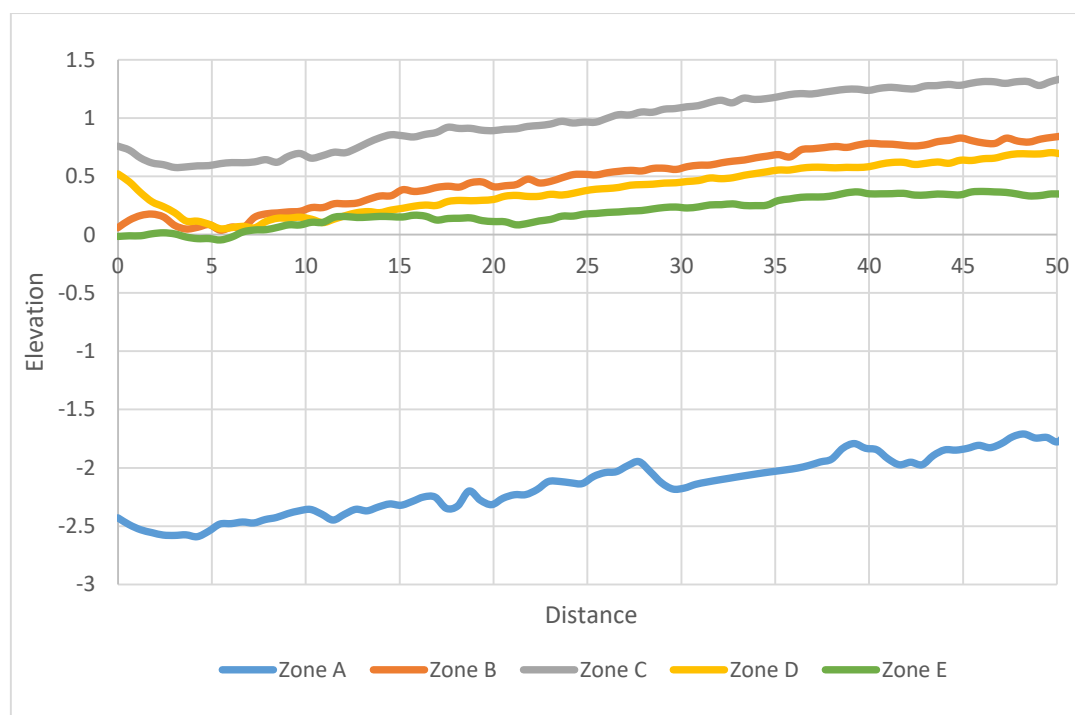
Figure 10: Beach profile for zone A, B, C, D and E

Figure 10 shows the plotted graph of beach profile for zone A, B, C, D and E. The profile for each zone were plotted based on the elevation and distance. Based on the graph shown pattern at zone A, it shows the lowest value and can be related to the shoreline changes. The shoreline changes at zone A is 2.406 m. and while zone B shows an increased pattern profile because location B is near the revetment and groin area. For zone A the shoreline changes are related to the graph as the value is 2.046 m. Despite the location of zone A, monsoon transition that has been occur on November are one of the factors that contribute the changes. Monsoon transition triggers the strong waves thus resulted in abrupt changes in this area. However, based on the graph shown for zone B, C, D and E, its shows quite a similar pattern. Zone E are lower compared to zone B, C, and D. The location of E where it is located at the right side of the study area which are one of the areas that is not covered by the revetment. In addition, this area is connected with the mangrove area where there is a water that keep flowing into this coastal zone. This two-factor area is crucial, which it is one of the reasons of erosion are critical at this area after zone A. From this observation the graph pattern and shoreline changes at zone A, B, C, D and E are reported as 2.046 m, 1.978 m, 1.698 m, 0.956m and 0.812m.
