## **A study on the Effect of Reinforcement Corrosion Using Ultrasonic Pulse Velocity Test**

**Abstract:** Reinforcement corrosion in steel is one of the major concrete deteriorations that may induce a reduction of the load-bearing capacity as well as incur underlying safety risks on the durability of the reinforced concrete structure. Consequently, a routine inspection of structure that is cost-efficient and timesaving should be carried out to assure that the corrosion does not spread uncontrollably. Experimental work was conducted to study the sensitivity of reinforcement corrosion towards the Ultrasonic Pulse Velocity test (UPV) and to evaluate the presence of corrosion based on the Ultrasonic Pulse Velocity test. Two specimens of cross-section 150 x 165 and length 350 mm were reinforced with two 10 mm bar diameters were used in this study. The impressed current test of 0.08 mA/cm<sup>2</sup> would be conducted to accelerate the corrosion and Visual Inspection, Half-Cell Potential (HCP) method, and most importantly Ultrasonic Pulse Velocity (UPV) test would be performed for determining the sensitivity and presence of corrosion. The results indicated there is a possibility that

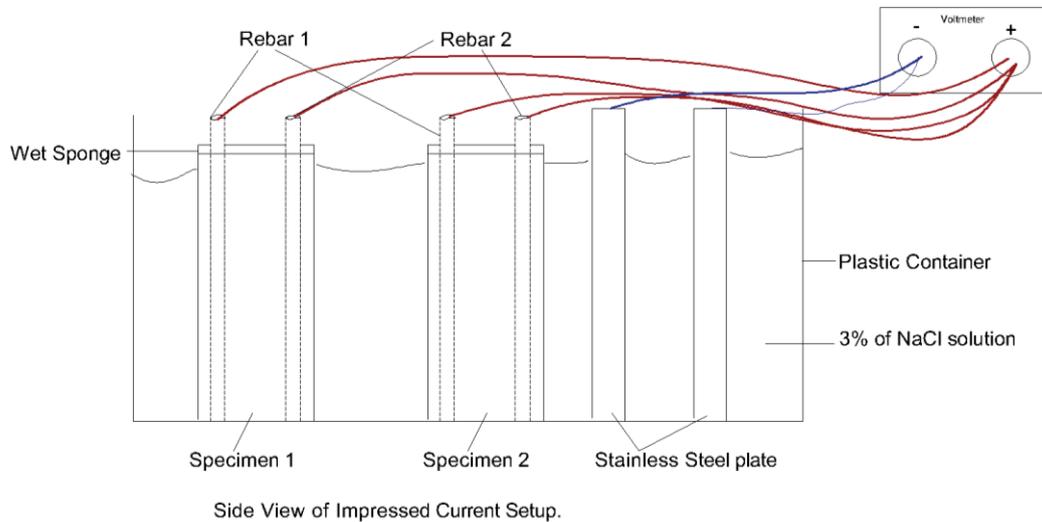
**Figure 4: Setup of Impressed Current test for the project**

Before applying the Impressed current test, Specimen 1 and Specimen 2 were cleaned to remove some rust and soaked in a 3 % of Sodium Chloride Solution (NaCl) for 8 days to ensure full saturation then, the initial Impressed Current values were recorded. Figure 4 below shows the setup of the Impressed Current test for this project. For generating corrosion, the current was set to flow from cathode to anode through the electrical connection yet in the electrolyte, current flow from anode to cathode.

The specimens were set upright and were soaked partial immersion in 3 % of Sodium Chloride Solution which acts as an electrolyte, the reinforcing bar was set to be an anode where the oxidation or corrosion will occur and two stainless steel plates will be served as cathode where reduction occurs. According to the study by Saifullah and Clark [11], the density of current should not be exceeding 0.25 mA/cm<sup>2</sup>. Thus, the current density of 0.08 mA/cm<sup>2</sup>. was selected and monitored within 8 days of Impressed Current test. Sponges act as a counter electrode functioned for current to flow and were placed in contact between rebar and the concrete.

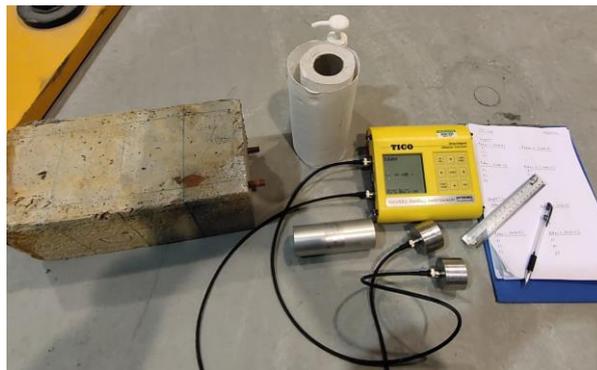
**Figure 8: Preceq Tico Ultrasonic Instrument used**

On the Ultrasonic Pulse Velocity method, the reading of the specimens before and after Impressed Current test will be recorded via Preceq Tico Ultrasonic Instrument consisting of two transducers of 54kHz, two cables, a calibration rod, couplant, and a carrying case as Figure 8.
