International
Journal of
Sustainable
Construction
Engineering and
Technology

Effective Building Surveying Using Laser Scanning for Heritage Building Documentation

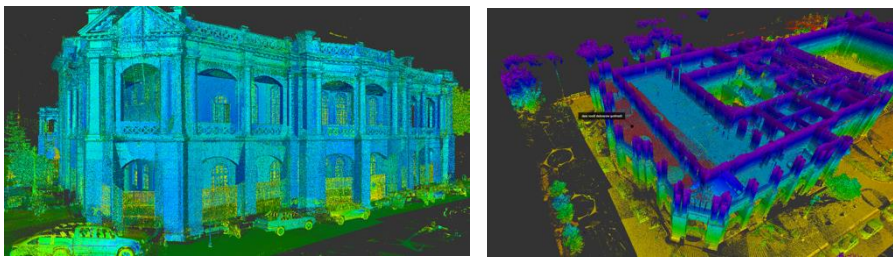
Despite being connected, Ipoh Town Hall (Figure 1) is currently used as a hall while the post office was abandoned during the time of the survey. Most of the Ipoh Town Hall building was in good shape; however, there were minor flaws in the ceiling, exterior, internal walls, doors, windows, stairs, and columns. Among the more prevalent flaws were cracks in the wall plaster, paint-related issues (peeling, spalling, and blistering), decaying window and door frames, moisture, and damaged ceiling panels. During the walk-in survey, there were no significant issues with the building's structural integrity.

Fig 1 - Point-cloud image of Ipoh town hall and post office

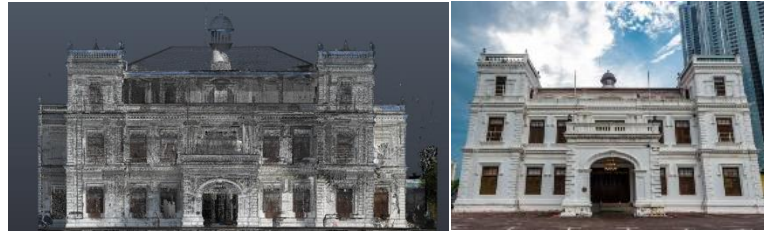
Bangunan Dato' Jaafar (Figure 5) was a mansion owned by the former Johor Chief Minister, Dato' Jaafar. It is currently used as a museum after being handed to *Yayasan Warisan Johor* as the caretaker. The key areas where defects were found during the walk-in survey were the façade, floor, ceiling, HVAC system, lighting system, electrical system, plumbing, doors, windows, and landscaping. The most frequent flaws in this structure were termite infestations, mould growth, moisture, floor slanting, paint and wallpaper-related flaws (peeling, spalling, and blistering), and cracks (Figure 6). The severity was assessed and noted during the walk-in survey; nevertheless, a more accurate assessment of the severity was achieved with the help of TLS. For instance, TLS allowed the precise angle of stairs and cantilevered floor slanting to be ascertained. Other than that, both walk-in survey and non-destructive test were used to assess the condition of the building.

Fig 5 - Point-cloud image and photo image of Bangunan Dato' Jaafar
