Climatic Influence on Slope Failure: A Case Study at Kem Terendak, Melaka

Raazlizam Lias¹, Ismacahyadi Bagus Mohamed Jais^{2*}, Diana Che Lat³

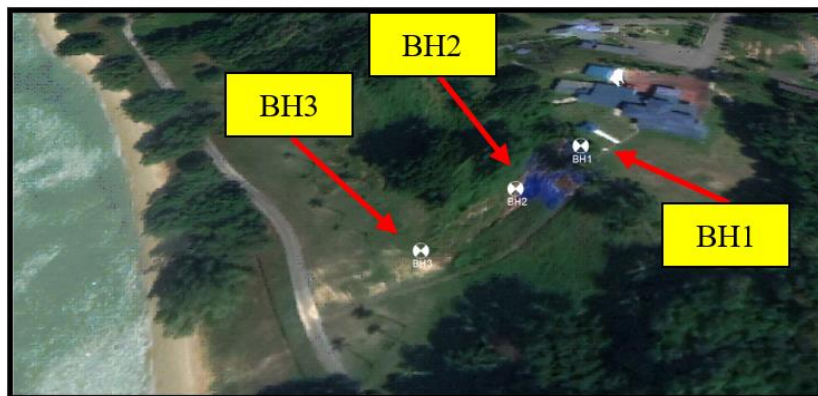
Fig. 6 - Location of borehole test

The subsurface profiles and conditions beneath the landslide area infer from the soil investigation report completed mid of April 2020 by an appointed site investigation contractor. One cross-section consists of Borehole 1, 2 and 3 were developing across the landslide area (refer to Figure 6). To furnish the analysis, the soil information encountered from the bore log will table into the group for ease of reference (refer to Tables 2 until 5).

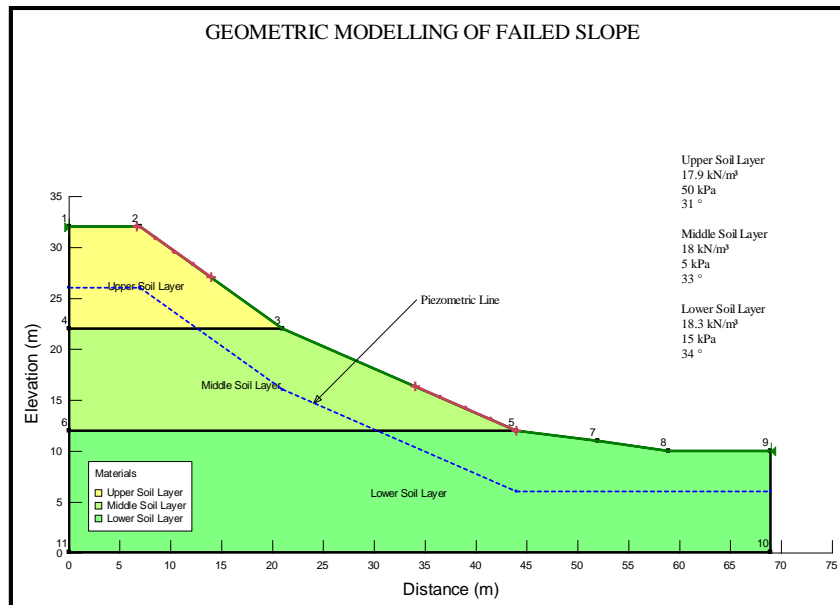
Fig. 7 - Slope modelling in Slope/W 2012

All information such as slope geometric, soil profile, soil engineering characteristics and piezometric line will analyse in the Seep/W 2012 and Slope/W 2012 software. The analysis will unravel the value of Factor of Safety on slopes that have failed in three conditions, stable state water, rising groundwater and wetting front (refer to Figures 7 and 8).
