Geotechnical Failures Case Histories of Construction on Soft Soils, Forensic Investigations and Counter Measures in Indonesia

Paulus P. Rahardjo¹

¹Parahyangan Catholic University, Jl. Ciumbuleuit No. 94 Bandung, INDONESIA

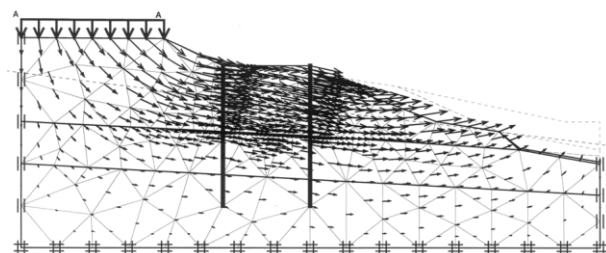
Many slope failures in West Java are caused by uncontrolled fill placement such as in North of Bandung and in Purwakarta. It is shown in Fig. 20, very high fill (about 25 m) was placed without clearing of the original slope and without compacting. The slope failed because of the quality of the fill and the existing soft soils under the embankment. To overcome this problem, the fill was added at the toe of the slope bridging the gap with the other hill across the embankment. Additional fill was added to flatten the slope in a more engineered way.

Fig. 20 Numerical modelling of landslide in Purwakarta [14].

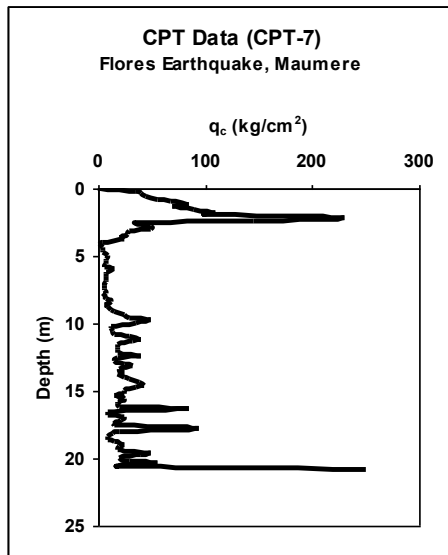
Fig. 28 CPT result in Maumere City [18].

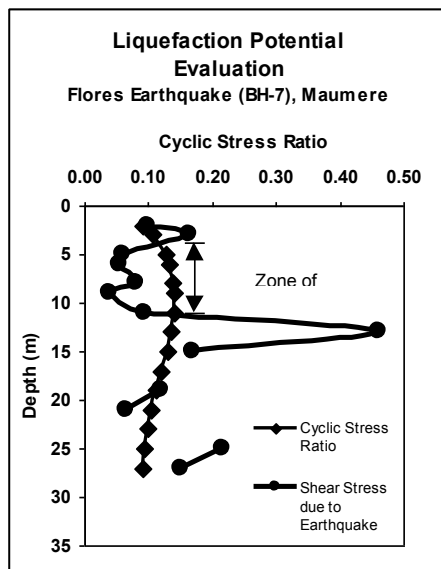
Fig. 29 Liquefaction potential of Maumere City soil deposit [18].

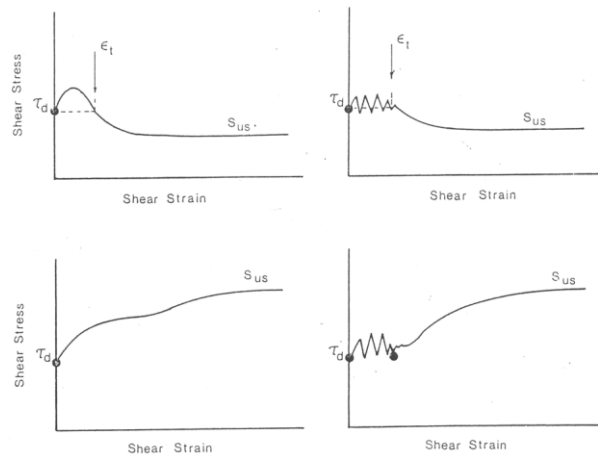
Explanation of liquefaction flow failures were made by Castro [4] where sloping ground induced shear stresses on the soil element below. Under normal condition, this initial shear stress is lower than the peak shear strength of the soil, and hence, the slope is stable when there is no disturbance. However, during earthquake, straining of the soil element cause decrease of shear strength to its residual or steady state condition. When the undrained steady state shear strength is lower than the initial shear stress, liquefaction flow failures take place. Fig. 33 shows the stress strain condition of this mechanism.

Fig. 30 Stress strain behavior of saturated sand under monotonic and cyclic loading [4]

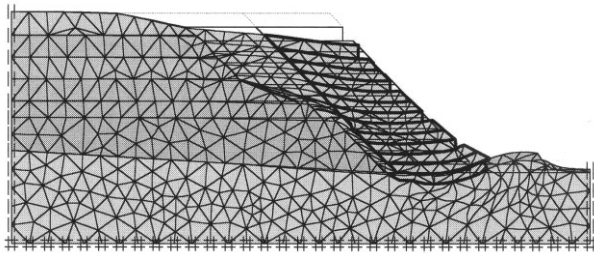
Two houses on top of the slope damaged due to the movement of the soil. Based on this lesson, the developer redesign and reconstruct the slope using approach that geotextile is not to be used in combination with expansive

Fig. 33 Simulation of failures of reinforced earth slope [19].

soil. The rehabilitation of the slope was by lining along the canal.
