# Geological Terrain Mapping using Geographic Information System (GIS) and Drone Photogrammetry

**Abstract:** The research area was conducted within the Bukit Persekutuan, Kuala Lumpur, and it was located at the latitude 3° 8'32.93"N and longitude 101°40'32.80"E. The researcher carried out geological terrain mapping to evaluate the research area in accordance with the geological terrain classification attributes of each thematic map produced, namely, Terrain map, slope gradient map, erosion, and instability map, as well as construction suitability map. The occurrence of landslide events within the research area becomes a major contributing factor to thoroughly conducting an investigation by field mapping and analysing using the Geographic Information System (GIS) technology. The application of Geographic Information System (GIS) and drone photogrammetry images play an essential role to analyze and process the data, thus, generate the thematic maps. The research area indicates that about 79.11% of the overall area was not appreciable with erosion, 8.58% contribute to the erosion, 11.00% of recent general instability, and 2.97% represent a landslide event. The suitability for develo

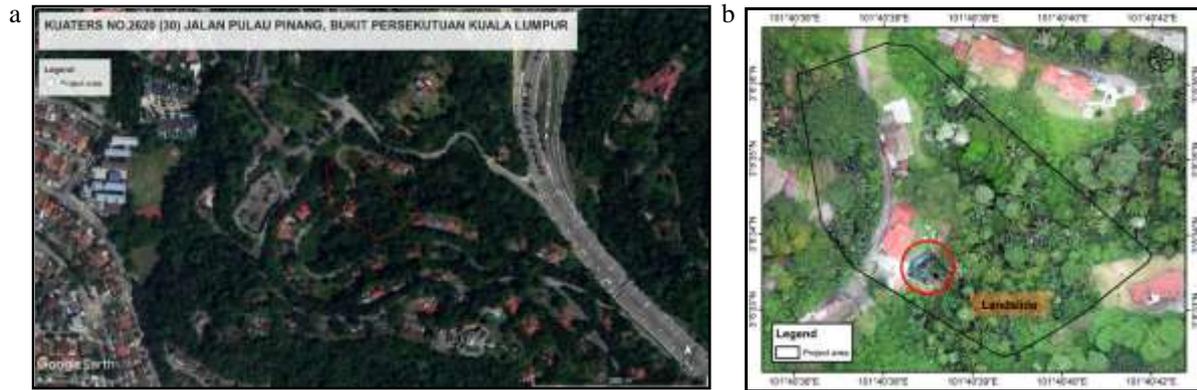
**Fig. 1 - (a) Satellite image view of the project site, located in Kuarters No.2620 (30) Jalan Pulau Pinang, Bukit Persekutuan Kuala Lumpur; (b) Drone orthomosaic viewed of the research area**

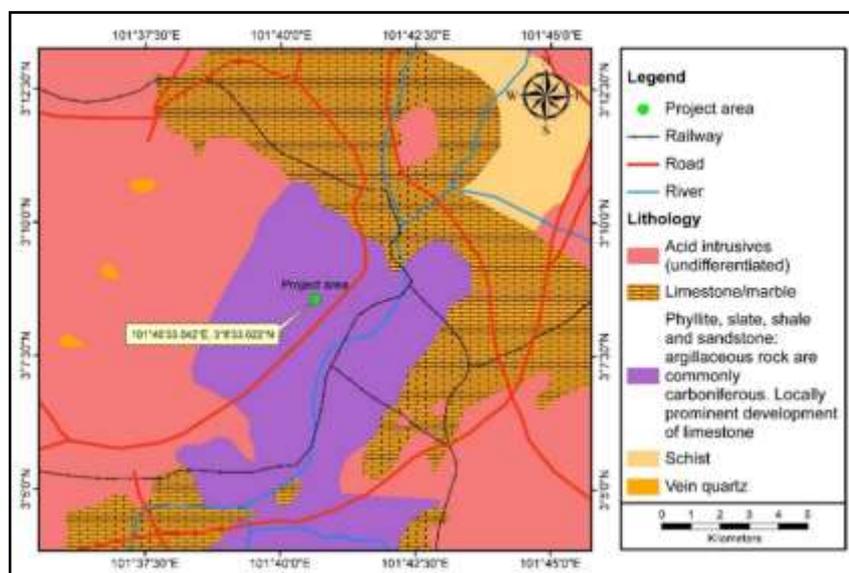
**Fig. 2 - The types of rock units exist at the site and the surrounding area in Bukit Persekutuan, Kuala Lumpur**

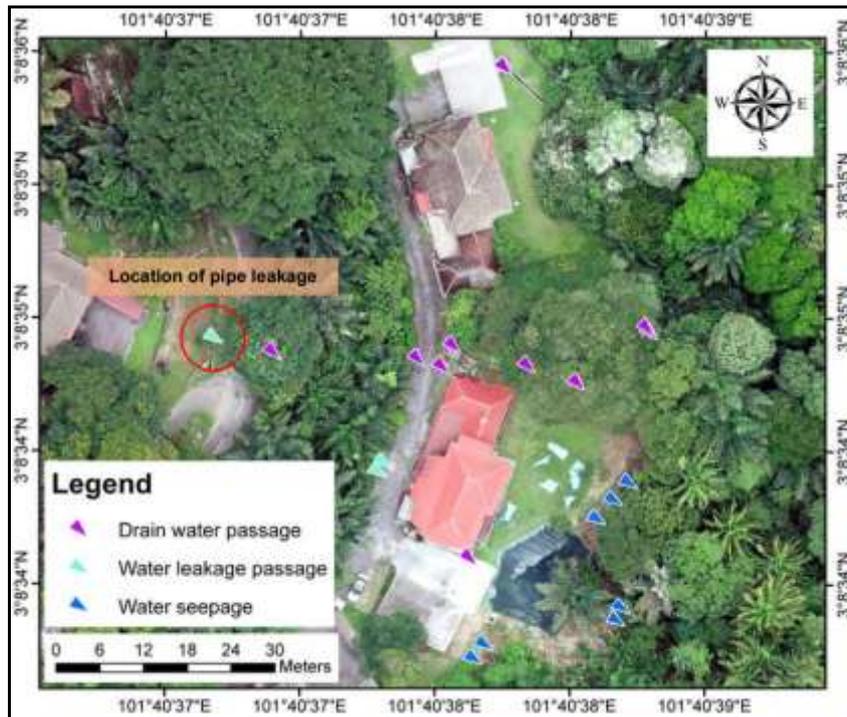
Fig. 4 - The location of water passages in the research area

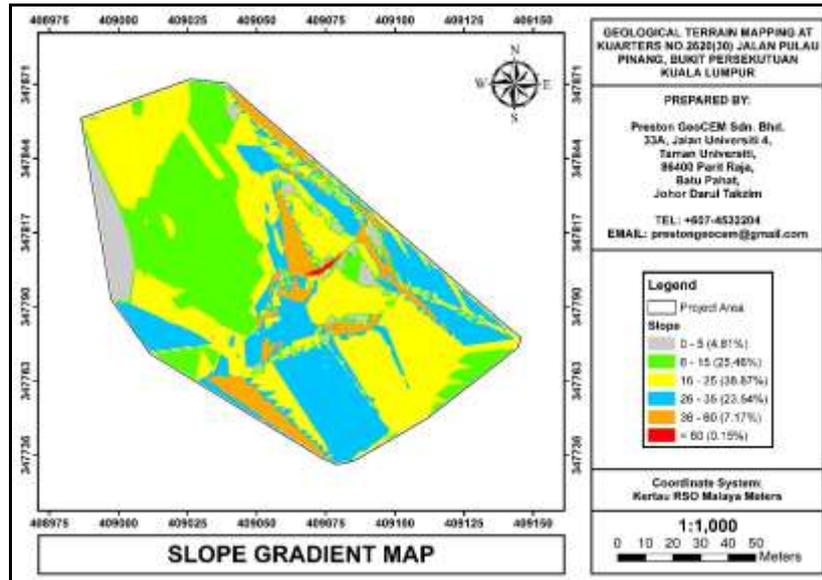
The slope gradient calculated from the topography survey plan is shown in Figure 11. The computer-generated slope gradient map shows that approximately 30.27% of the total site area has a slope gradient of less than 15°. The study also indicates that areas with a slope gradient of 16° to 25° comprise 38.87% of the total site area. Other than that, the areas with a slope gradient of 26° to 35° comprise approximately 23.54% of the total site area. In comparison, the areas with a slope gradient of more than 36° comprise approximately 7.32% of the total site area.

Fig. 11 - Slope gradient map produces for the research region analysis. The project site can be categories as a flat area

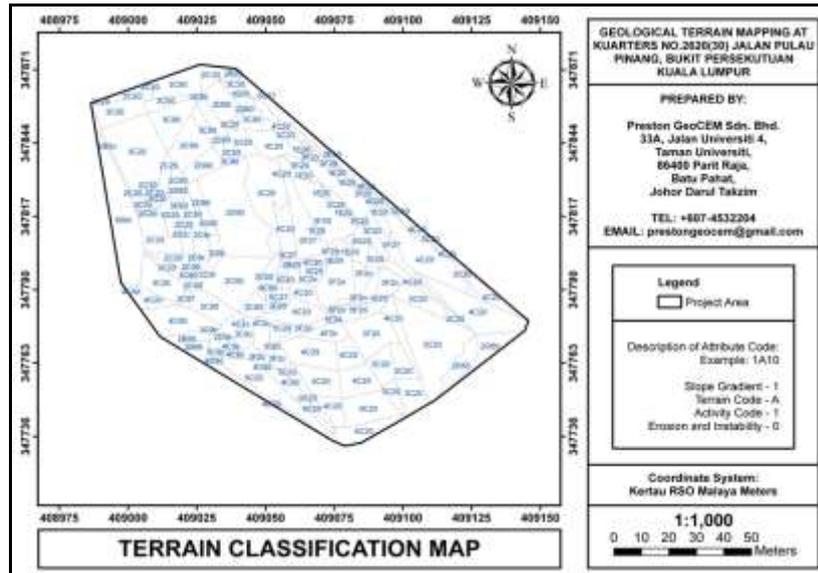
The terrain classification map summarizes all findings from field mapping and GIS analysis at the project site. The terrain classification map compiled four parameters; slope gradient, terrain code, activity code, and erosion and instability. As suggested by Jabatan Mineral and Geosains Malaysia, each parameter was given a code, referred to in the Appendix section. The combination of four different information was used to produce a construction suitability map with different classes. The terrain classification map for the project site is presented in Figure 13.

Fig. 13 - The terrain classification map at the project site

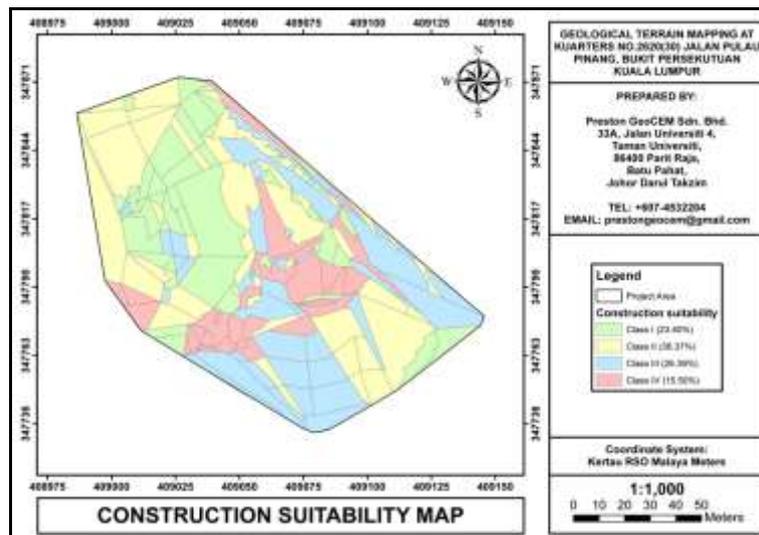
The construction suitability map was produced from the geological terrain classification map. The terrain classification attribute for regional studies is shown in the Appendix section. The map of construction of suitability map generated from terrain classification map is shown in Figure 7. It was estimated that almost 59.77% of the total area in the project site was categorized as Class I & II. These areas are usually flat and do not show any sign of slope instability and erosion. At the same time, almost 26.39% of project sites were classified as Class III. These areas were expected to have high to extreme geotechnical limitations and required intensive site investigation works. Significant slope instability and erosion were identified in these classes. The other 15.50% of the area was illustrated as a Class IV, and it was included extremely high geotechnical limitations and required very intensive site investigation works. Besides, Class IV was not suitable for any development purposes.

Fig. 14 - The distribution of classes in the project site based on various parameters
