Vibration Analysis on Centrifugal Pump in UTHM Biodiesel Plant

Taranjit Singh¹, Nurhafizzah Hassan^{1*}

¹ Faculty of Mechanical and Manufacturing Engineering
Universiti Tun Hussein Onn Malaysia, Parit Raja, 86400, Batu Pahat, Johor, MALAYSIA

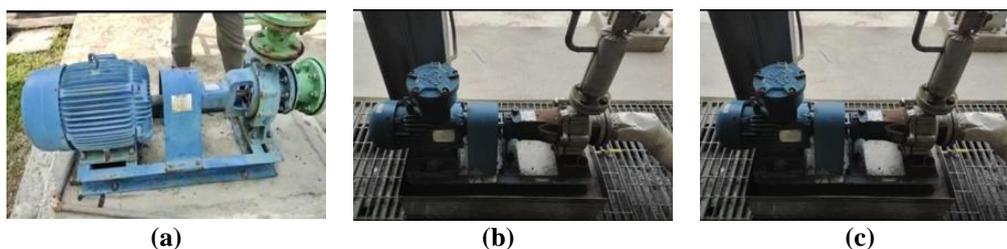
Fig. 4 (a) Pump P001; (b) Pump P202; (c) Pump P219

Table 1 shows the health condition of pump P001 with the average velocity of data collection of four times. Point 2 (horizontal direction) has the highest vibration velocity of 5.57 mm/s near the coupling shaft (motor side), which shows an unacceptable limit based on the ISO 2372 vibration severity chart. Meanwhile, point 1 (horizontal) has a velocity of 4.97 mm/s and point 3 (axial) has a velocity of 3.91 mm/s in which both show an unsatisfactory condition. The overall vibration velocity indicates that the pump is deplorable and needs to be shut down immediately for maintenance. The vibration severity is much higher at the motor side bearing location compared to the pump bearing location.

Table 2 shows the health condition of pump P202 with average velocity data of five times. Point 2 (vertical) has the highest vibration velocity of 3.95 mm/s near the coupling shaft (motor side), which shows an unsatisfactory limit. Meanwhile, point 3 (horizontal) has a velocity of 3.03 mm/s and point 4 (axial) has a

velocity of 2.95 mm/s in which both shows an unsatisfactory condition. The overall vibration velocity indicates that the pump is less severe than P001 but still need to be shut down immediately for the maintenance. The vibration severity is much higher at the pump side bearing location compared to the motor bearing location.
