Building Conditions Assessment of Timber Mosques at Batu Pahat

This research aims to assess the condition of the timber mosque at Masjid Jamek An Nur Kampung Patah Pedang and Kampung Parit Lapis Bangas Mosque, Batu Pahat. The study will use a Building Condition Assessment (BCA) checklist to identify any signs of structural damage or deterioration in the timber components of the mosque. The research will also evaluate the quality and condition of the structure of the mosque using the BCA checklist and propose recommendations for repairs or replacements for any deteriorated or damaged components of the timber mosque.

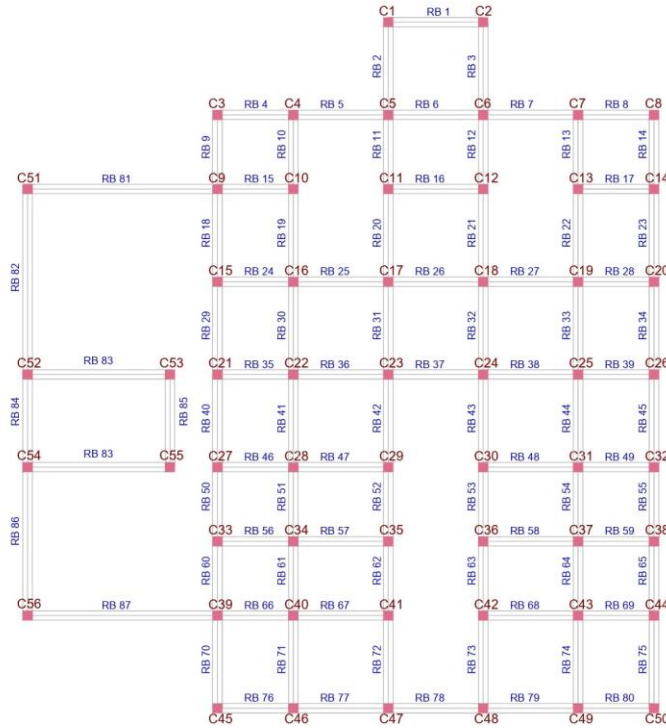
Fig. 4 Layout Plan Kampung Parit Lapis Bangas Mosque.

The assessment of Kampung Parit Lapis Bangas Mosque, as detailed in figure 11, should be cross-referenced with Figure 4 for easier defect localization. Sixteen timber defects were identified, with cracks/split and insect attacks, particularly termites, being the most prevalent, followed by various types of rot, peeling paint, knots, and others. Figure 12 shows the analysis of severity index for Kampung Parit Lapis Bangas Mosque.

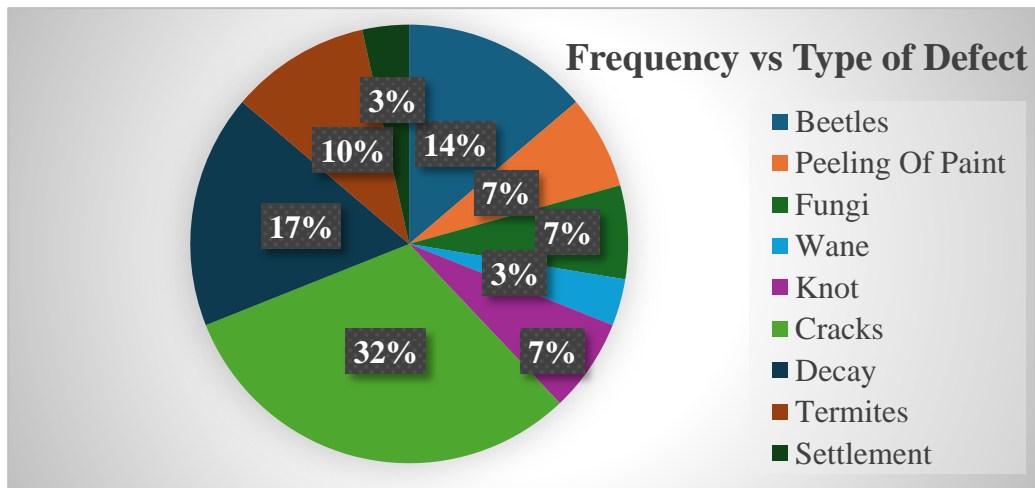
Fig. 7 Frequency vs Type of Defect.

Figure 7 below shows the frequency of defects occurring at Jamek An Nur Kampung Patah Pedang mosque. As seen in the chart, the highest frequency is for cracks, accounting for 32%, followed by decay with a frequency of 17%. The third-highest frequency is for beetles, amounting to 14%, and termites account for 10%. The remaining three defects, namely peeling of paint, fungi, and knots, make up 7%, while wane and settlement each contribute 3%.

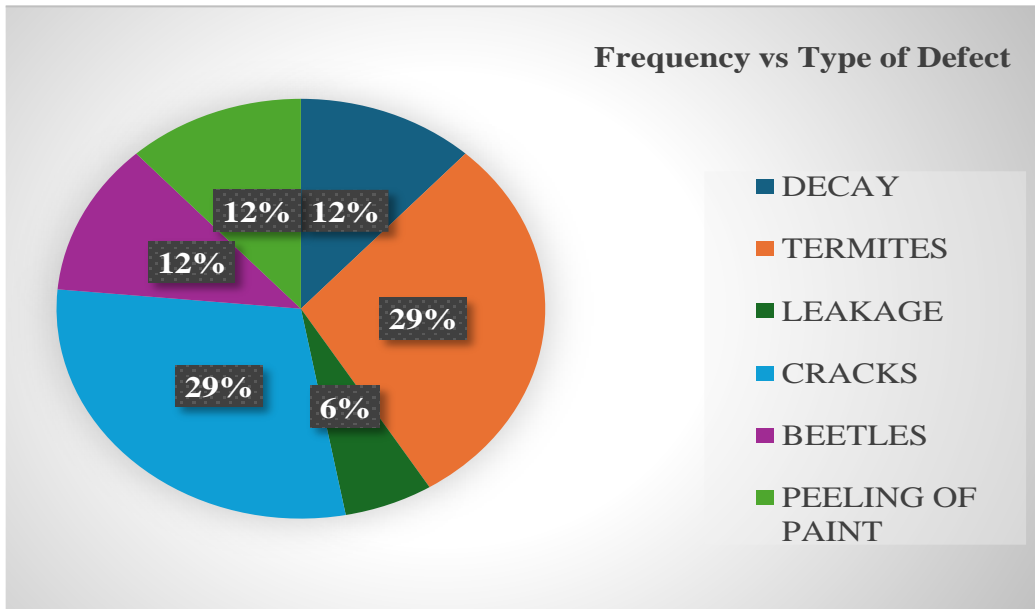
Fig. 13 Frequency vs Type of Defect.

Figure 13 below depicts the occurrence frequency of defects at Kampung Parit Lapis Bangas Mosque. As observed in the chart, the most prevalent occurrences are cracks and termites, constituting 29%, followed by decay, peeling of paint, and beetles with a frequency of 12%. The least frequent occurrence is leakage, accounting for 6%.
