# Thermal Gradient Pattern of Shallow Pitting Via Active Thermography-Water and Steam

**Abstract:** Pipelines are extensively used worldwide to transport water, oil and gas. Wall thinning or pits can be produced in the internal of the pipe after being used for a certain period of the time due to some factor such as erosion-corrosion and pitting corrosion. This problem concern lots of company in various industry because leakage of pipe cause system failure, hazard at workplace and increase of maintenance cost. This study detected internal wide and shallow pitting of pipe using infrared thermography. ASTM A106 Grade B carbon steel pipe test specimen was drill with five similar size defects shallow pitting within different depth. The result found that all defects appear at 90°C temperature exposure, while only four defects appear at 70°C and 80°C of temperature exposure. This is due to the higher temperature introduced into the pipe, the higher temperature gradient could be observed. Introducing a 90°C of heat source will produce the shortest time for the spot to appear while for 70°C take the longest time. Image analysis software assists to conclude that the defect areas are within

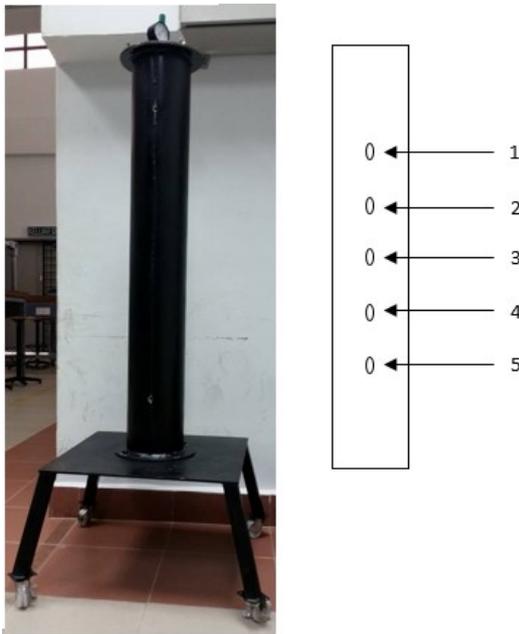
Fig. 1 Pipe with defect illustration

As to perform the study, a 1.0 m height of ASTM A106 Gr.B carbon steel pipe was used. The 6 inches diameter pipes with 10mm thickness were drilled at the inner surface with five similar size defects but different depth. Figure 1 shows the carbon steel pipe induced with an artificial defect while Table 1 lists the depth of the shallow pitting.

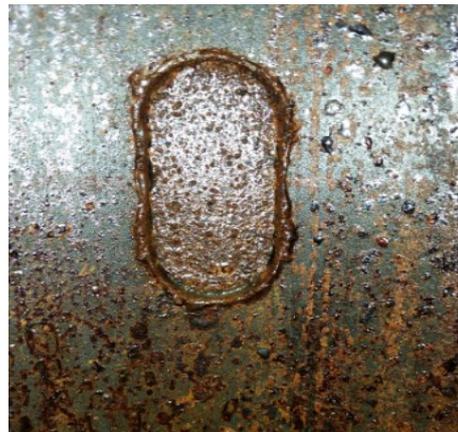
Fig. 9 Artificial wide and shallow pitting in pipe

Figure 9 shows an artificial of wide and shallow pitting in the carbon steel pipe. The actual cross section area is 626.71 mm<sup>2</sup>. Size ratio can be achieved by comparing both Thermal Image and Actual Image cross section area as to reveal another value added data.
