# Morphology of a Breached Embankment Due to Overtopping Flow

**Abstract:** An embankment is a man-made hydraulic structure, is built to provide flood control. It also presents risks to property and life due to their potential to fail and causes catastrophic flooding. In order to mitigate these risks, authorities and regulators need to carefully analyse and inspect embankment dams to identify potential failure modes and protect against them. This paper presents embankment failure morphology and the amount of erosion due to overtopping flow. The breached morphology is analysed for an embankment slope of 1V:3H. The embankment is constructed in the laboratory using a medium sand grain size of non-cohesive soil. The dimension of embankment height is 0.1 m and has been tested with inflows rate of  $Q = 0.8 \times 10^{-3} \text{ m}^3/\text{s}$ . Experimental results showed that the breached peak discharge is influenced by the morphology of the sediment eroded. The volume loss calculation of the embankment erosion is calculated using SURFER 8, indicating the volume of  $0.01 \text{ m}^3$  with the peak breached discharge of  $3.63 \times 10^{-3} \text{ m}^3/\text{s}$ , respectively. In c

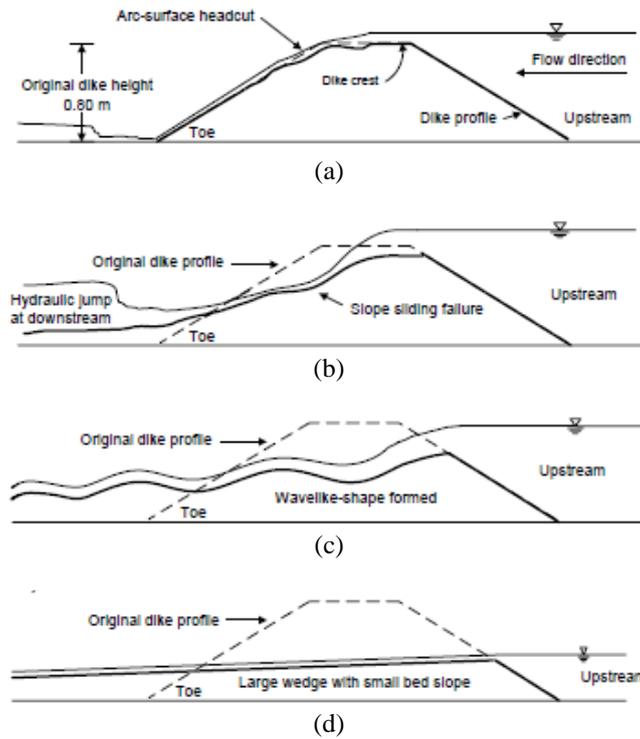
**Fig. 1 - Process of dike erosion due to overtopping: (a) Initial stage with small erosion on dike crest; (b) The second stage with slope sliding failure; (c) The third stage with wave shape formed; (d) The last stage with large wedge formed [15]**

Chinnarasri [15] have investigated the erosion of homogeneous embankment due to overtopping to determine the flow pattern by experimenting. From the experiment, he stated that after the overtopping has occurred, the damage could be classified into four stages, as illustrated in Fig. 1. Zone 1 is the region where less erosion might happen due to subcritical flow approaching the embankment, and the flow velocities and shear stresses above the crest are relatively low. Further along the crest, a so-called transition zone from subcritical to critical flow is observed (illustrated as Zone 2). This zone exhibited high stresses due to the changes in the energy slope. Zone 3 is an area with a high potential for erosion. The flow started to accelerate rapidly along the downstream slope, resulting in increased shear stresses at the downstream corner of the crest. In the process, the velocities over the embankment downstream face accelerate, causing the sediment entrainment into the flow and cause significant embankment erosion. In many cases of dam failure, the bottom of the breach will continually erode downwards until it reaches the bottom of the dam. Thus, suspended load gradually transported downstream concerning time and caused sand erosion until the embankment reaches a maximum failure. The formation of sediment typically changes along the length of the channel due to continuous flowing water [12]. There is a variety of shape to represent breach morphology, including rectangular, triangular, trapezoidal, parabolic, and semi-circular, among others. At the moment, there does not appear to be a method by which an exact breach shape can be computed.

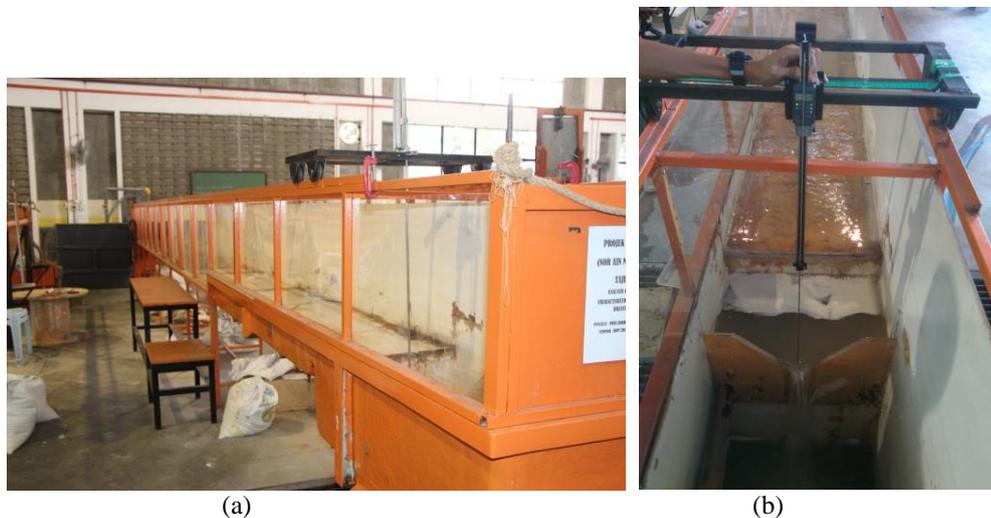
**Fig. 2 - Experimental setup: (a) A 11 m long x 0.6 m deep x 0.5 m wide flume; (b) a V-notch to measure discharge**

The breaching test for the embankment was carried out and took place at the Hydraulics and Hydrology Laboratory, Department of Hydraulics and Hydrology, Faculty of Civil Engineering. The testing was conducted in a 11 m long x 0.6 m deep x 0.5 m wide flume, as shown in Fig. 2. The water is pumped from the water tank to flowing from upstream to the downstream channel by passing through the embankment dam located at the middle of the channel, as illustrated in Fig. 3. Two cameras were installed to capture the progression of temporal embankment breaching to view from the top and front side. Then a v-notch is built at the end of the channel to measure the breached hydrograph during the breaching process. As for the embankment material, non-cohesive soil is used to construct the 0.1 m high embankment. The width of the embankment crest is 0.1 m. The face slope of the embankment is compacted and fixed at 1V:3H, as shown in Fig. 4. The breaching test uses a constant inflow rate of  $0.8 \times 10^{-3} \text{ m}^3/\text{s}$ . The inflow keeps constant until the overtopping process started and the water enters through the notch above the embankment crest.

where  $Q$  is the rate of discharge ( $m^3/s$ ),  $C_d$  is the coefficient of discharge, which takes a value of 0.61,  $g$  is the acceleration due to gravity,  $\theta$  is the angle of the V-notch and  $H$  is the height of water flowing through the notch. Eq. (1) is then used to obtain the hydrograph by plotting the discharge value against the time taken during the test. The value of peak outflow and time to peak is determined from the hydrograph obtained. Meanwhile, the water depth at the V-notch is measured using a point gauge to calculate the outflow discharge, as illustrated in Fig. 2(b).

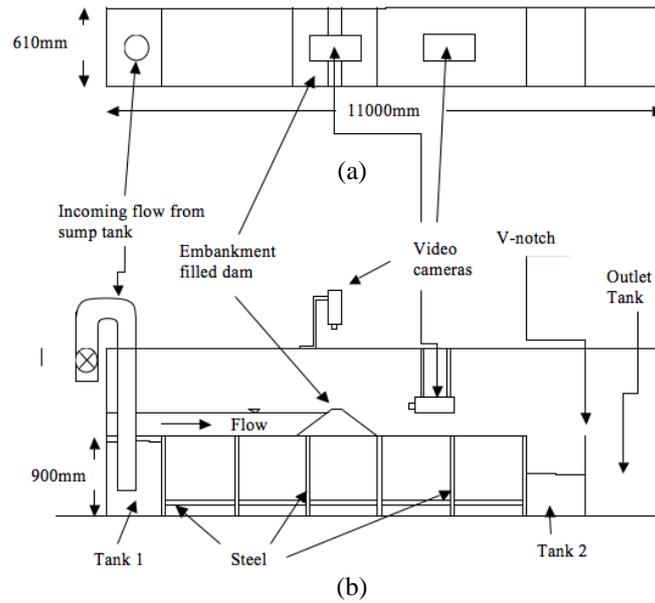
Fig. 3 - A schematic diagram of a channel setup: (a) plan view; (b) side view

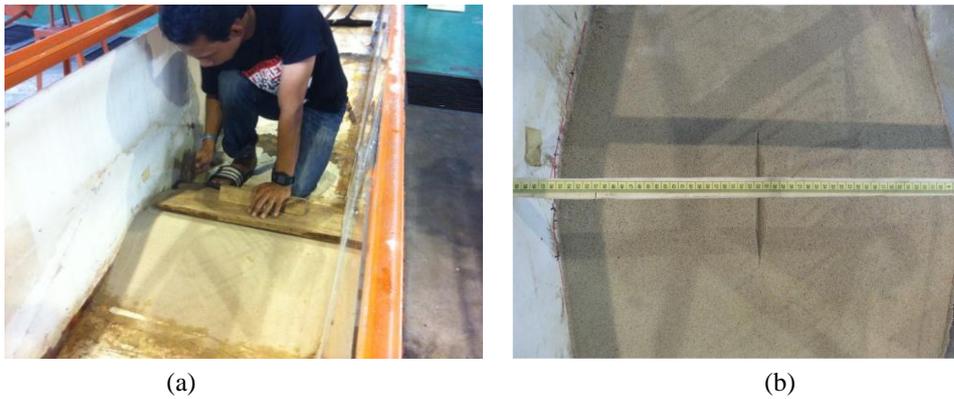
**Fig. 5 - Compacting the embankment: (a) compaction method; (b) a notch as the weak point of the embankment**

As for the embankment compaction procedures, the initial testing procedure was sieving the material of non-cohesive soil, which is in a range between 600 $\mu$ m and 250 $\mu$ m. Material sieved was compacted layers by layers to form the embankment at the middle of the channel, as shown in Fig. 5(a). The embankment compaction took place in two lifts of 50 mm each with water was sprayed for the ease of the compaction works. At the centre of the embankment crest, a notch was built, as shown in Fig. 5(b). It functioned as the weak point of the embankment dam. The notch size was 10 mm in height and 30 mm in width.

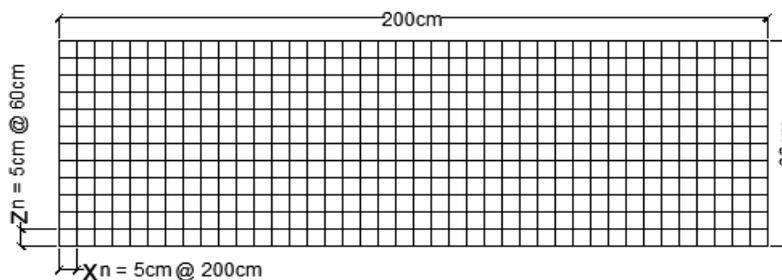
**Fig. 6 - A plan view of grids created as an intersection point to measure the sediment heights**

The analysis of volume calculation is carried out using a SURFER 8 program. It uses to contour a 3D surface mapping of embankment breached using shading and colours to emphasise the elevation data. The volume value of the surfaces created for specific reference surface,  $z = 0$  is calculated according to the rules of Trapezoidal rule, Simpson's rule and Simpson's 3/8 rule. The difference between these calculation rules depends on the different interpolation methods and grid ranges. Fig. 6 shows the grid used to record the data for the 3D surface modelling.

After the embankment has completely breached, the sediment morphology is recorded using a point gauge to determine the height of the sediment at a grid. Then the data is plotted in 3 axes;  $x_n$ ,  $y_n$ , and  $z_n$  ( $n = 1, 2, 3, \dots$ ) whereby  $y_n$  is sediment height at each point of the grid intersection of  $x$  and  $y$  axes. Each grid is fixed to 5 cm for  $x$ -axis and  $z$ -axis, while, the  $y$ -axis represents the height of the sediment recorded.

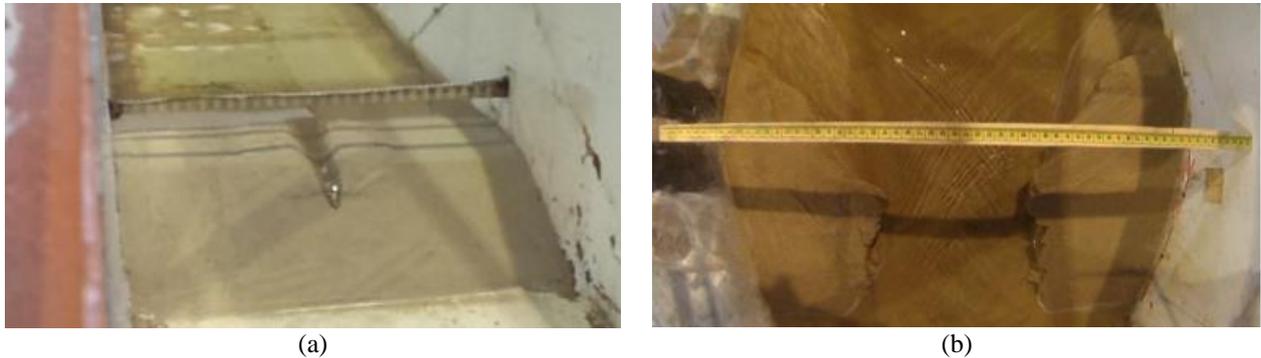
**Fig. 7 - Experimental morphology of an embankment failure: (a) Initial breaching; (b) after completely breached**

The breaching process starts when the flow enters into the notch as the result of overtopping flow. This is due to the fact that the water forces the embankment material been eroded. Also, the effect of hydrostatic forces behind the embankment triggers the embankment material to be transported away due to instability to cause failure to the embankment. After the breaching process has been completed, half of the embankment has been eroded by the stream and formed such bed locks, as shown in Fig. 7(b). The formation of sediment eroded to the downstream is varies based on the input of flow rates and compaction degree of the sediment.

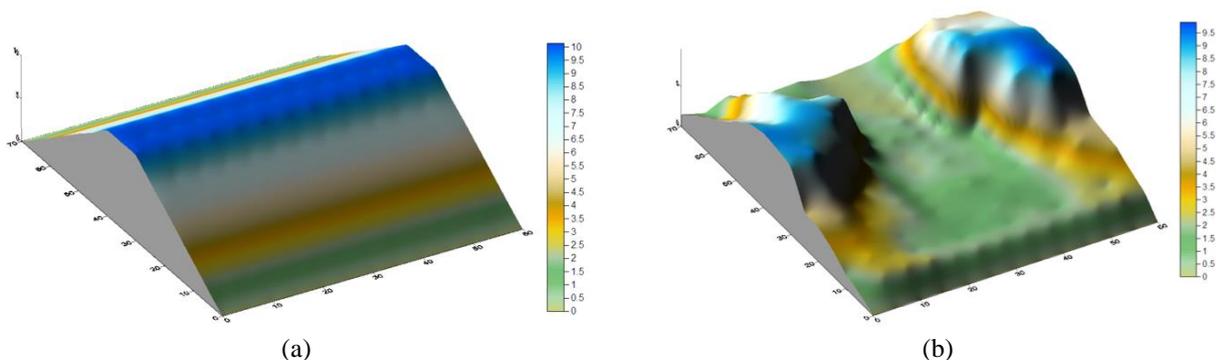
**Fig. 8 - 3D surface morphology using SURFER 8 of an embankment failure: (a) Before and (b) After failure. The legend (in colours) represents the elevation in cm**

When the embankment starts to breach, it continues to erode parts of the embankment. The process was initiated from the weakness part of the sediment. In this study, the final shape of the breached embankment due to erosion was almost symmetrical between both sides, which has a similar result found in [9]. Fig. 8 shows a plot of breached morphology and breached hydrographs after the embankment has completely breached. The heights of sediment remaining were recorded and plotted in SURFER 8 software for the volume loss calculation. The data was recorded for 5 seconds interval. The result of the peak flow rate for breach outflow hydrograph obtained was approximately  $3.63 \times 10^{-3} \text{ m}^3/\text{s}$ , which is occurred at 105 s, as shown in Fig. 9. Once the flow enters the notch (at  $t = 0 \text{ s}$ ), the overtopping begins and causes the breaching, approximately after 70 s. The erosion starts at the middle of the embankment (the notch) and widens laterally before eroding vertically like a trapezoidal shape from a front view. This might due to the initial shape of v-notch built at the crest of the embankment to trigger the erosion. When the water starts to flow through the notch, erosion takes place slowly at the middle of the crest until the embankment fails. The severe failure is due to hydrostatic pressures exerted on it, and this can be observed from the sharp changes in the hydrograph produced. The volume of the failure embankment is then measured and calculated using SURFER 8. The volume before the failure is approximately  $0.024 \text{ m}^3$ , which is close to the exact value of the theoretical calculation. After the failure, the remaining embankment volume calculated was approximately  $0.014 \text{ m}^3$  for all the calculation methods (rules) from the SURFER software. The results indicate that the volume loss of the failure embankment due to erosion was approximately  $0.0079 \text{ m}^3$ , as indicated in Table 2. Fig. 8 illustrates the erosion pattern of the breached embankment from the SURFER 8 analysis.

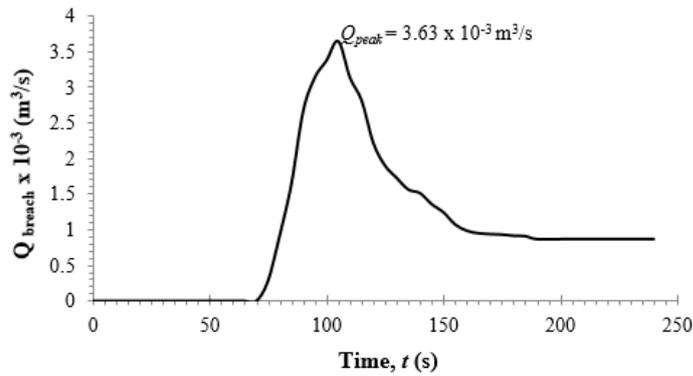
Fig. 9 - A breached hydrograph of the embankment failure

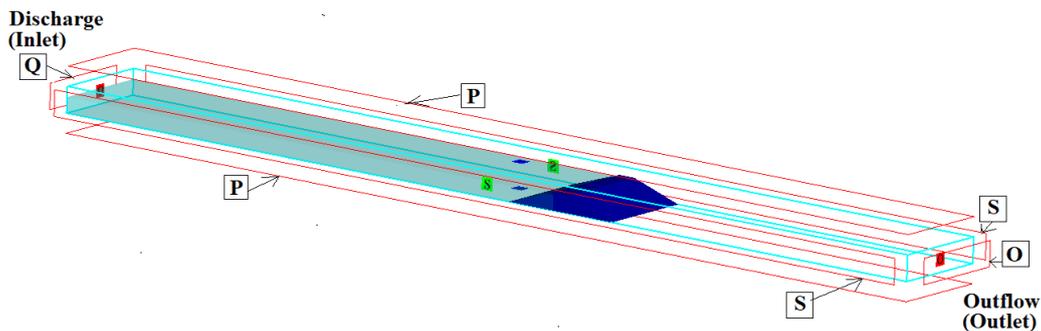
Fig. 10 - Initial and boundary conditions setup: S– symmetry, Q – Discharge (inlet), O – Outflow (outlet) and P- Specified Pressure. The dark blue represents the embankment, and the light blue area represents the initial flow depth

The simulation results using the FLOW-3D version 11 are presented as a validation. The model setup is similar to the set up in the laboratory. The sediment scours model in FLOW-3D uses a packed sediment as bedload transport to simulate the erosion. A packed bed is an erodible solid object that is used to represent solid objects in the hydrodynamic solver. The morphological change in the packed bed is governed by the conservation of sediment mass. The model used the Meyer-Peter and Muller with a critical Shields number of 0.05, entrainment coefficient 0.018, and a bed load coefficient of 8; as default values in the model setup. The embankment is made of two sediment grain sizes: 0.3 mm and 0.4 mm, and a density of 2080 kgm<sup>-3</sup>. This material is closely similar to the experimental of breach embankment where the grain size ranging from 0.2 mm – 0.5 mm. Fig 10 shows the initial and boundary conditions of the model setup in FLOW-3D.

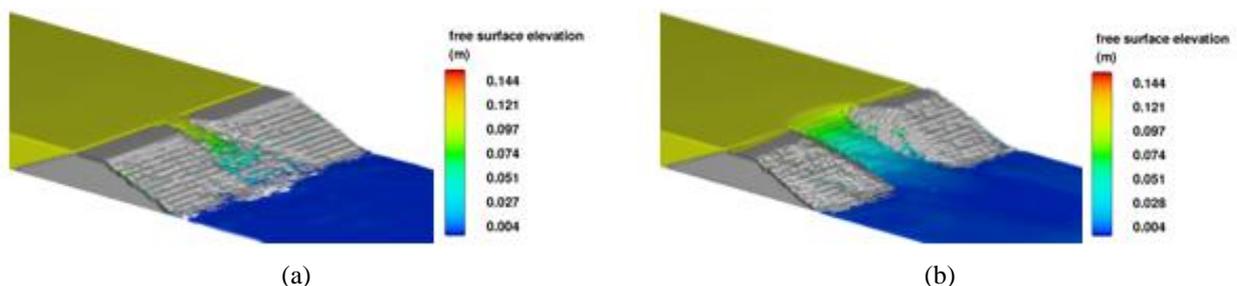
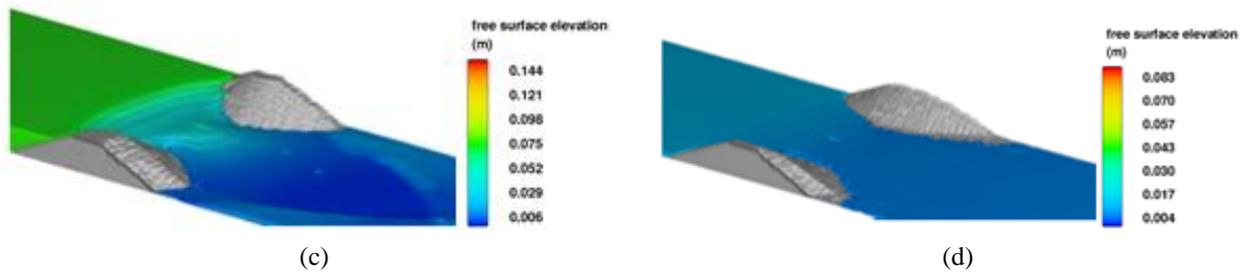
**Fig. 11 - Temporal progression of free surface flow over the breached area: (a)  $t = 40$  s; (b)  $t = 60$  s; (c)  $t = 78$  s; and (d)  $t = 250$  s**

Results on free surface elevation for a specific time, are shown in Fig. 11. As the flow enters the notch, the flow accelerates onto the embankment downstream face, so-called overland sheet flow. At this point, the embankment erodes at the surface and tends to deepen the erosion vertically, as shown in Fig. 11(a), and laterally in Fig. 11(b) to Fig.11(d). **Error! Reference source not found.** 12 plots the breached hydrograph and remaining embankment volume after the breach is completed. It showed that after approximately 250 s of the simulation time, there is no breaching occurred. The result indicated that the peak flow occurred at  $t = 78$  s, with a maximum peak discharge of  $5.19 \times 10^{-3} \text{ m}^3\text{s}^{-1}$ . Meanwhile, the remaining embankment volume at a peak time was  $0.012 \text{ m}^3$ . The embankment continually eroded until the flow became stable after approximately 200 s. The final remaining embankment volume recorded was  $0.007 \text{ m}^3$ .

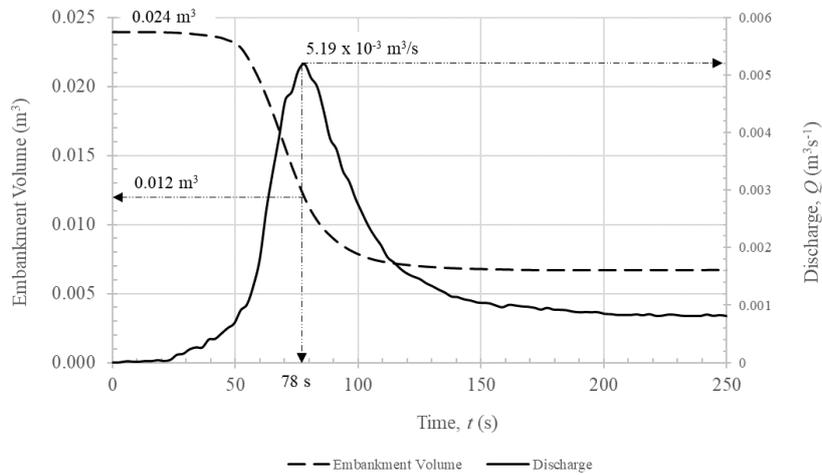
**Fig. 12 - The breach hydrograph and embankment volume during the breaching time**

Table 2 shows the comparison results of volume loss and the breached hydrograph between FLOW-3D and the experimental results of Case Study E1. The volume loss calculation from the experiment using the Trapezoidal Rule in SURFER and MATLAB analysis was found the same value of approximately  $0.01 \text{ m}^3$ . However, in FLOW-3D, the embankment volume loss calculated was  $0.017 \text{ m}^3$ , which gave a percentage difference of 42.7%. As for the breach of hydrograph analysis, FLOW-3D predicted difference of 30.2%. Similarly, the result of time to reach the peak flow indicates a difference of 34.6%. The analysis showed that the FLOW-3D predicts more erosion compared to the experimental results. This might due to the characteristics of the packed sediment arrangement setup in FLOW-3D, which affects the numerical method's results in the transport equation.
