Development of Graphical User Interface for Analysing Induction Motor Current Frequency Spectrum

Abstract: In this paper, the development of a graphical user interface (GUI) for analysing the induction motor current frequency spectrum by applying the motor current signature analysis (MCSA) method is presented. Conventionally, analysing the current signature can be time-consuming and reduce the efficiency of the analysis work. Due to that, a GUI is developed to allow the engineer to conduct the analysis efficiently whereby many motors can be monitored. The faults that are analysed are broken rotor bars, stator winding faults, static eccentricity, and dynamic eccentricity. The software used to develop the GUI is the MATLAB App Designer, which allows the user to design the layout and specify the programming according to the desired outcome. To verify the GUI workability, the analysis is carried out by using the conventional method whereby the current measurements provided are analysed in MATLAB. Then, the same data is analysed in the GUI developed. The analysis from both MATLAB and GUI was developed to show that there is an occurrence of at least one type of fault in the motors analy

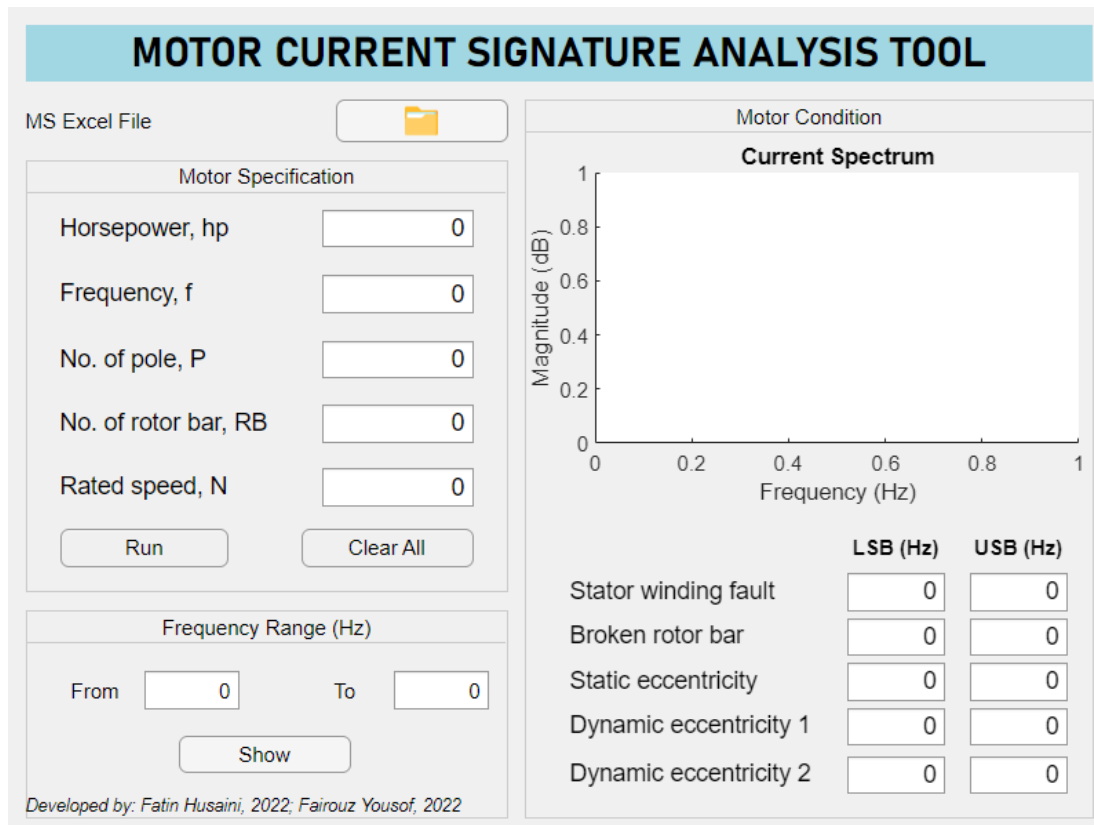
Figure 2: Layout of the developed GUI

Figure 2 shows the layout of the developed GUI. The layout of the GUI can be customized by using the available tools and settings. The type of file that can be read by this GUI is an xlsx file only. Users can start by opening the current measurement file, and then fill in the motor specifications. To analyse the current and obtain the sideband frequency, click the ‘RUN’ button. The spectrum will be presented, and the value of the sidebands’ frequency are shown respectively. To clear the input and output data, click the ‘Clear All’ button. The interface can be maximized according to the user’s screen size. The spectrum can be zoomed in and zoomed out to analyse it further.

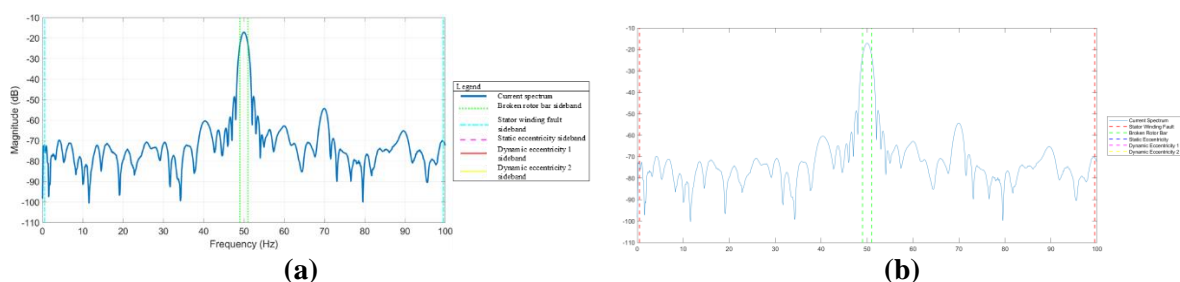
Figure 4: (a) Low-frequency current spectrum in the frequency domain for chilled water pump 1 motor from a manual calculation using MATLAB, (b) Frequency spectrum for chilled water pump 1 from GUI

As shown in Figure 4 (a), the current spectrum range is up to 100 Hz. It can be observed that the motor experience a broken rotor bar as there is a peak at both sidebands. As observed from the stator winding fault lower sideband, 0.5 Hz and upper sideband, 99.5 Hz, there is no significant rise in the magnitude which indicates that the motor is free from stator winding fault. The data for high frequency is unavailable. As shown in Figure 4 (b), observing from the broken rotor bar sidebands, the motor experience as a broken rotor bar. There is no peak at other sidebands. It can be concluded that the fault analysis by using the graphical user interface developed is accurate.
